ARCHITECT'S FIELD REPORT

PROJECT	Eagle's Nest Townhouses 11 Morning Glory Way & 31 Marcellina Lane Mt. Crested Butte, CO 81225	DATE	5/9/11
----------------	--	-------------	--------

WORK OBSERVED
Phase II – Roof Audit, Existing Conditions Units 1 through 8

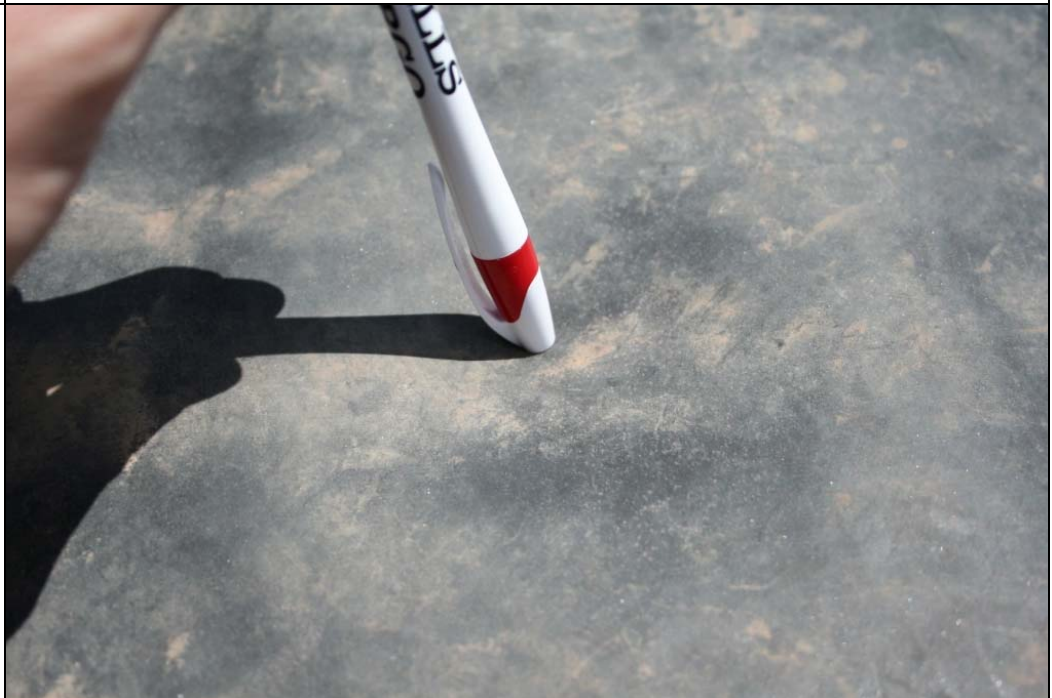
**Unit 1
Photo 6**

Notes: Detail of membrane condition – membrane is bubbling up and is not adhered to the substrate. Note dimple caused by pressure from pen.

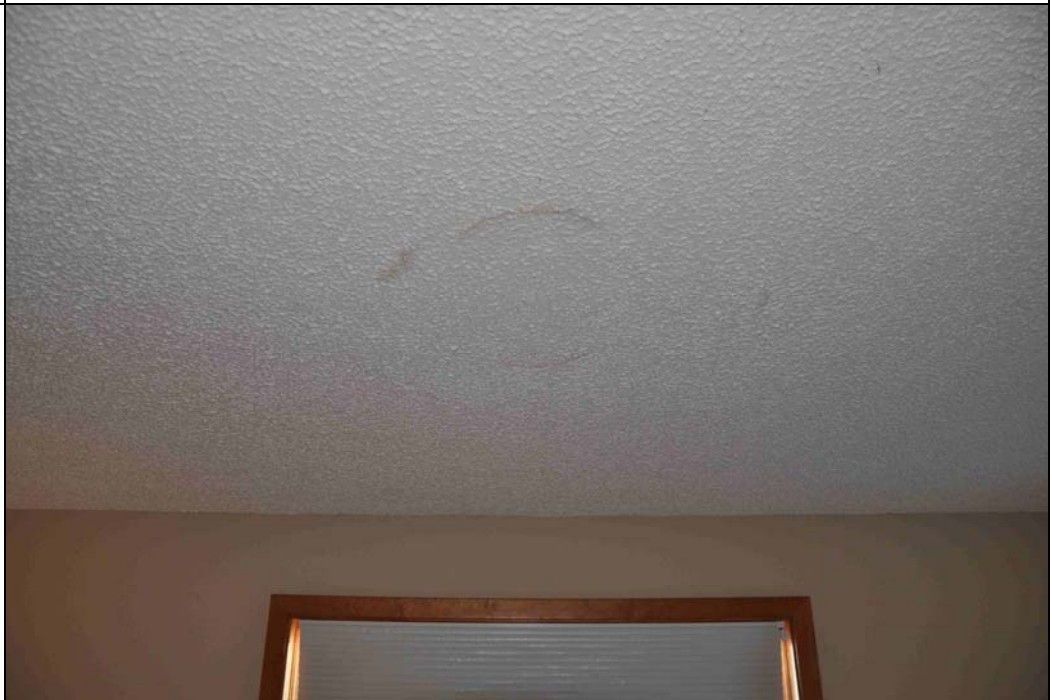
**Unit 5
Photo 6**

Notes: CBL Interior Photo of drywall damage.

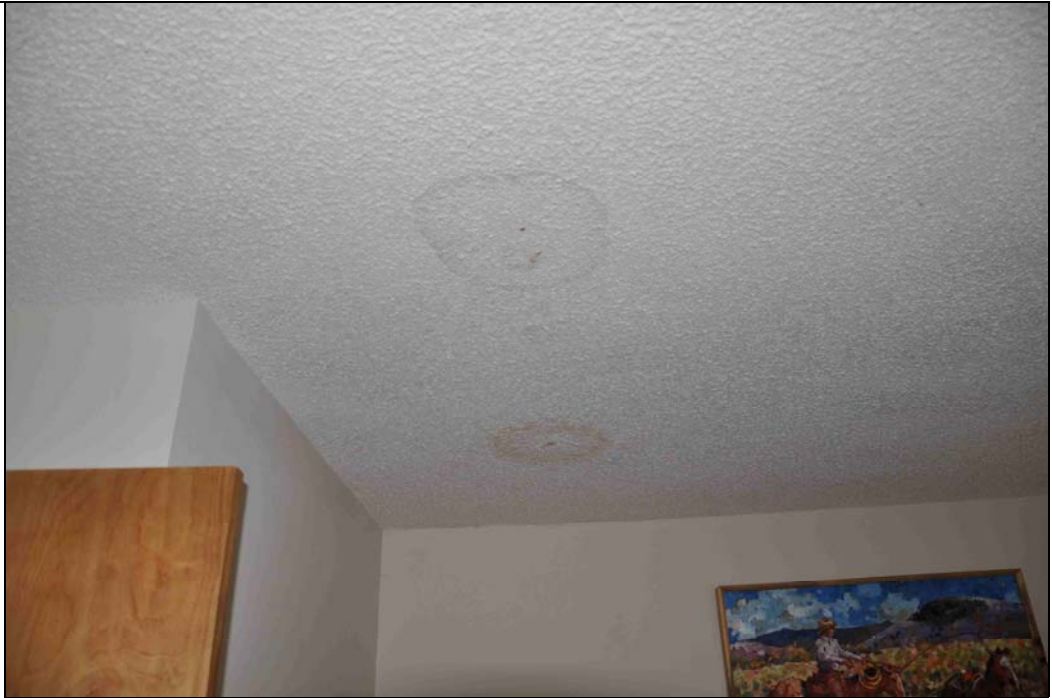
**Unit 6
Photo 5**

Notes: CBL Interior Photo of drywall damage.

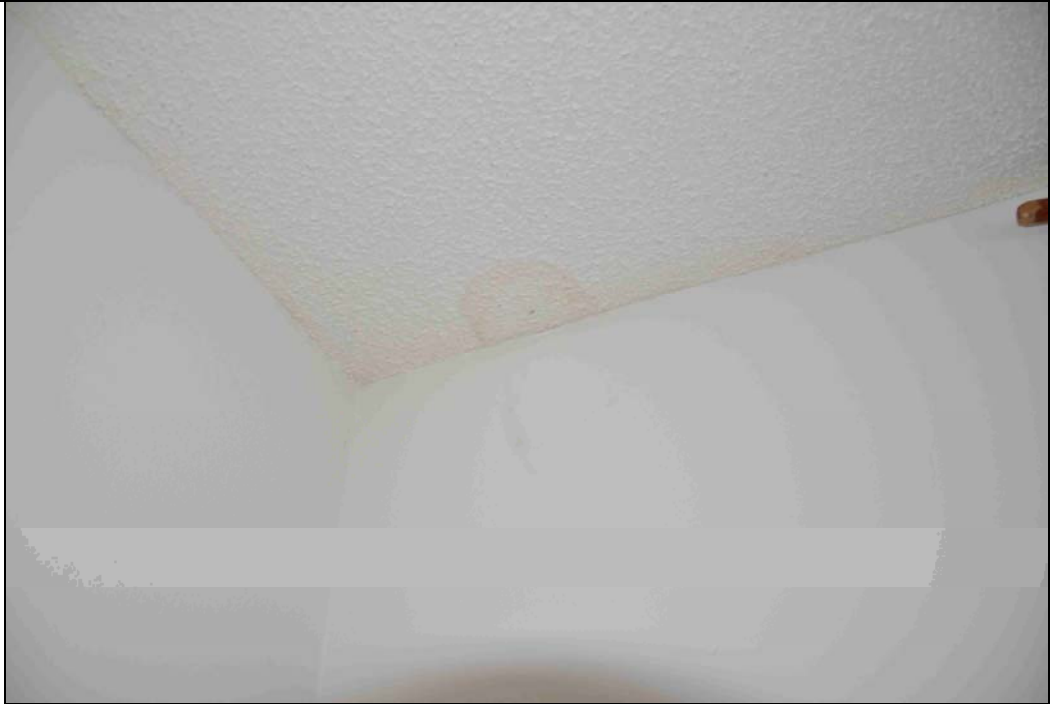
Unit 8
Photo 6

Notes: CBL Interior Photo of drywall damage.

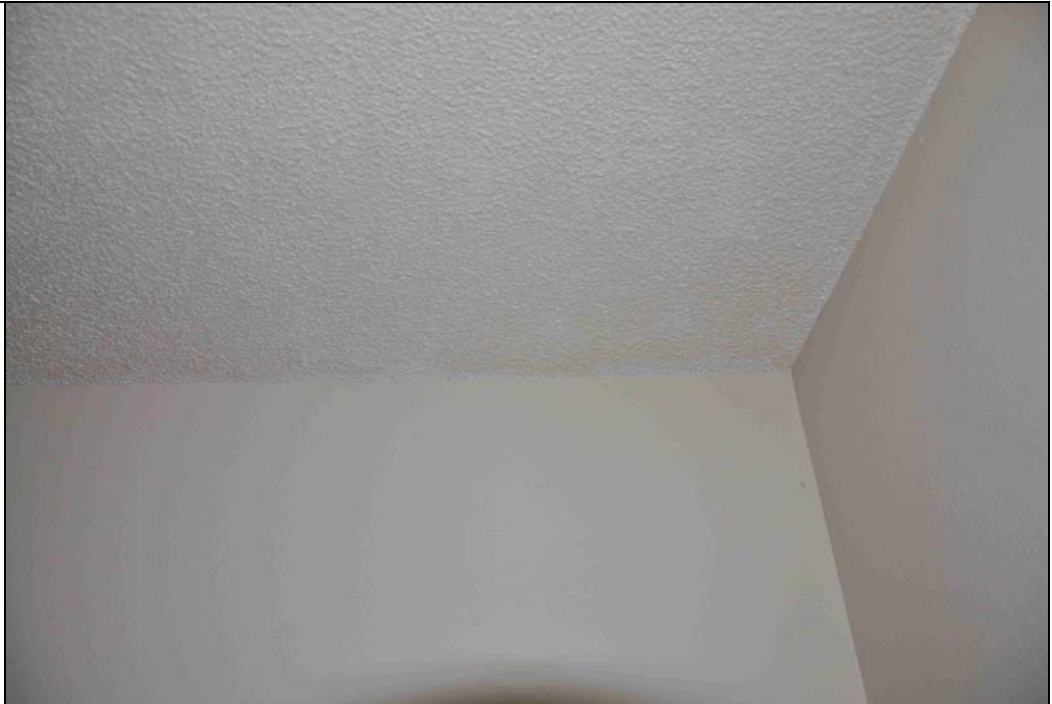
**Unit 12
Photo 4**

Notes: CBL Interior photo showing drywall damage.

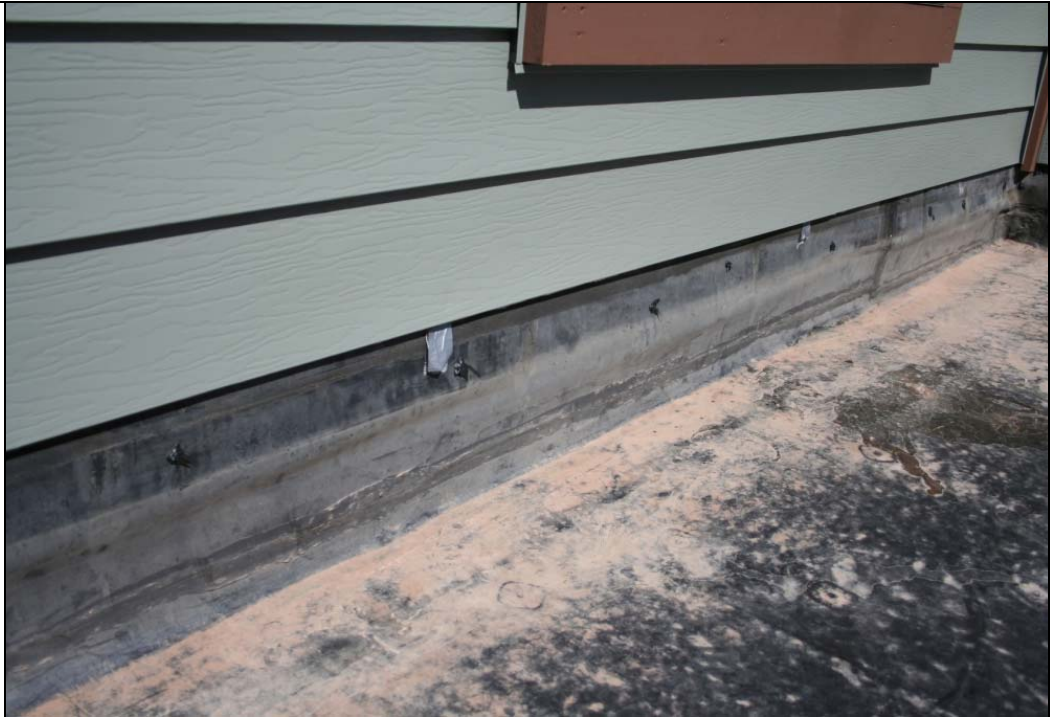
**Unit 17
Photo 5**

Notes: Nail holes/penetrations have been sealed along the perimeter.

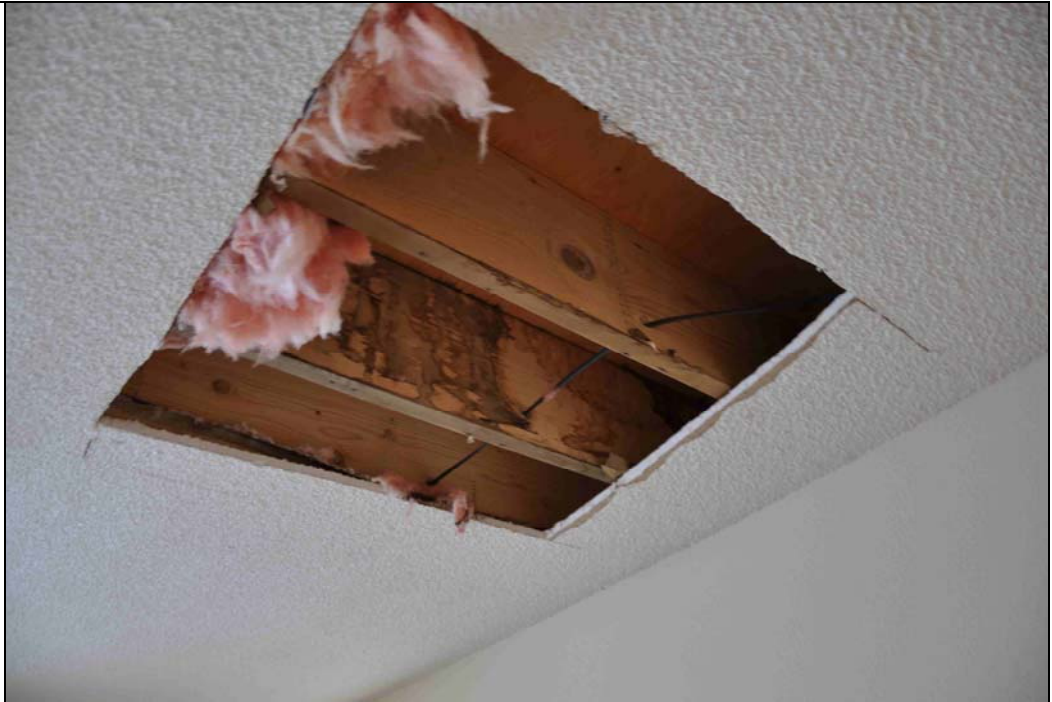
**Unit 17
Photo 7**

Notes: CBL Interior photo of drywall damage. Damaged area has been removed.

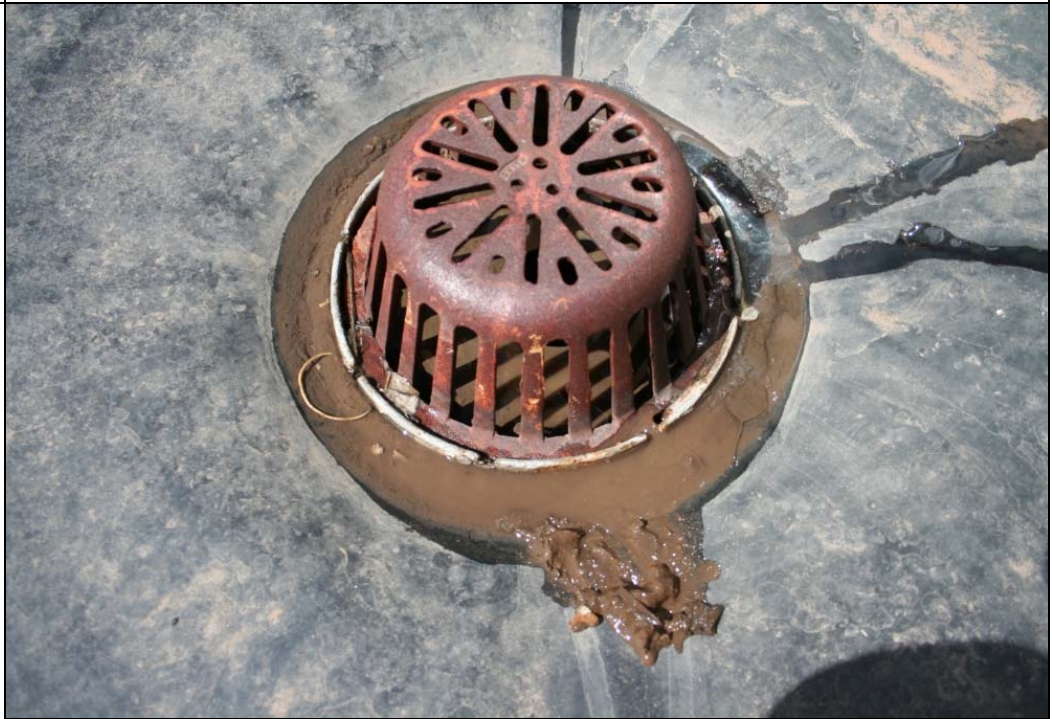
**Unit 18
Photo 5**

Notes: Debris and dirt removed from outside ring of roof drain.

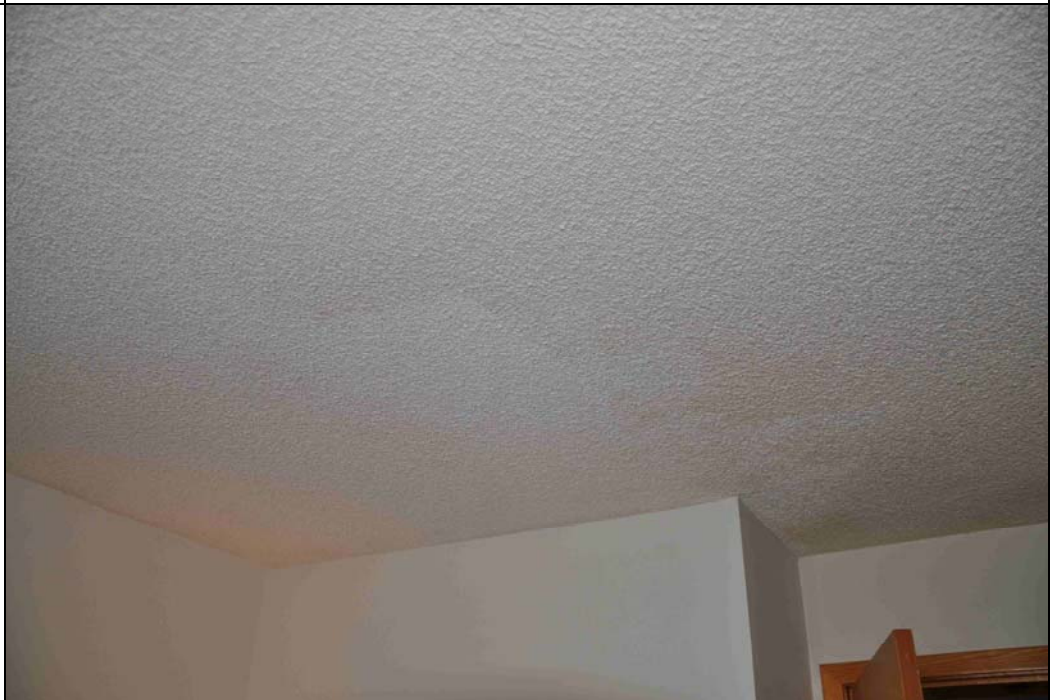
**Unit 18
Photo 7**

Notes: CBL Photo of interior drywall damage.

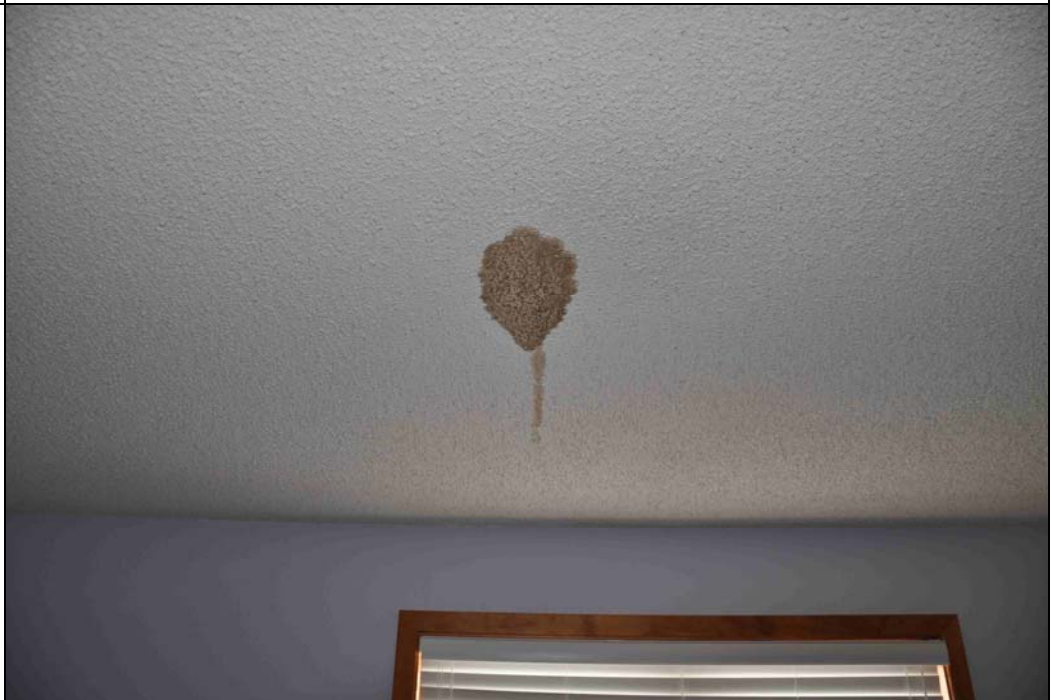
**Unit 19
Photo 6**

Notes: CBL Interior photo showing drywall damage.

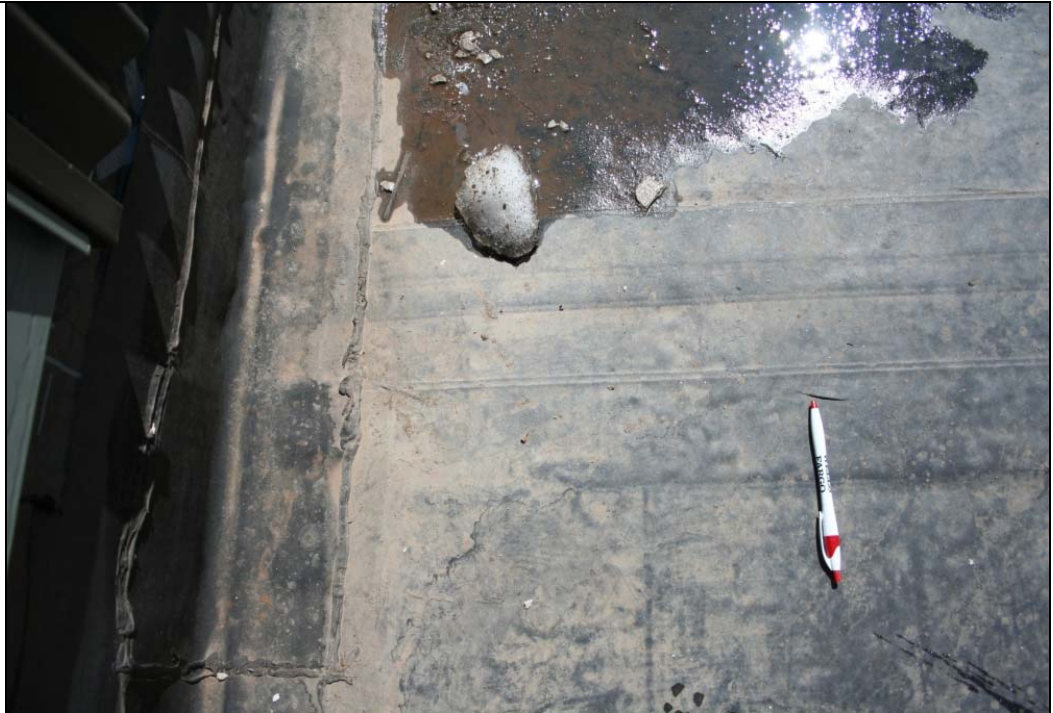
**Unit 20
Photo 5**

Notes: Gash in membrane approximately 1'-4" north of the south wall.

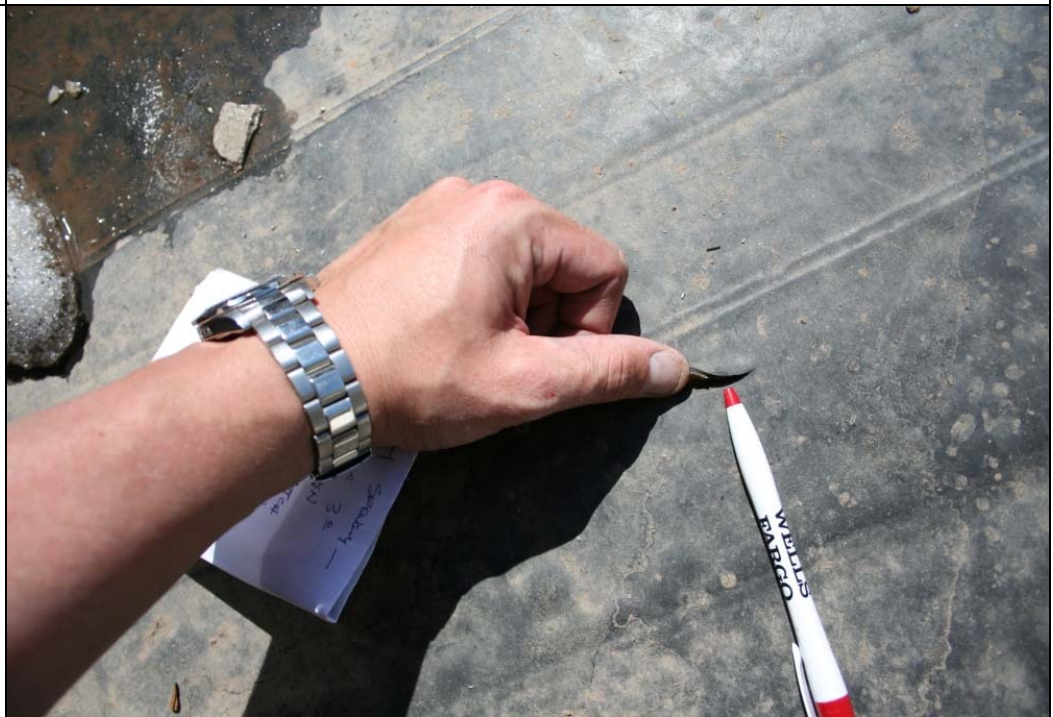
**Unit 20
Photo 6**

Notes: Detail of gash in Photo 5. Measures approximately 1" long.

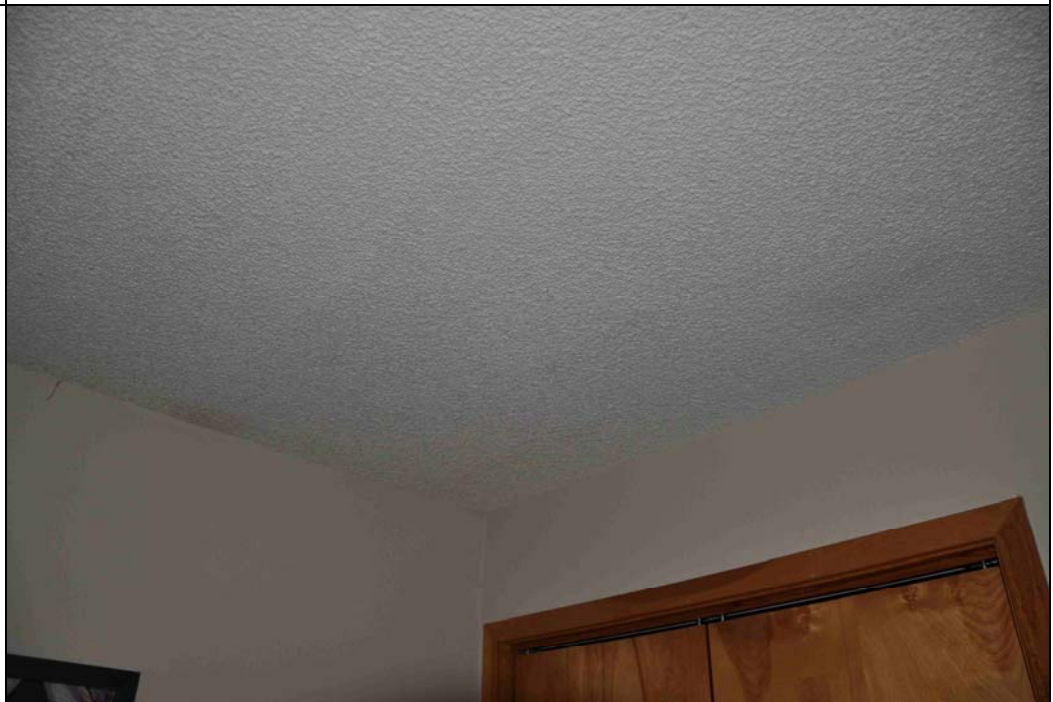
**Unit 21
Photo 11**

Notes: CBL Interior photo showing drywall damage.

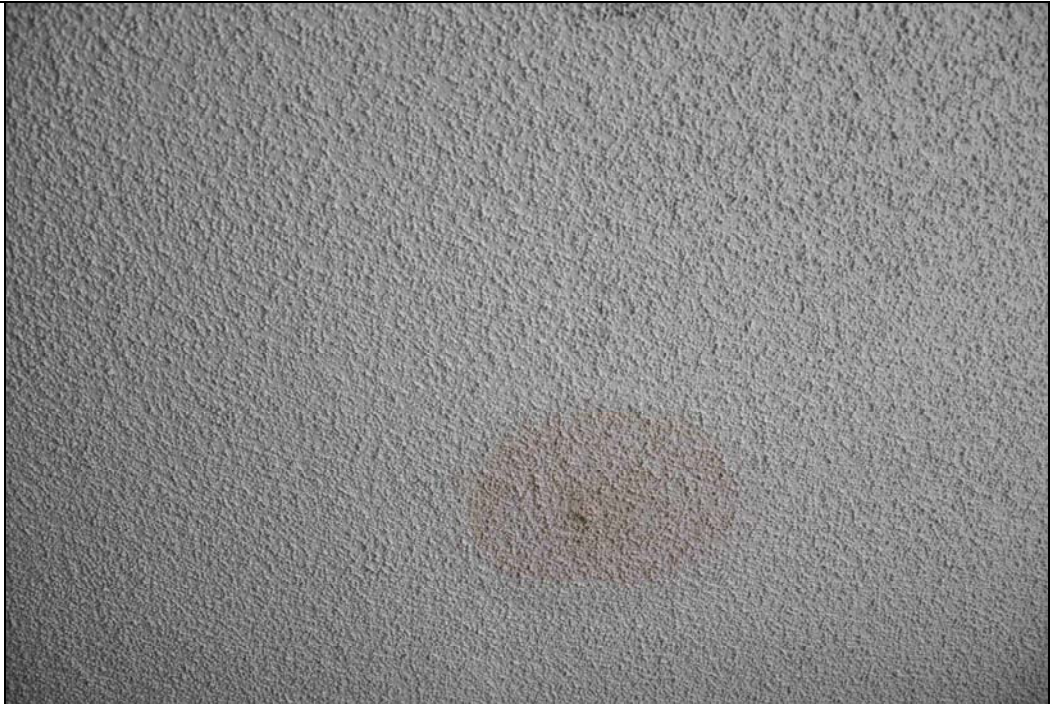
**Unit 22
Photo 5**

Notes: CBL Interior photo of drywall damage.

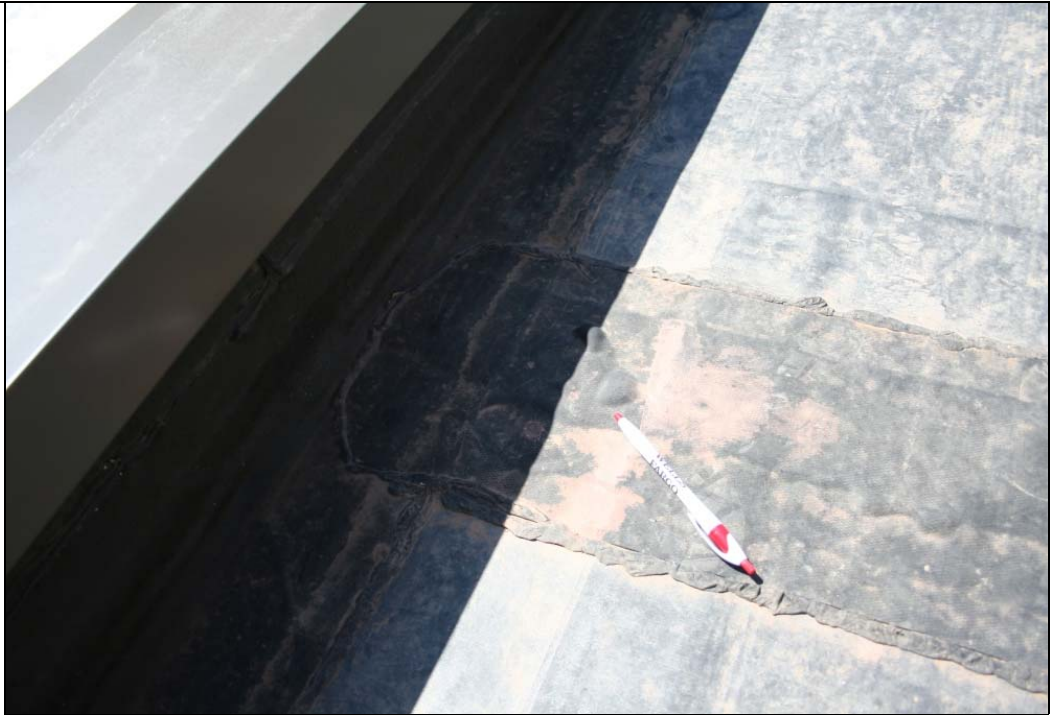
**Unit 23
Photo 4**

Notes: Bubbling in seam in multiple locations.

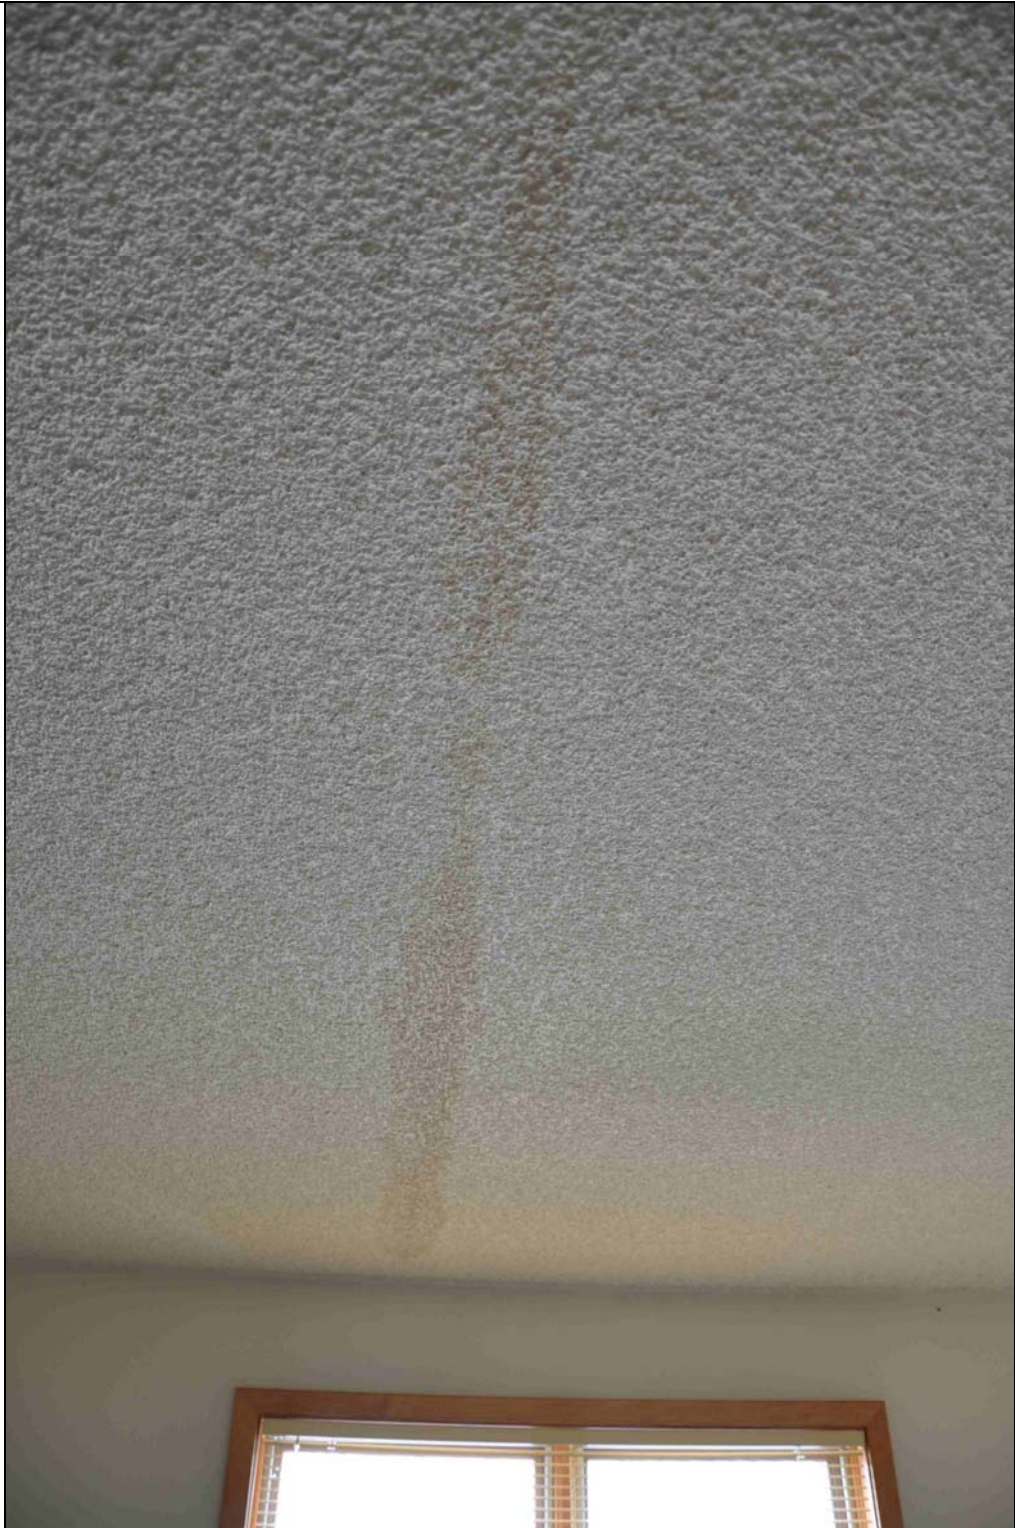
Unit 24
Photo 4

Notes: CBL Interior Photo of drywall damage.

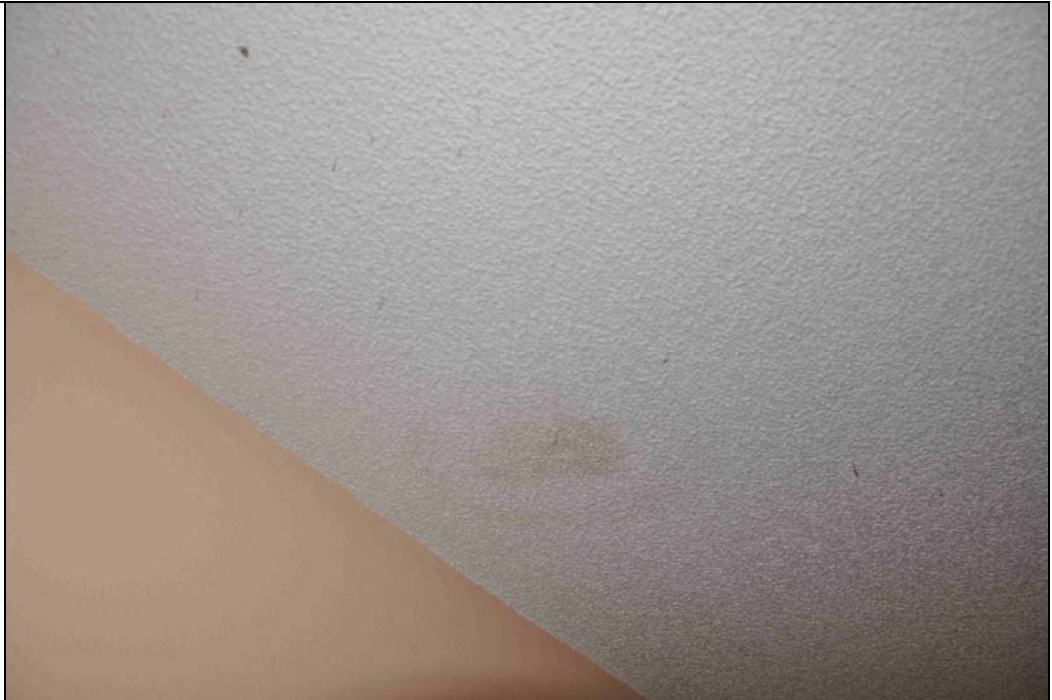
**Unit 25
Photo 5**

Notes: CBL Interior photo of drywall damage.

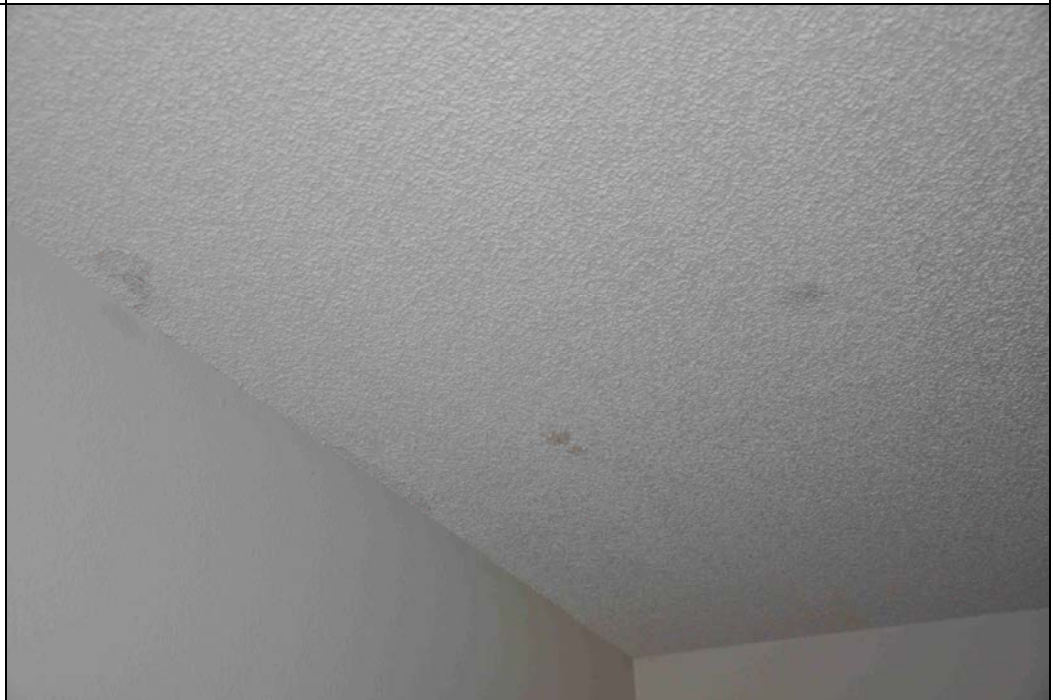
**Unit 26
Photo 5**

Notes: CBL Interior photo showing drywall damage.

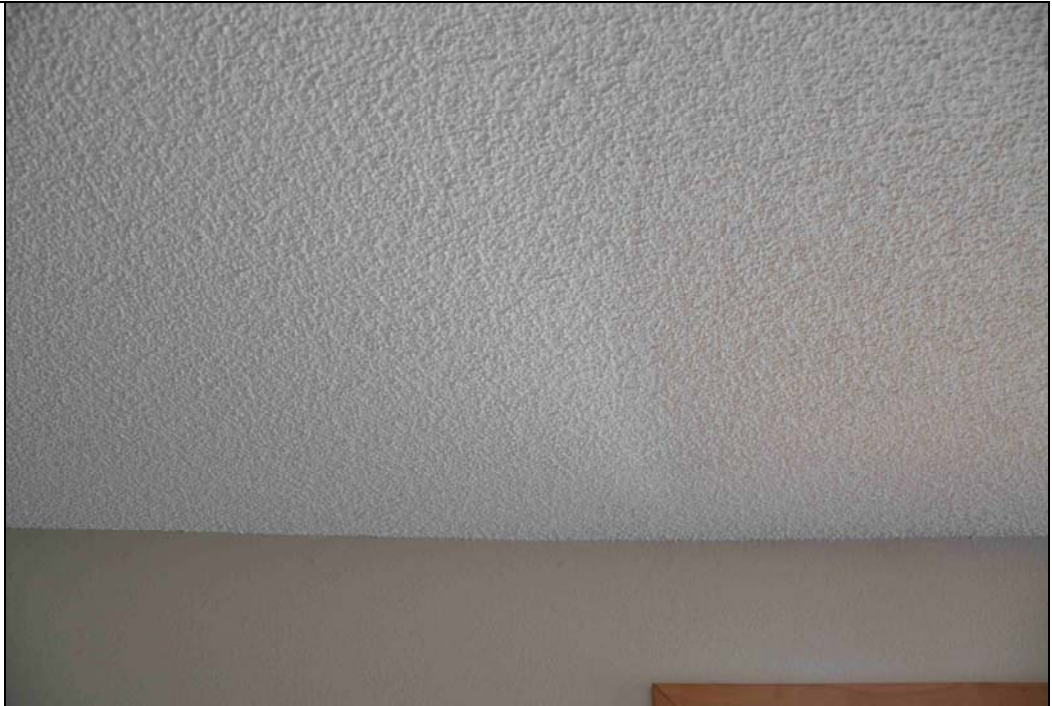
**Unit 27
Photo 5**

Notes: CBL Interior photo showing drywall damage.

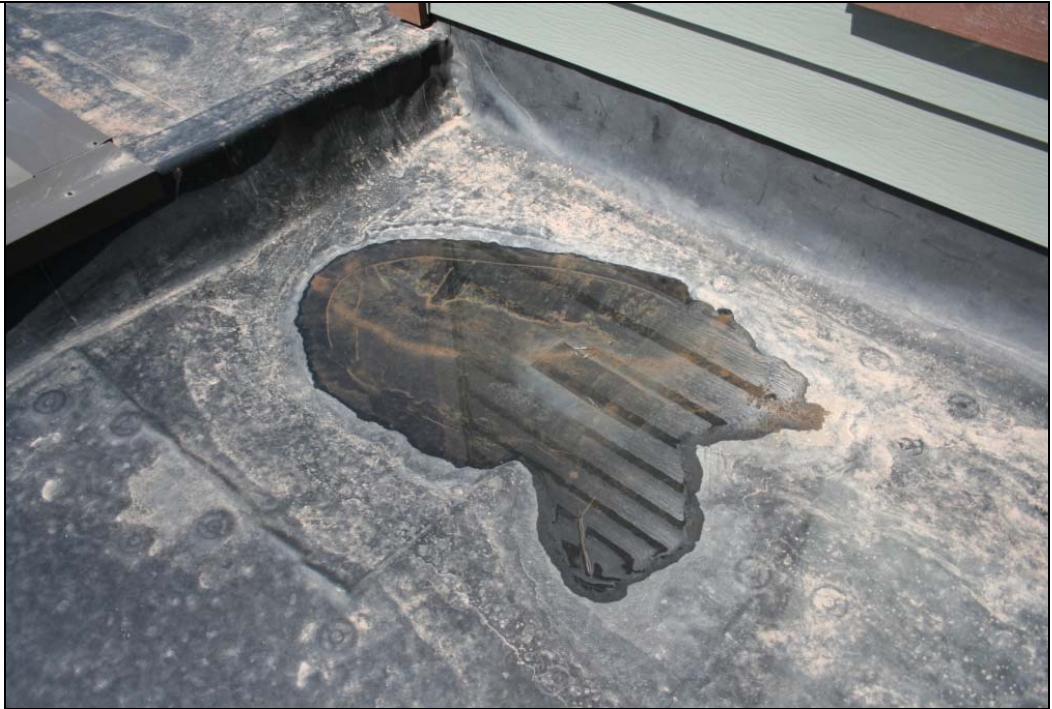
**Unit 28
Photo 4**

Notes: Ponding water in northeast corner. Rectangular area in corner approximately 3' by 4' (outline visible) is loose and unstable.

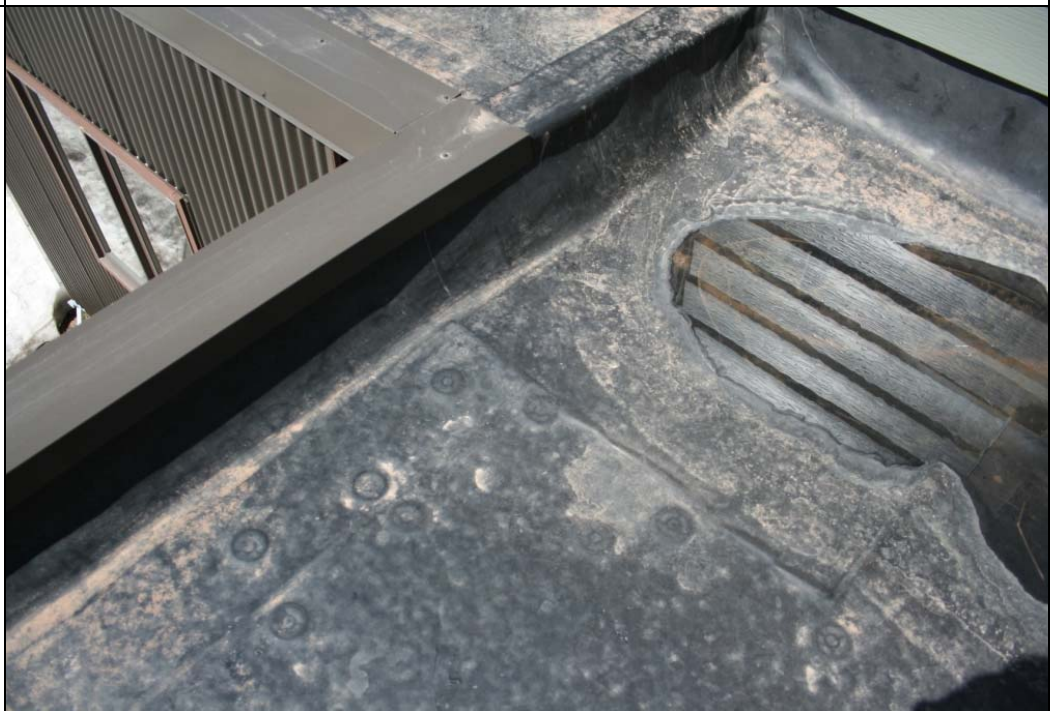
**Unit 28
Photo 5**

Notes: Detail of ponding water and area of loose substrate from Photo 4.

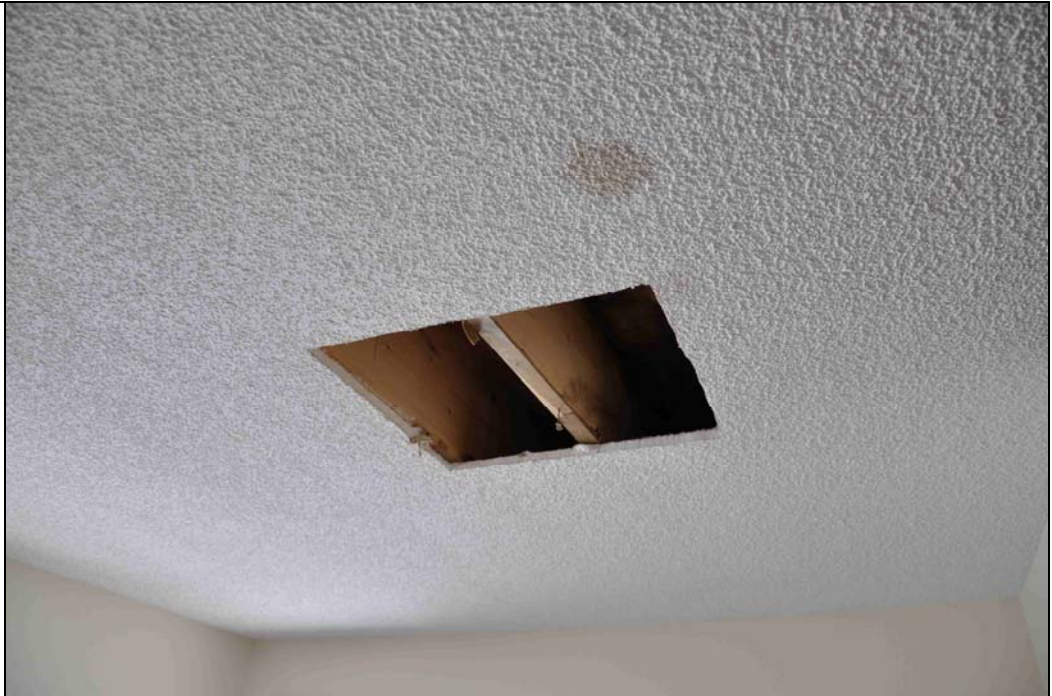
**Unit 28
Photo 6**

Notes: CBL Interior photo of drywall damage. Area of damaged drywall has been removed.

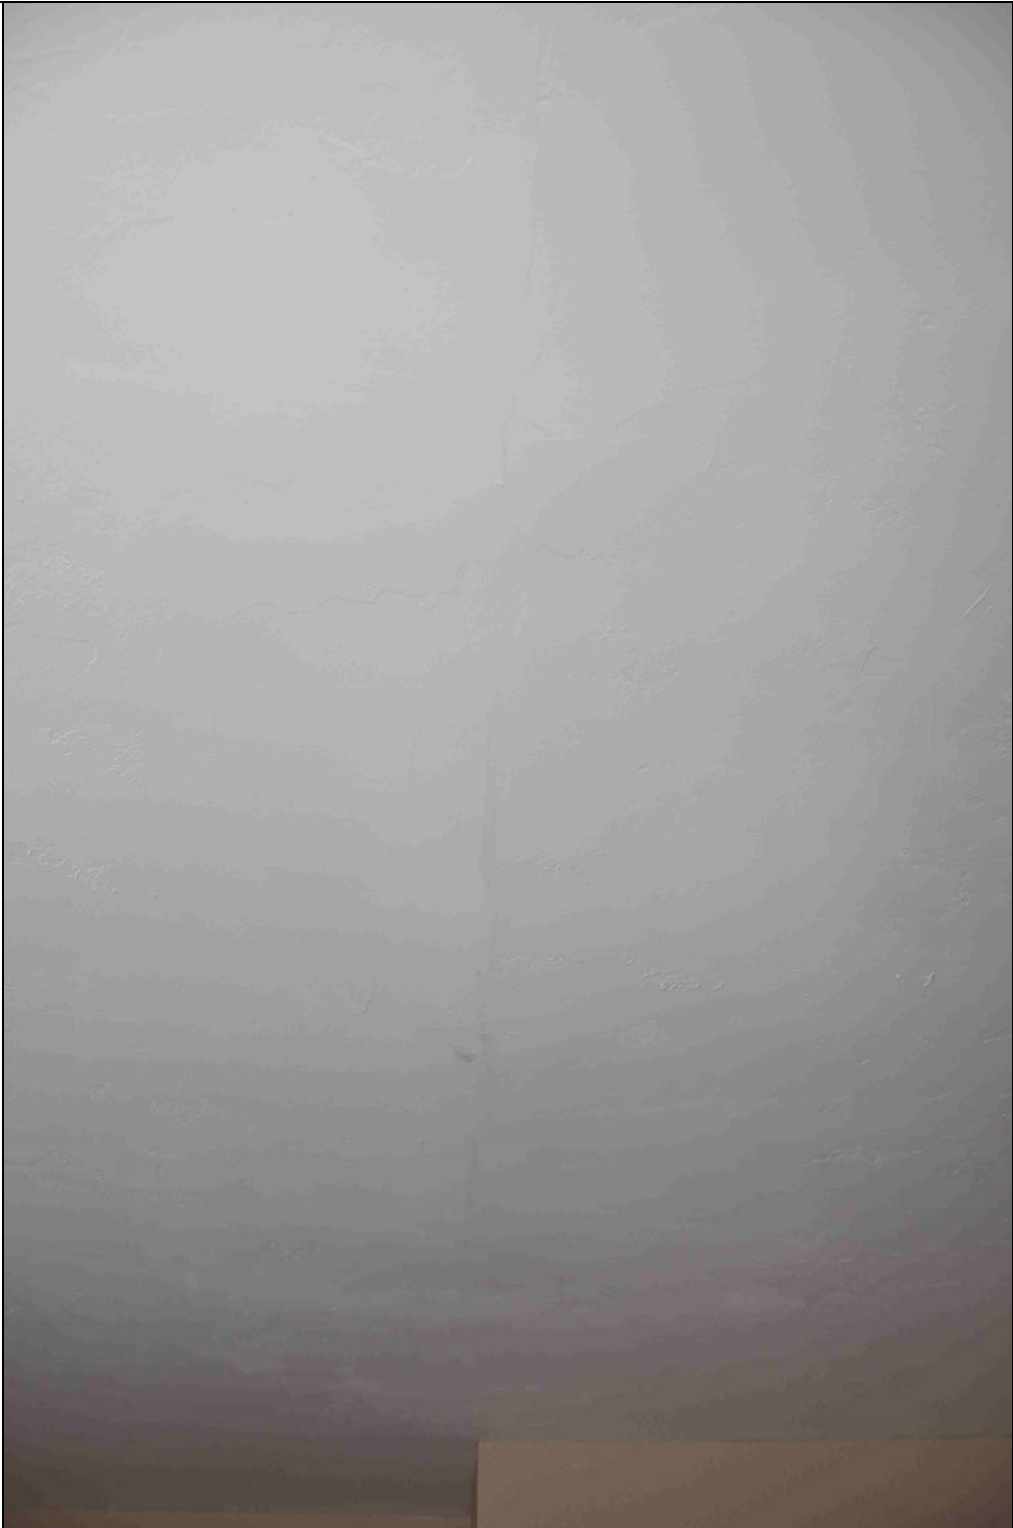
Unit 29
Photo 4

Notes: CBL Interior photo showing drywall damage.

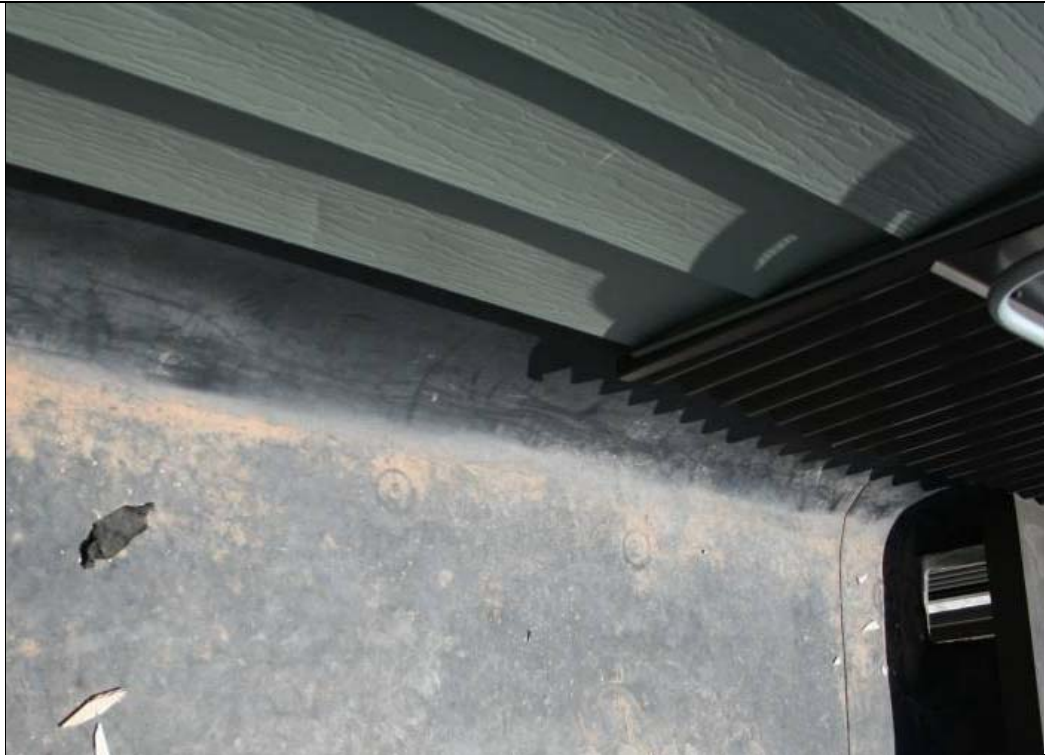
**Unit 30
Photo 3**

Notes: Location photo of sealant. It was not determined if this sealant covers a penetration.

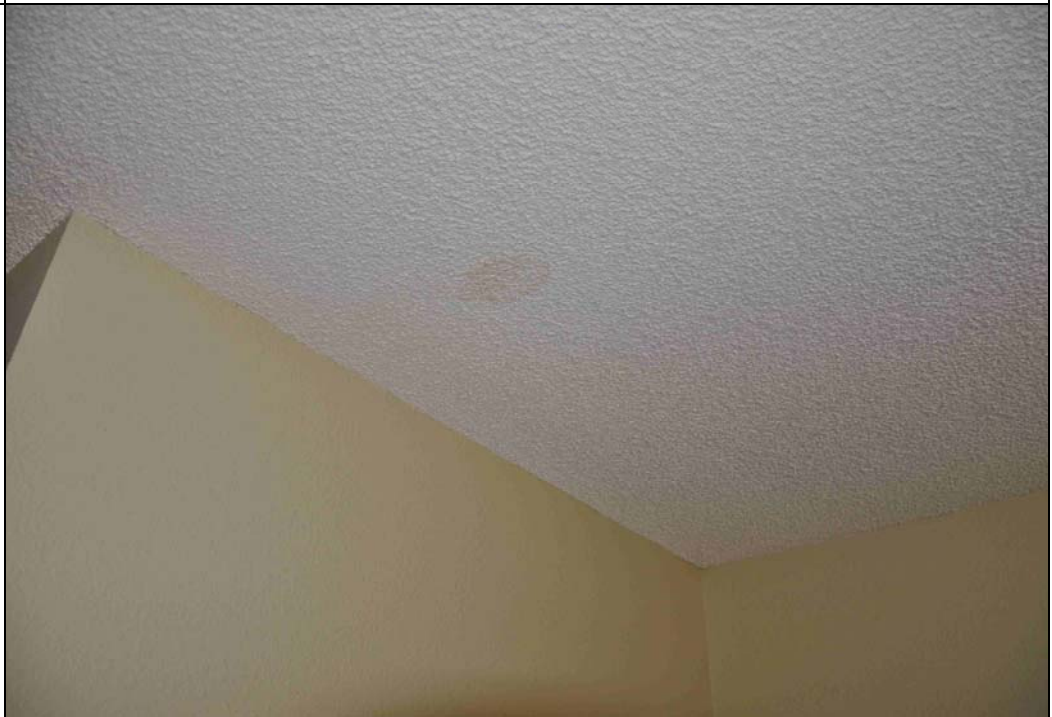
**Unit 31
Photo 5**

Notes: CBL Interior photo showing drywall damage.

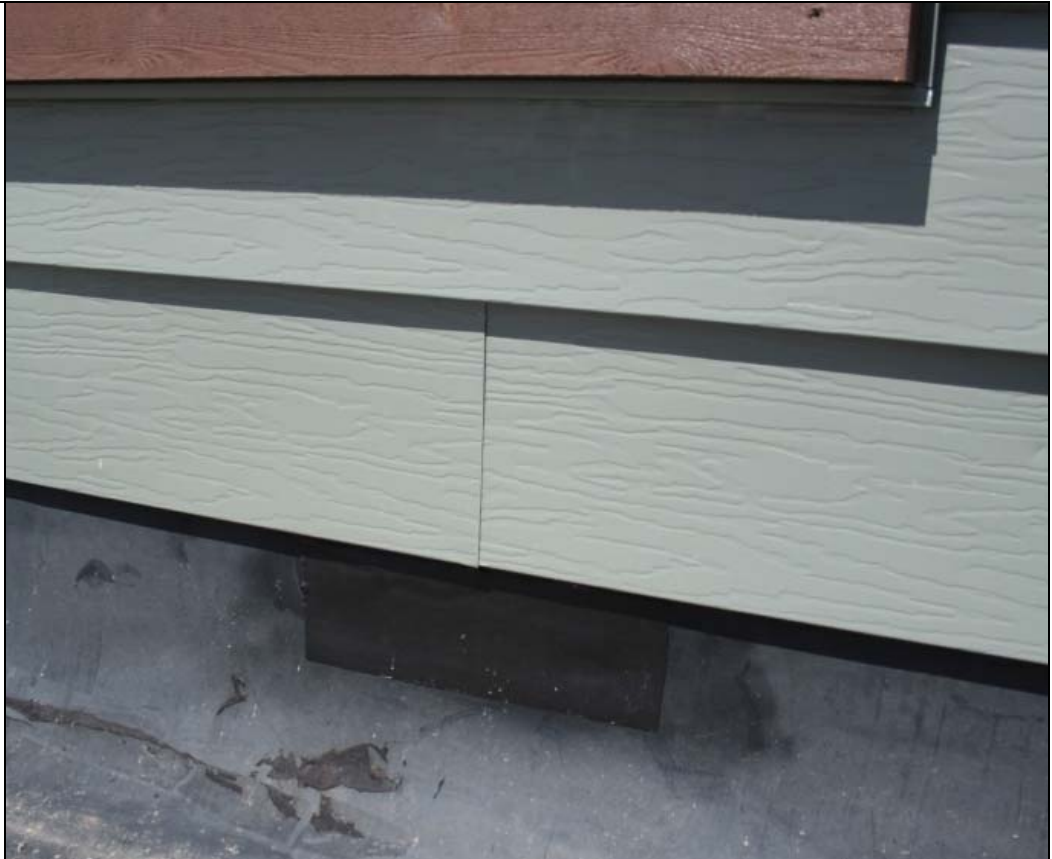
**Unit 32
Photo 5**

Notes: Patch located in sidewall just underneath the west window.

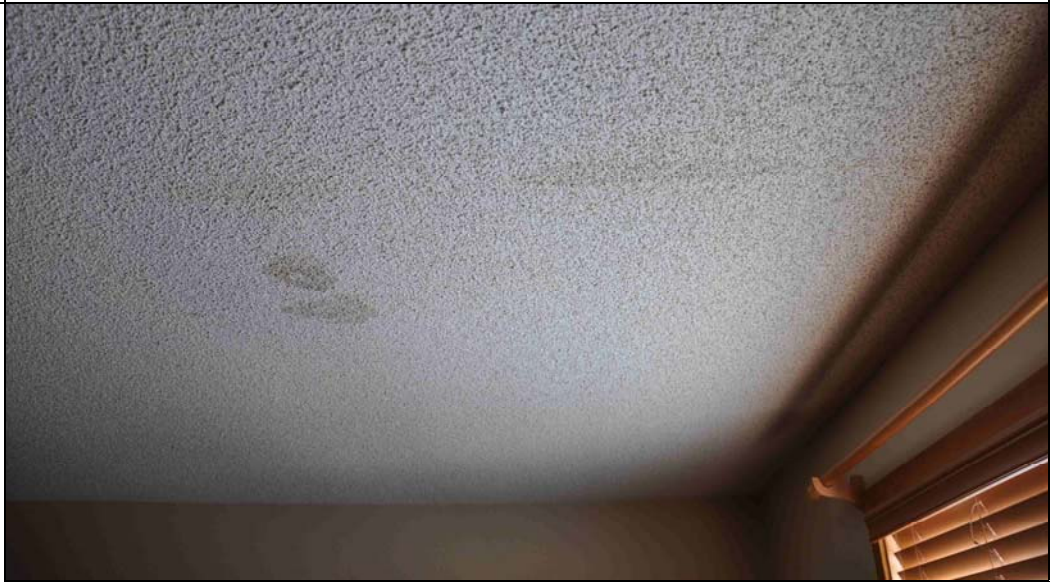
**Unit 32
Photo 6**

Notes: CBL Interior photo showing drywall damage.

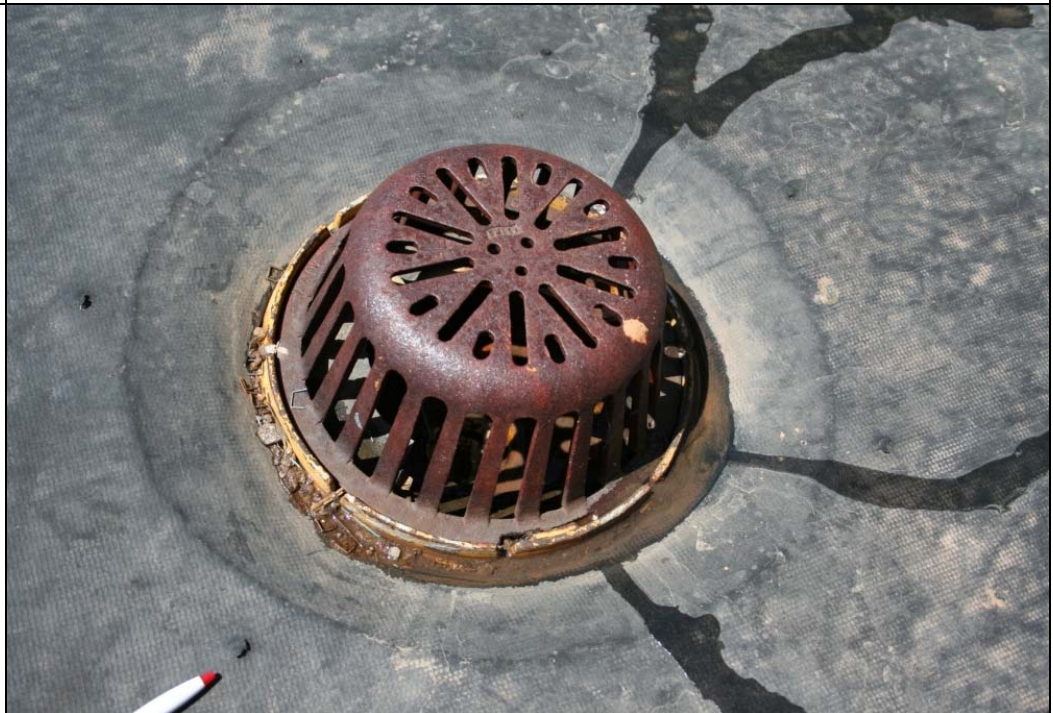
**Unit 33
Photo 8**

Notes: Multiple nail heads protruding around perimeter of drain.
