ARCHITECT'S FIELD REPORT

PROJECT	Eagle's Nest Townhouses 11 Morning Glory Way & 31 Marcellina Lane Mt. Crested Butte, CO 81225	DATE	5/9/11
----------------	--	-------------	--------

WORK OBSERVED
Phase II – Roof Audit, Existing Conditions Units 1 through 8

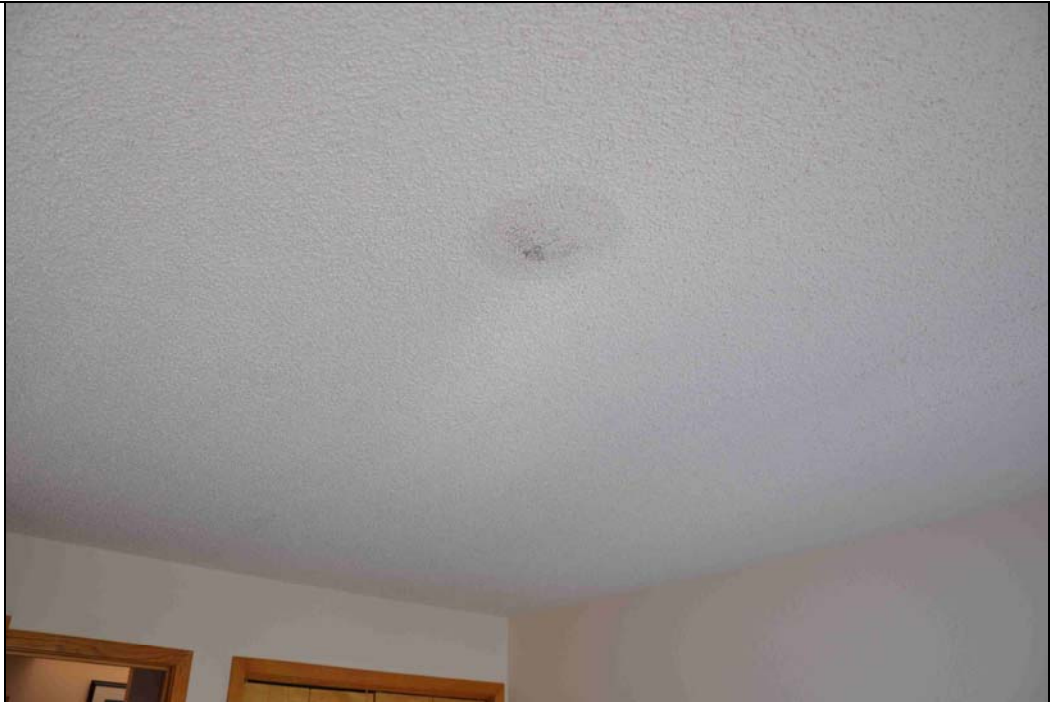
**Unit 34
Photo 8**

Notes: CBL Interior photo of drywall damage.

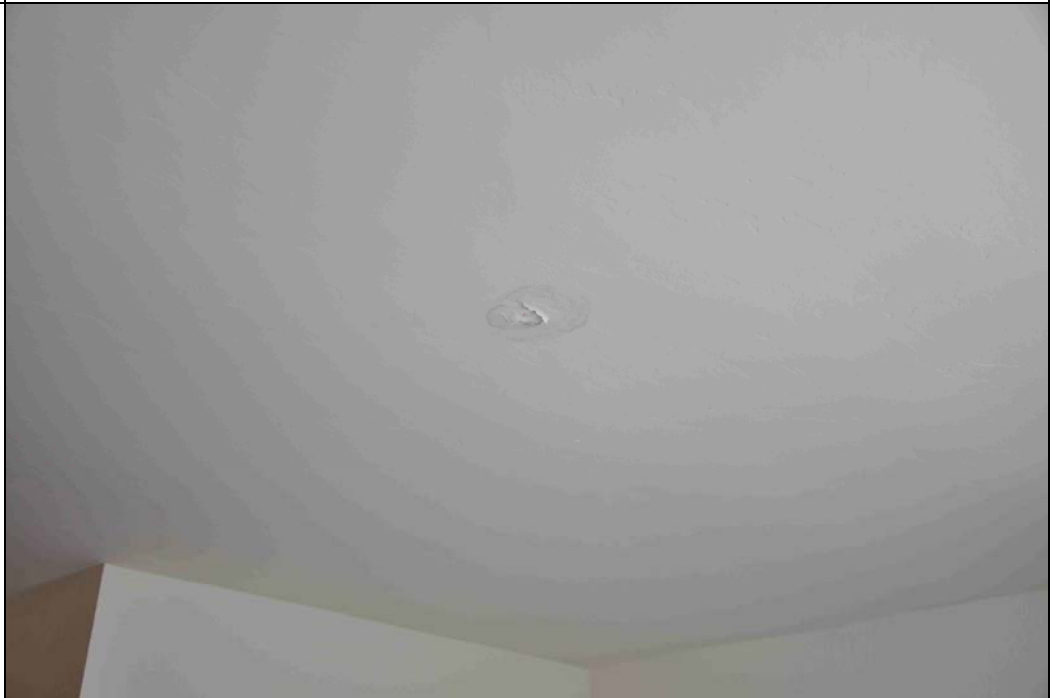
**Unit 35
Photo 3**

Notes: CBL Interior Photo of drywall damage.

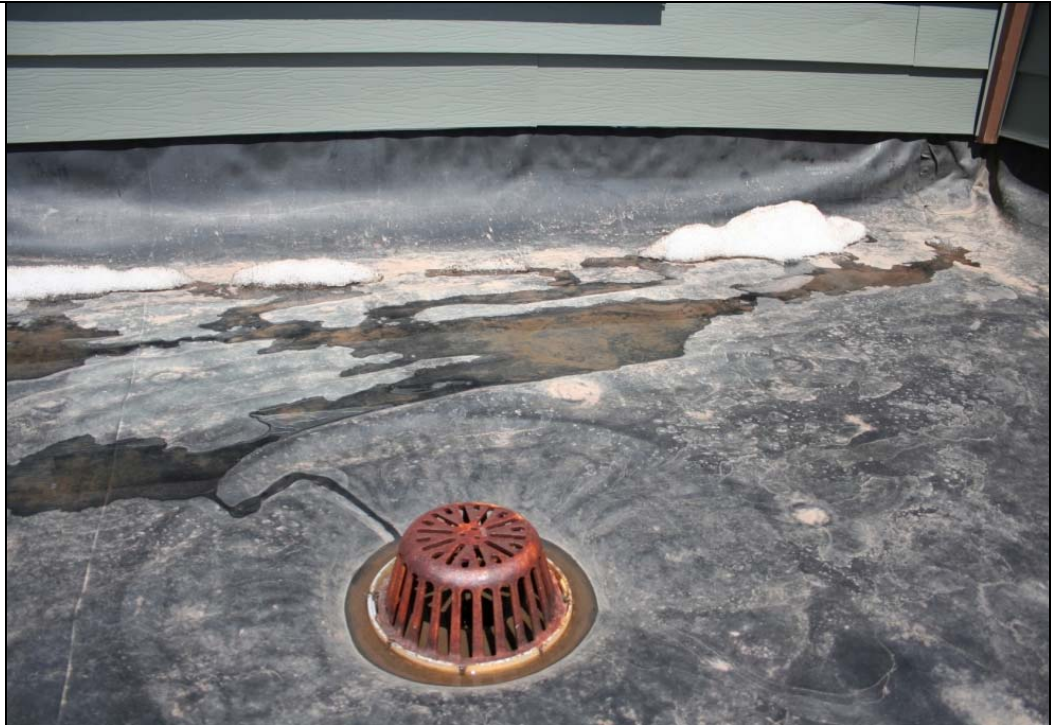
Unit 36
Photo 7

Notes: Membrane is not adhered to substrate.

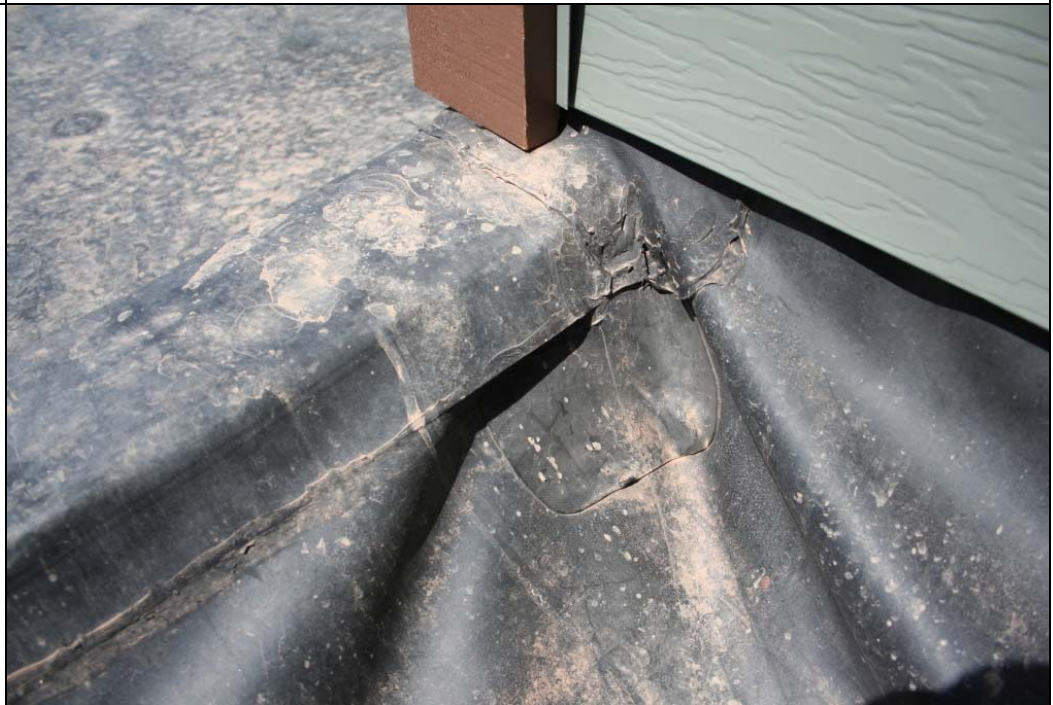
Unit 36
Photo 8

Notes: Large gap in lapped membrane on north parapet cap. Not necessarily indicative of leak.

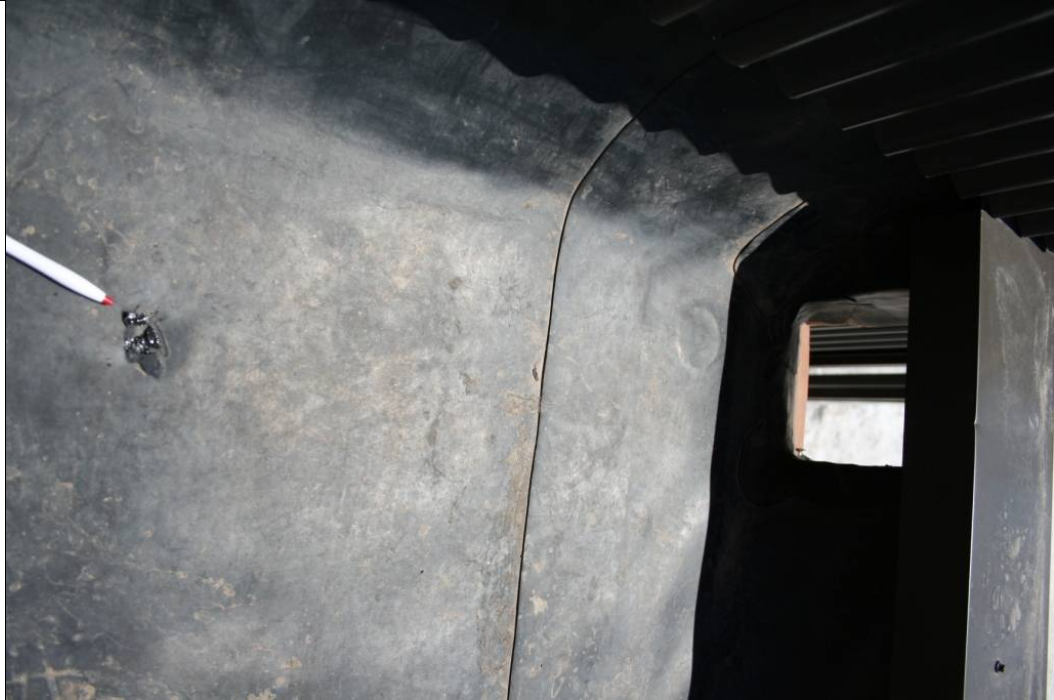
**Unit 36
Photo 9**

Notes: Hole in membrane in southwest corner. Area was previously sealed.

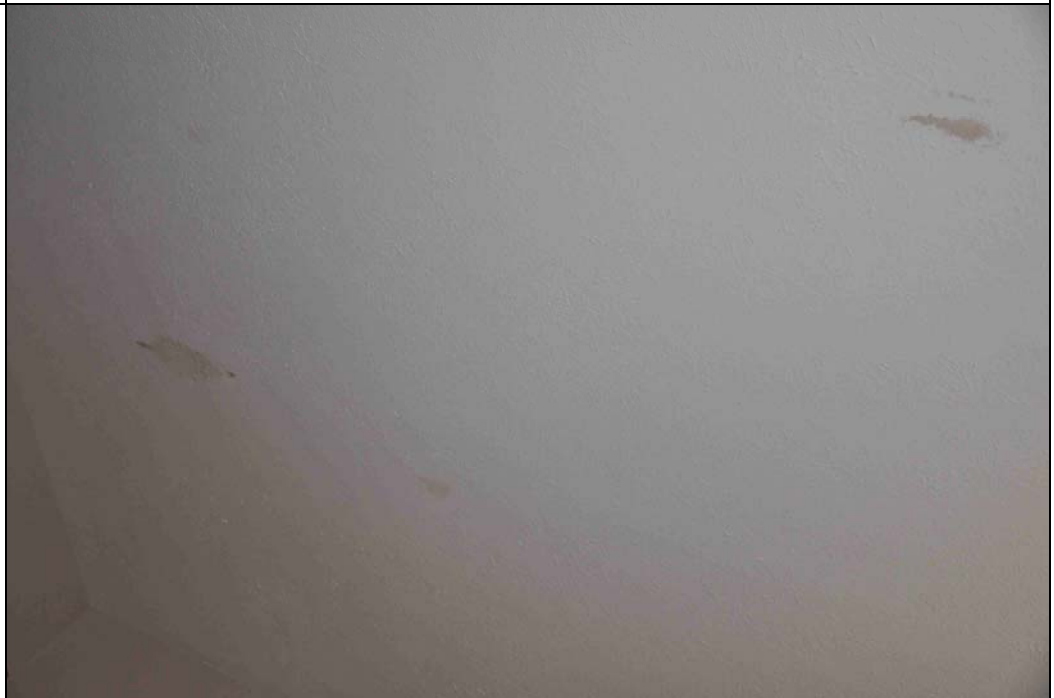
**Unit 36
Photo 10**

Notes: CBL Interior Photo of drywall damage.

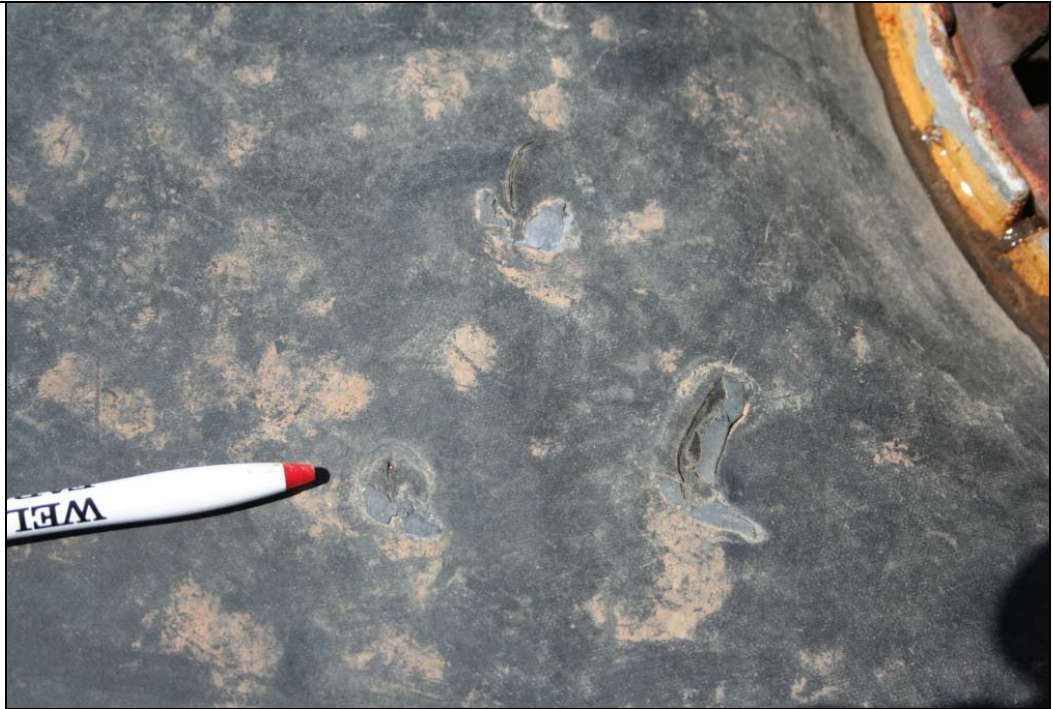
**Unit 37
Photo 5**

Notes: Sealed holes west of drain. Sealant is in poor condition.

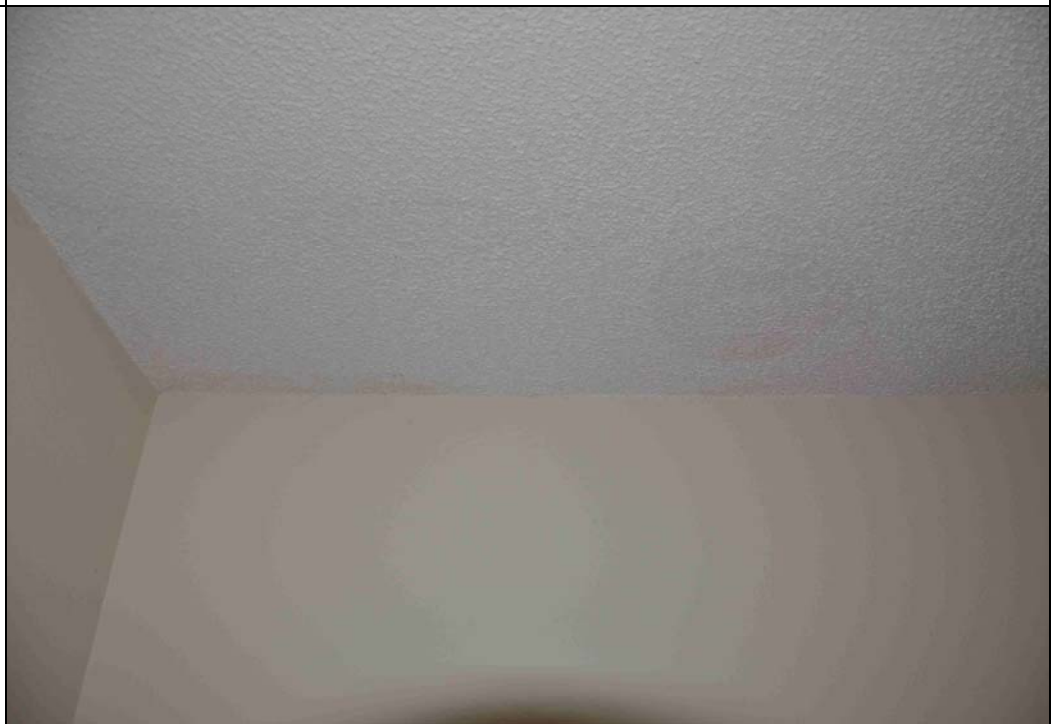
**Unit 37
Photo 6**

Notes: CBL Interior Photo of drywall damage.

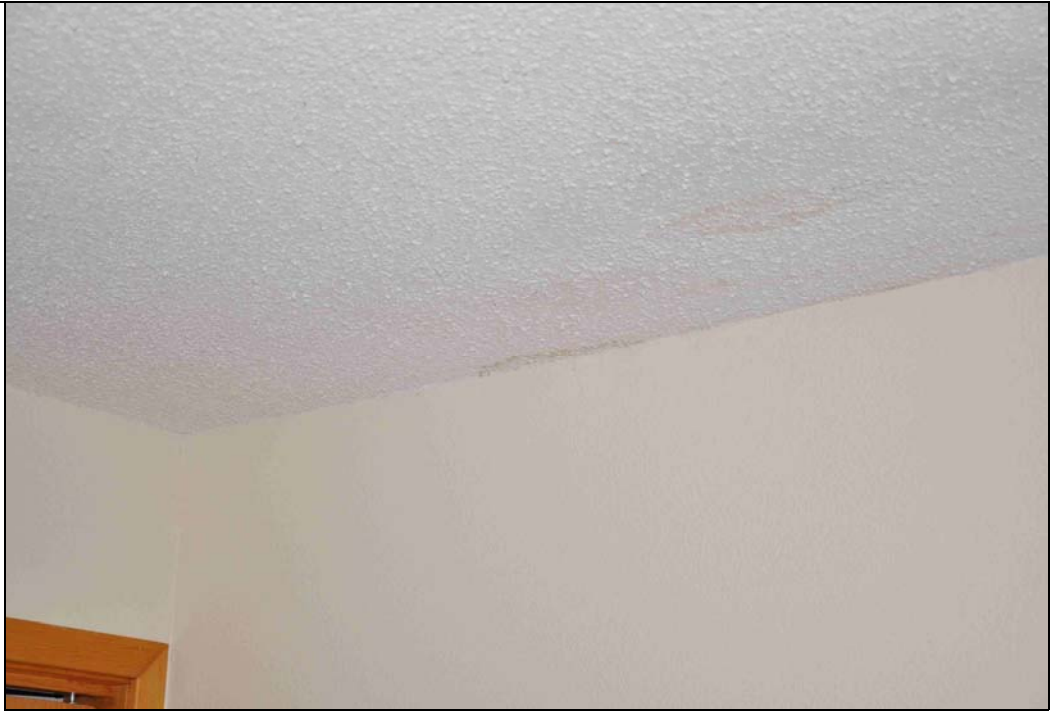
**Unit 38
Photo 5**

Notes: CBL Interior Photo of drywall damage.

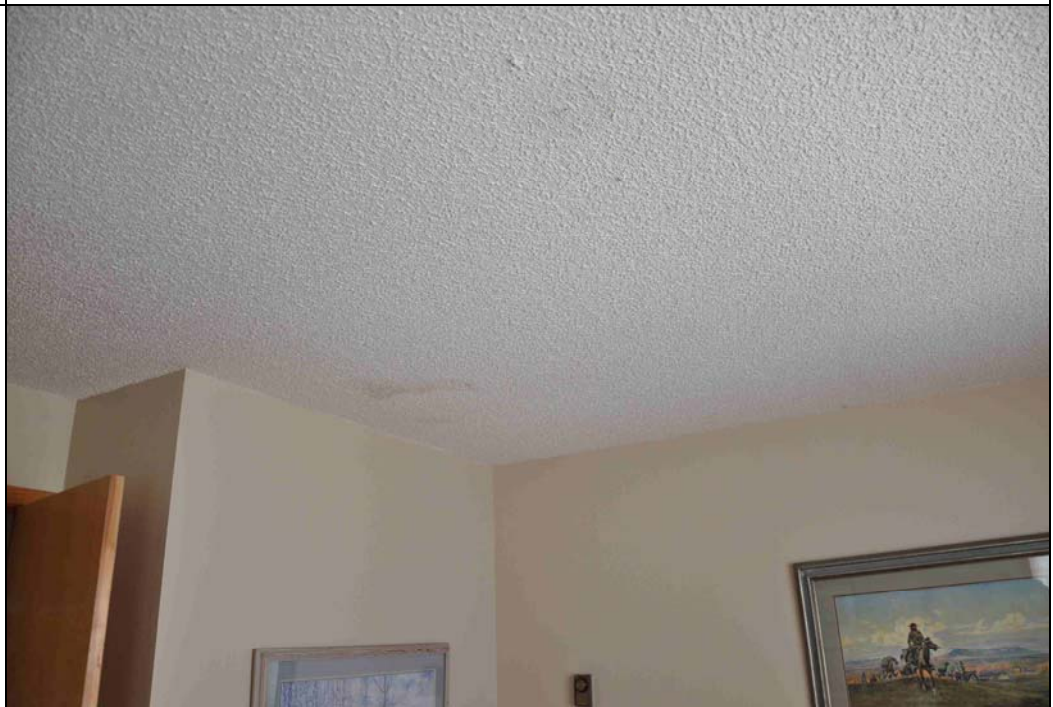
**Unit 39
Photo 5**

Notes: CBL Interior Photo of drywall damage.

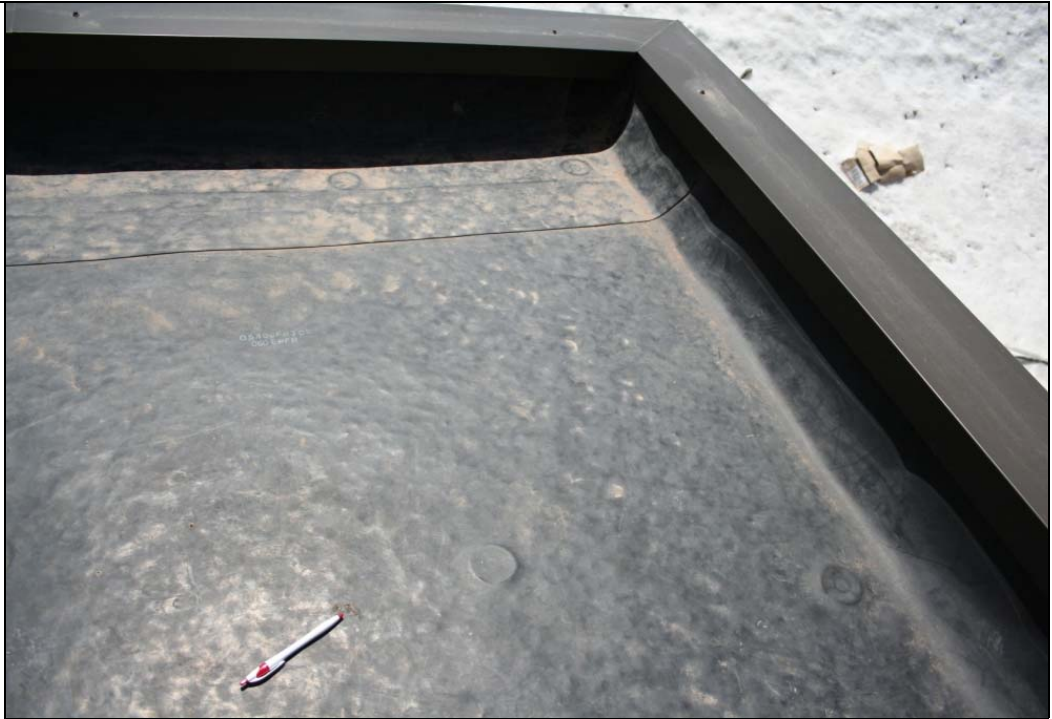
Unit 40
Photo 5

Notes: Hole 3-'6" north of drain.

Notes: Detail of Photo 5. Hole appears to have been previously fixed.

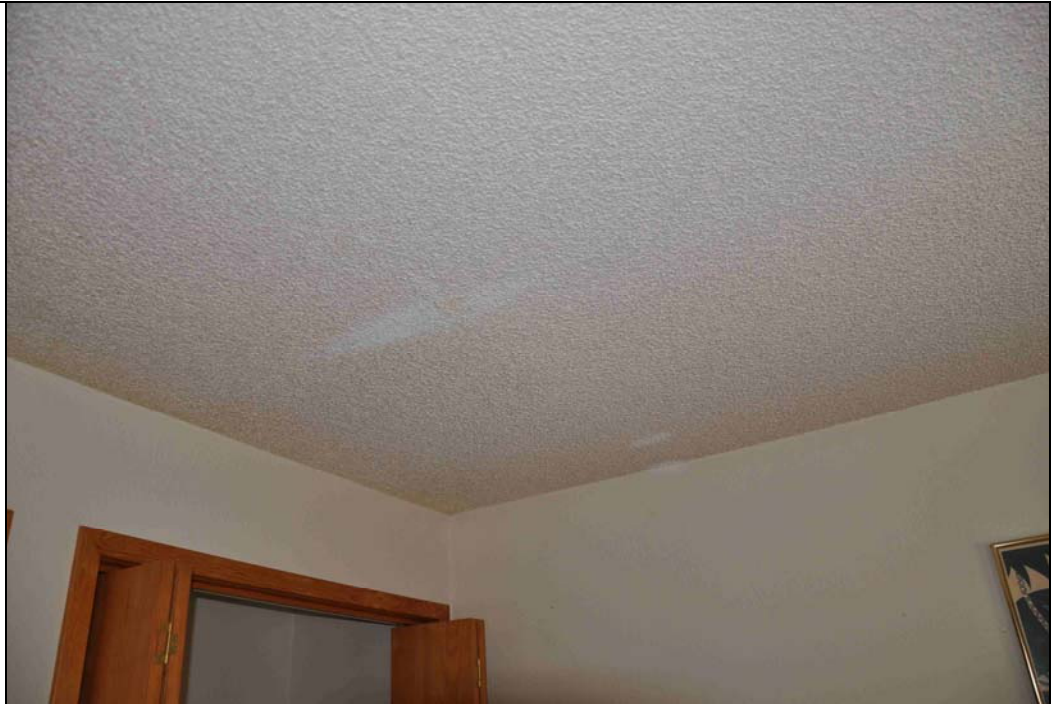
**Unit 40
Photo 7**

Notes: CBL Interior Photo of drywall damage.
