# ARCHITECT'S FIELD REPORT

101

<b>PROJECT</b>	<b>Eagle's Nest Townhouses</b> 11 Morning Glory Way & 31 Marcellina Lane Mt. Crested Butte, CO 81225	<b>DATE</b>	4/10/13
----------------	--	-------------	---------

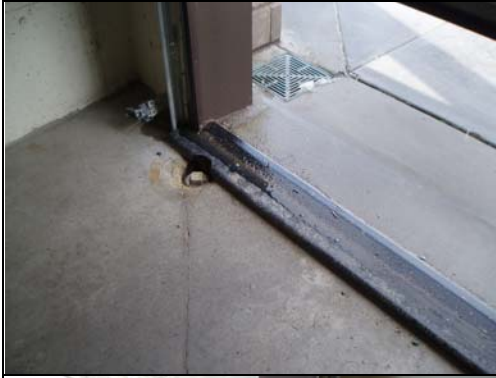
PHOTO –WORK ITEM	DESCRIPTION	ACTION
 	<p>4/10/13 – Photo 8 Unit 20 Garage Door Threshold</p> <p>Detail of the garage door apron. The darker color on the garage door is water splashing from the apron.</p>	<p>Note</p>

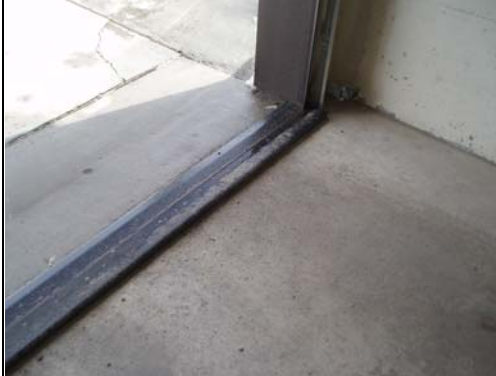
<p>4/10/13 – Photo 9 Unit 20 Garage Threshold</p> <p>Threshold Looking North</p>	<p>Note</p>

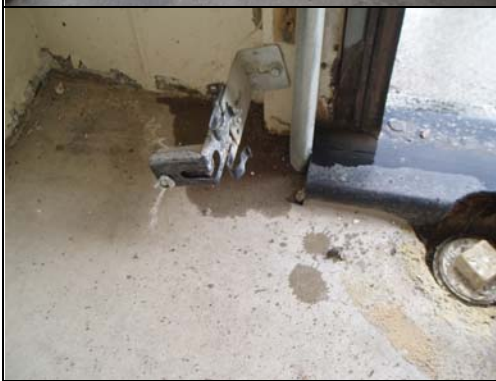
<p>4/10/13 – Photo 10 Unit 20 Garage Threshold</p> <p>Threshold Looking North</p>	<p>Note</p>
