ARCHITECT'S FIELD REPORT

130

PROJECT	Eagle's Nest Townhouses 11 Morning Glory Way & 31 Marcellina Lane Mt. Crested Butte, CO 81225	DATE	11/6/13
----------------	--	-------------	---------

WORK OBSERVED	
Phase IV Construction – Upper Level Renovations	
TRADES PRESENT	
Holgate Construction Co.

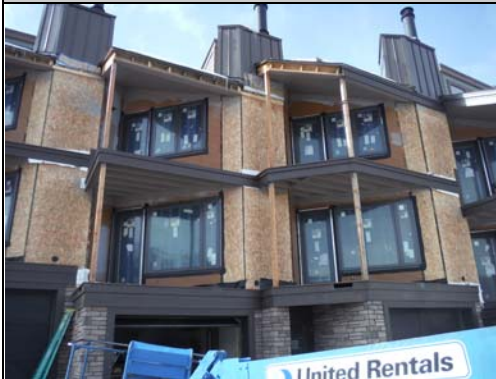
<p>11/6/13 – Photo 5 Units 5 & 6</p> <p>2nd floor decks are installed. Fascia boards are underway on Unit 6. Interior window trim is complete.</p>	<p>Note</p>

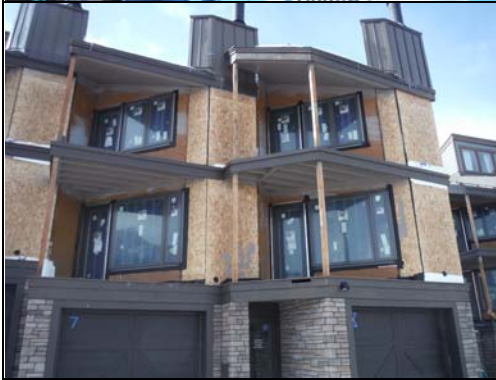
<p>11/6/13 – Photo 6 Units 7 & 8</p> <p>2nd floor decks are installed and fascia is complete. Interior window trim is complete.</p>	<p>Note</p>

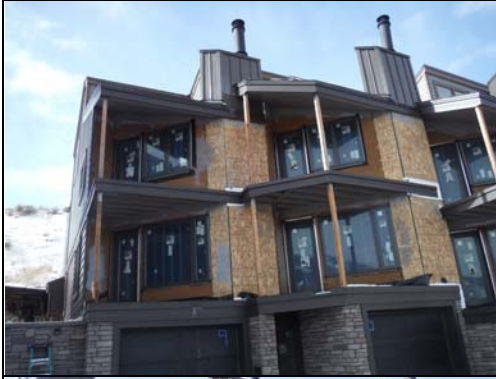
<p>11/6/13 – Photo 7 Units 9 & 10</p> <p>Fascia is complete. Awaiting decking. Interior window trim is in place and will be finished by the end of the week.</p>	<p>Note</p>

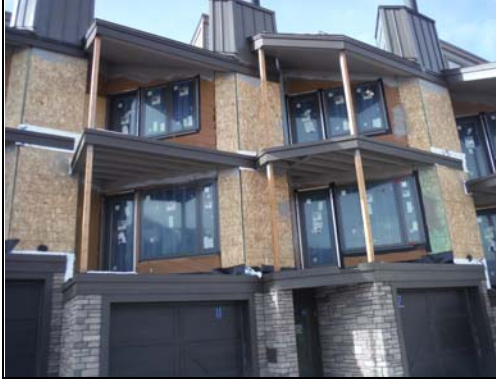
<p>11/6/13 – Photo 8 Units 11 & 12</p> <p>Fascia is complete.</p>	<p>Note</p>

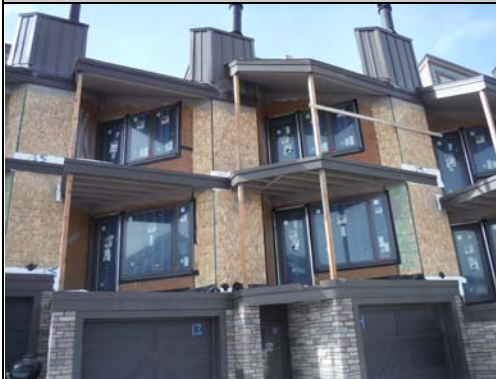
<p>11/6/13 – Photo 9 Units 13 & 14</p> <p>Fascia is complete.</p>	<p>Note</p>

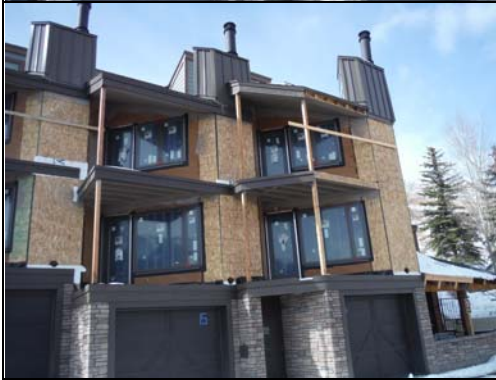
<p>11/6/13 – Photo 10 Units 15 & 16</p> <p>Fascia is complete.</p>	<p>Note</p>

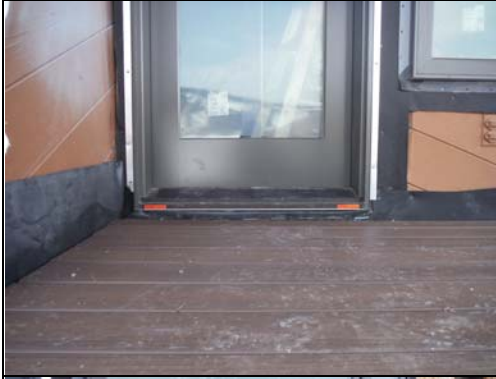
<p>11/6/13 – Photo 11 Unit 5, 2nd Floor Deck Installation</p> <p>Fibron deck boards have been installed on the 2nd floor.</p>	<p>Note</p>

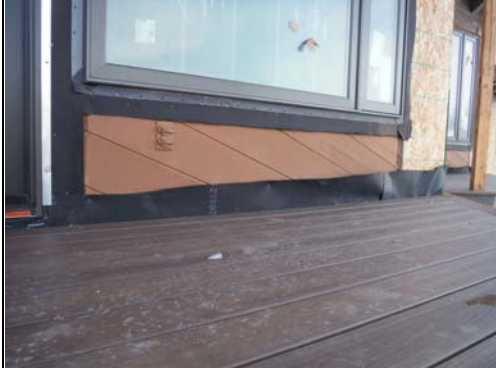
<p>11/6/13 – Photo 12 Unit 5, 2nd Floor Deck Installation</p> <p>Fibron deck boards have been installed on the 2nd floor. Note the membrane extends up the exterior wall approximately 4 inches above the deck surface.</p>	<p>Note</p>

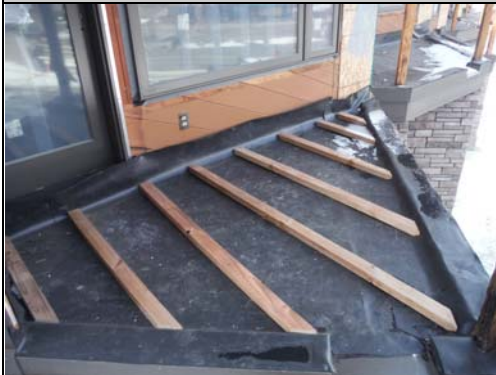
<p>11/6/13 – Photo 13 Unit 9, 2nd Floor Deck Membrane</p> <p>Deck membrane in place. Details were discussed with Mick.</p>	<p>Note</p>

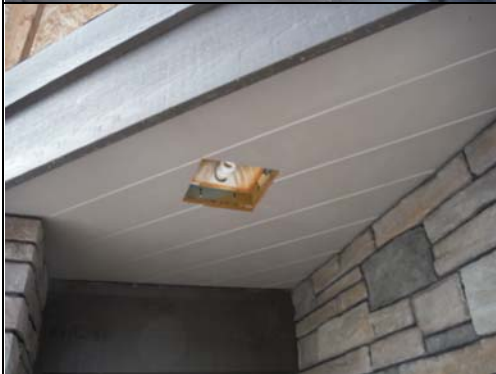
<p>11/6/13 – Photo 14 Typical Entry Ceiling</p> <p>Entry Ceilings have been painted. Awaiting light fixture trim work.</p>	<p>Note</p>

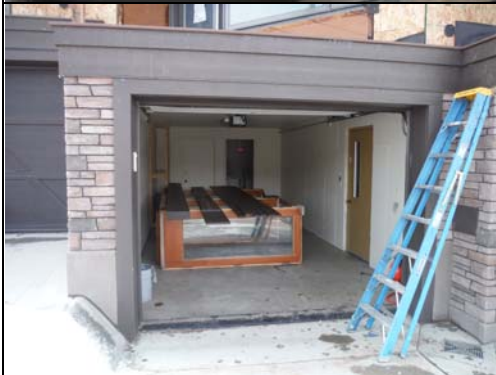
<p>11/6/13 – Photo 15 Unit #3 Garage</p> <p>Unit #3, #5 and #11 are being used to prep trim work.</p>	<p>Note</p>
