ARCHITECT'S FIELD REPORT

128

PROJECT	Eagle's Nest Townhouses 11 Morning Glory Way & 31 Marcellina Lane Mt. Crested Butte, CO 81225	DATE	10/23/13
----------------	--	-------------	----------

WORK OBSERVED	
Phase IV Construction – Upper Level Renovations	
TRADES PRESENT	
Holgate Construction Co.

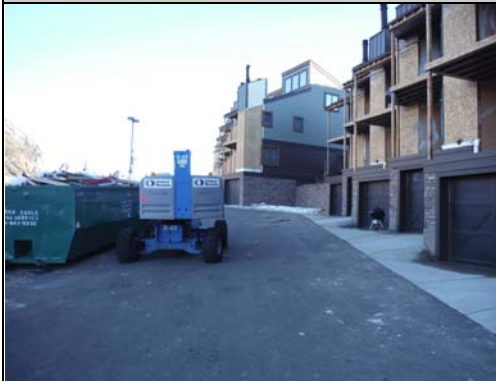
<p>10/23/13 – Photo 1 Upper Level, Building B Looking South</p> <p>Parking area and work area after close of work day.</p>	<p>Note</p>

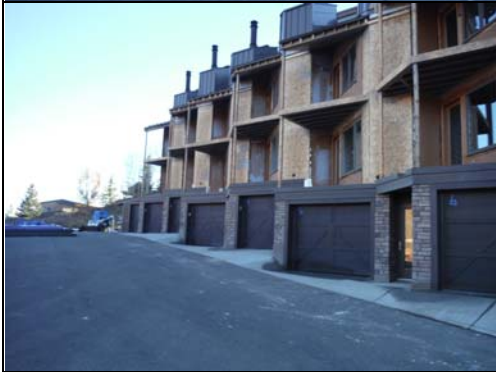
<p>10/23/13 – Photo 2 Upper Level Building A Looking South</p> <p>Work area is clean at the close of work.</p>	<p>Note</p>

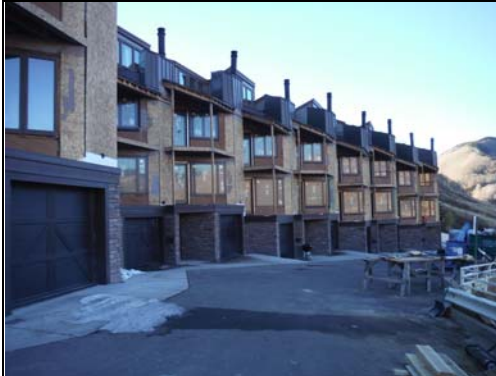
<p>10/23/13 – Photo 3 Upper Level Looking North</p> <p>Window installation underway. Note minor amount of snow melt.</p>	<p>Note</p>

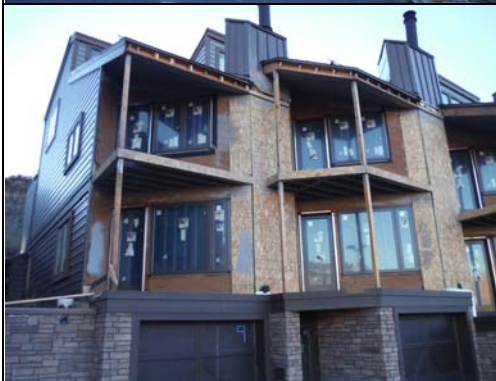
<p>10/23/13 – Photo 4 Units 9 & 10</p> <p>Paint, window and door installation are complete.</p>	<p>Note</p>

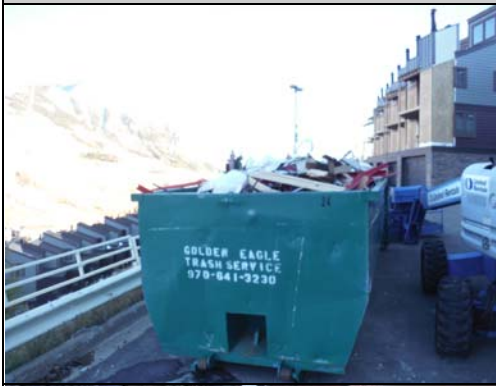
<p>10/23/13 – Photo 9 Upper Level Dumpster</p> <p>Dumpster is 100% full.</p>	<p>Note</p>

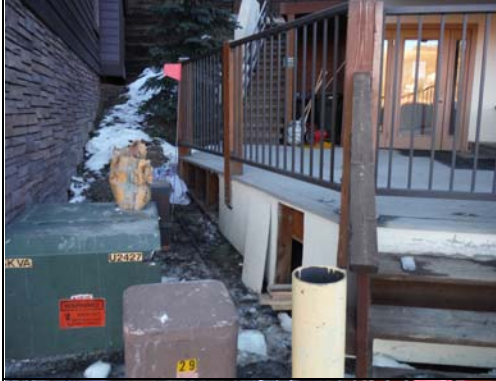
<p>10/23/13 – Photo 10 Lower Level Deck Repairs</p> <p>Pier has been excavated and poured.</p>	<p>Note</p>

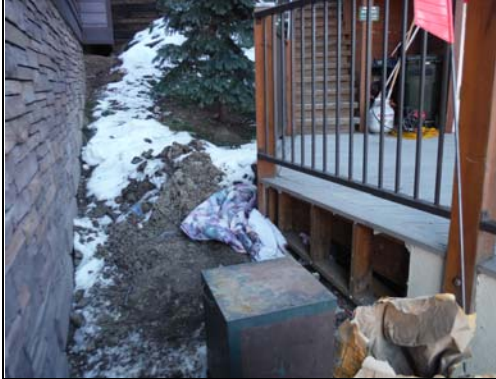
<p>10/23/13 – Photo 11 Lower Level Deck Repairs</p> <p>Blankets are protecting the new concrete. Deck appears level and stable.</p>	<p>Note</p>
