ARCHITECT'S FIELD REPORT

016

PROJECT **Eagle's Nest Townhouses** **DATE** 9/10/10
 11 Morning Glory Way & 31 Marcellina Lane
 Mt. Crested Butte, CO 81225

WORK OBSERVED
Phase I – Construction Field Report 08
TRADES PRESENT
Holgate Construction Company

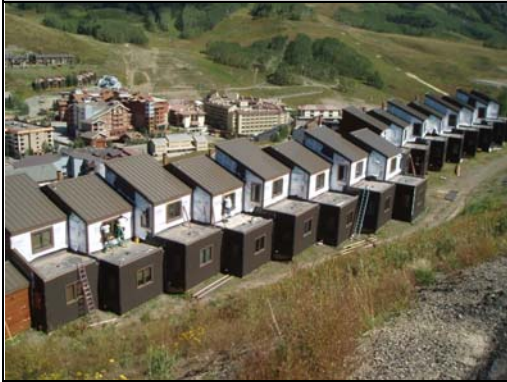
<p>9/10/10 – Photo 1 Upper Units – Rear View</p> <p>Corrugated metal siding installation complete except for inside and outside corner trim.</p>	None

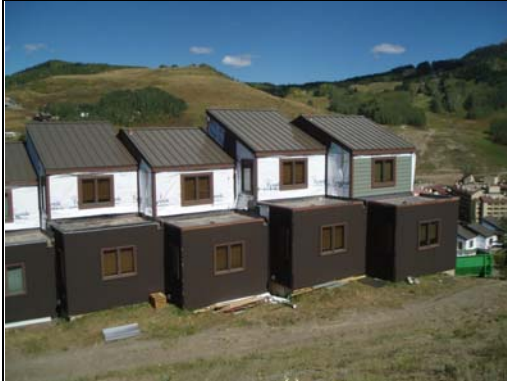
<p>9/10/10 – Photo 2 Units 1 through 4</p> <p>4th Floor window trim and wood corner trim installed. Coax cable finished. Units ready for horizontal steel siding.</p>	MHC

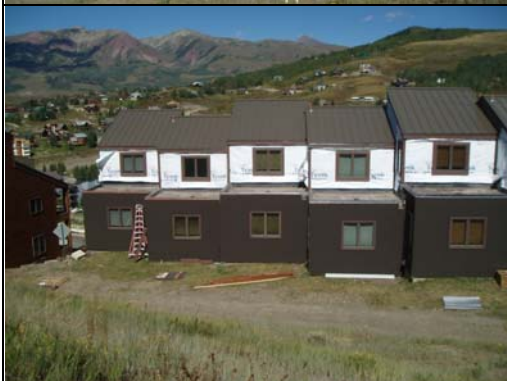
<p>9/10/10 – Photo 3 Units 5 through 8</p> <p>4th Floor window trim and wood corner trim installed. Coax cable finished. Units ready for horizontal steel siding.</p>	MHC

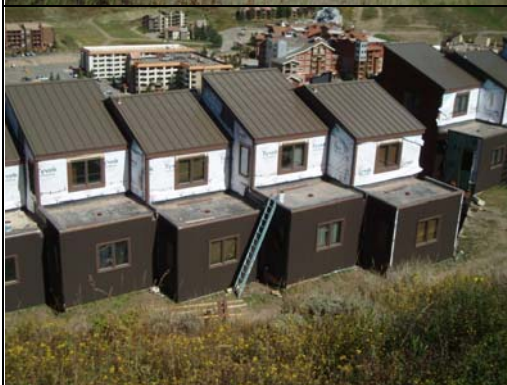
<p>9/10/10 – Photo 4 Units 9 through 12</p> <p>4th Floor window trim and wood corner trim installed. Coax cable finished. Units ready for horizontal steel siding.</p> <p>Note: Inside corner trim at 4th Floor has been custom fit.</p>	None

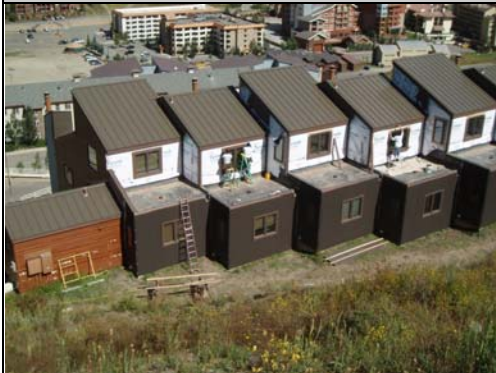
<p>9/10/10 – Photo 5 Units 13 through 16</p> <p>Workers finishing installation of wood window trim at 4th Floor.</p>	<p>None</p>

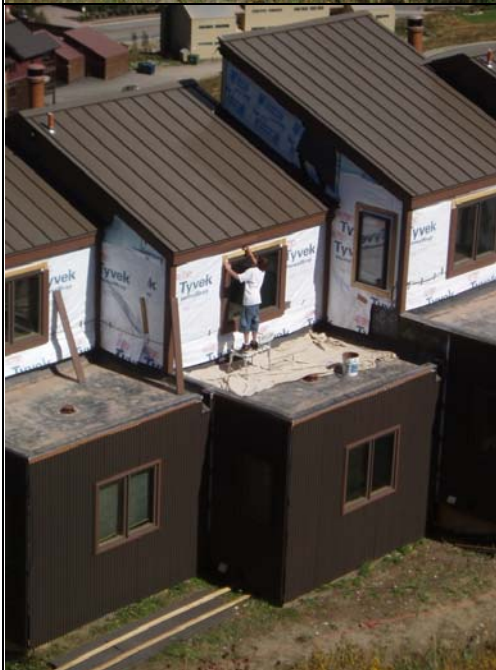
<p>9/10/10 – Photo 6 Unit 14</p> <p>Note: Worker stripping and finishing existing fascia. Units 1 through 13 have been completed. Paint color is the existing tone used on remainder of the fascia and trim and is also used on the new window and corner trim.</p>	<p>None</p>

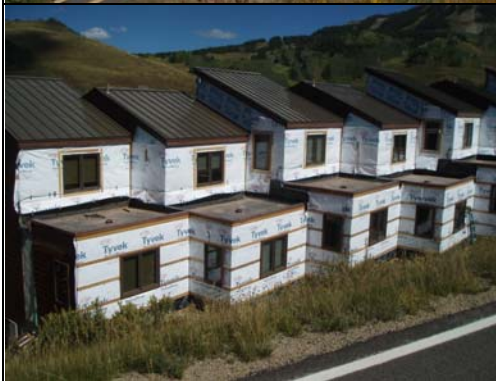
<p>9/10/10 – Photo 7 Units 17 through 20</p> <p>Units awaiting 3rd floor corrugated metal siding.</p>	<p>None</p>

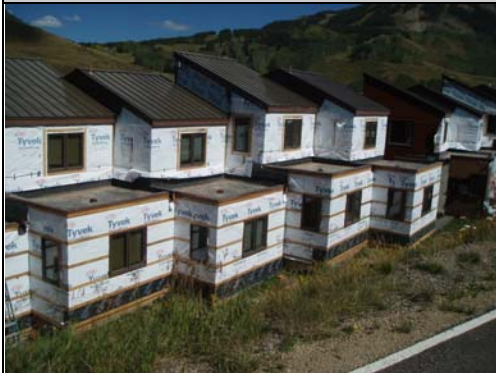
<p>9/10/10 – Photo 8 Units 21 through 24</p> <p>Units awaiting 3rd floor corrugated metal siding.</p> <p>Note: Mick is standardizing the location of wall exhaust caps to speed the corrugated metal installation.</p>	<p>None</p>

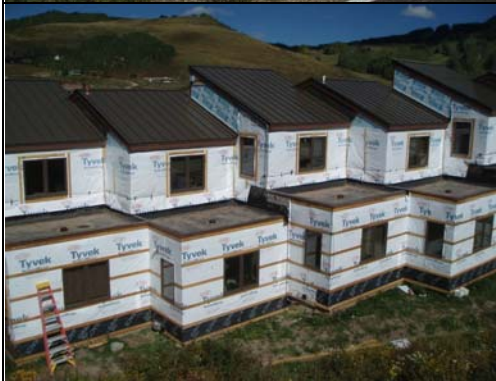
<p>9/10/10 – Photo 9 Units 25 through 28</p> <p>Tyvek and window furring complete.</p>	<p>None</p>

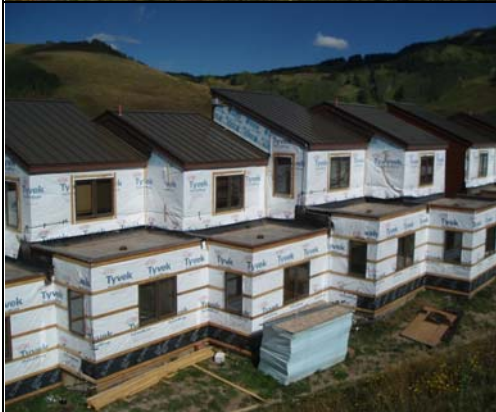
<p>9/10/10 – Photo 10 Units 29 through 32</p> <p>Tyvek and window furring complete.</p>	<p>None</p>

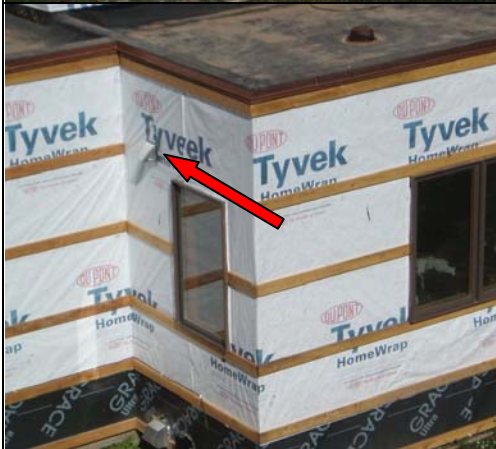
<p>9/10/10 – Photo 11 Unit 26</p> <p>Arrow indicates possible dryer vent cap. Mick will coordinate with corrugated metal installation.</p>	<p>None</p>

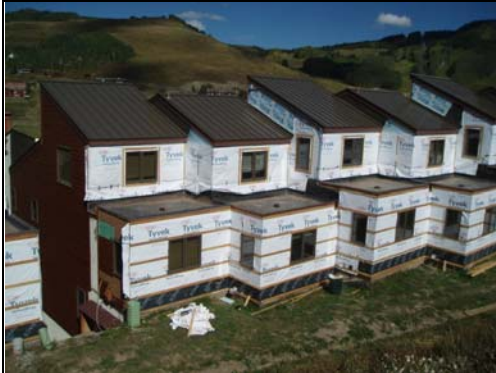
<p>9/10/10 – Photo 12 Units 36 through 33</p> <p>Tyvek and window furring complete.</p>	<p>None</p>

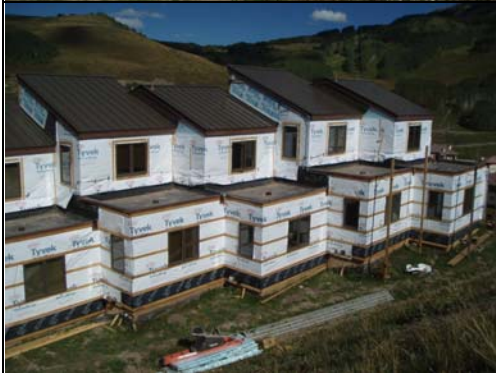
<p>9/10/10 – Photo 13 Units 37 through 40</p> <p>Tyvek and window furring complete.</p>	<p>None</p>

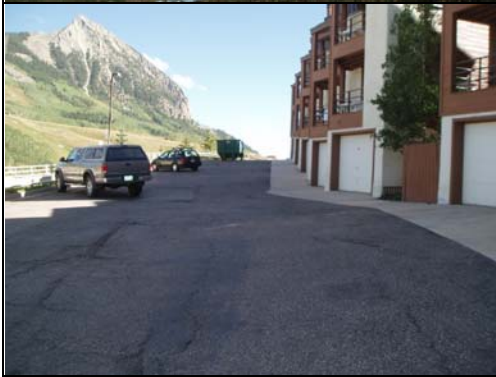
<p>9/10/10 – Photo 14 Lower Level Parking Area</p> <p>Parking area and construction work areas are absent of any debris or construction equipment.</p>	<p>None</p>
