**ARCHITECT'S FIELD REPORT**

**131**

<b>PROJECT</b>	<b>Eagle's Nest Townhouses</b> 11 Morning Glory Way & 31 Marcellina Lane Mt. Crested Butte, CO 81225	<b>DATE</b>	11/13/13
----------------	--	-------------	----------

<b>WORK OBSERVED</b>	
Phase IV Construction – Upper Level Renovations	
<b>TRADES PRESENT</b>	
Holgate Construction Co.

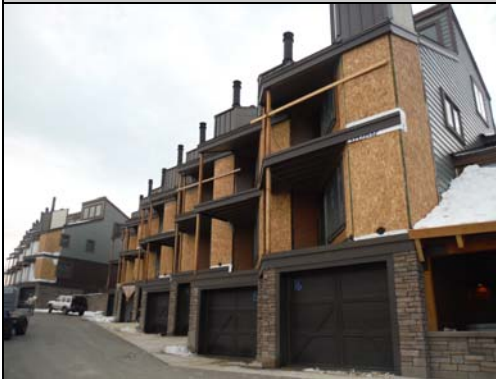
<p>11/13/13 – Photo 5 Building B Looking South</p>	<p>Note</p>

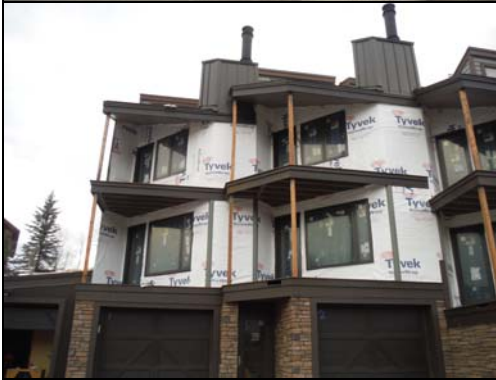
<p>11/13/13 – Photo 6 Units 1 &amp; 2</p> <p>2<sup>nd</sup> and 3<sup>rd</sup> Floor Decks are complete. Tyvek house wrap has been installed. Green metal corner trim and guardrail trim posts are underway.</p>	<p>Note</p>

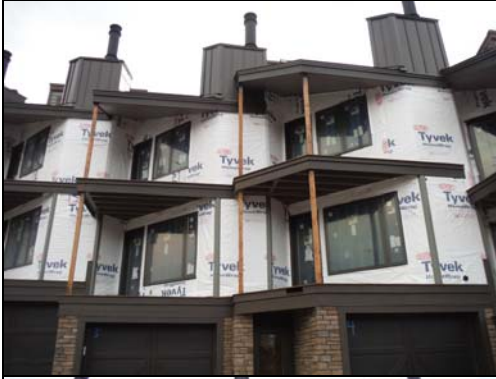
<p>11/13/13 – Photo 7 Units 3 &amp; 4</p> <p>2<sup>nd</sup> and 3<sup>rd</sup> Floor Decks are complete. Tyvek house wrap has been installed.</p>	<p>Note</p>

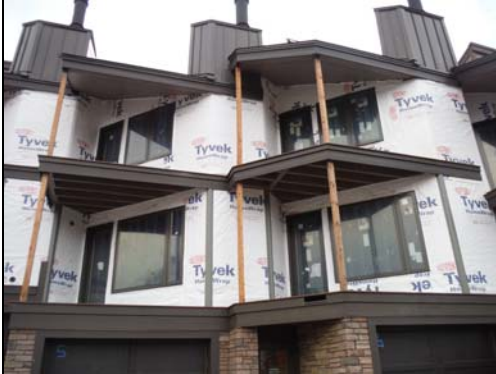
<p>11/13/13 – Photo 8 Units 5 &amp; 6</p> <p>2<sup>nd</sup> and 3<sup>rd</sup> Floor Decks are complete. Tyvek house wrap has been installed.</p>	<p>Note</p>

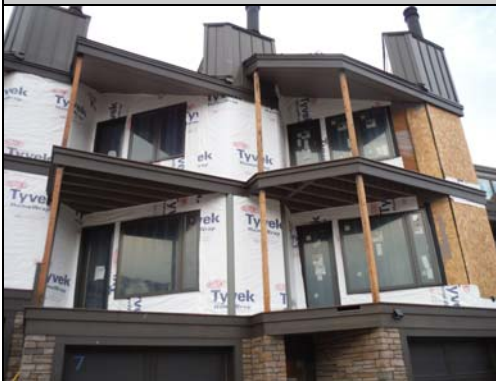
<p>11/13/13 – Photo 9 Units 7 &amp; 8</p> <p>2<sup>nd</sup> and 3<sup>rd</sup> Floor Decks are complete. Tyvek house wrap has been installed on Unit 7. Tyvek still pending at the corner condition.</p>	<p>Note</p>

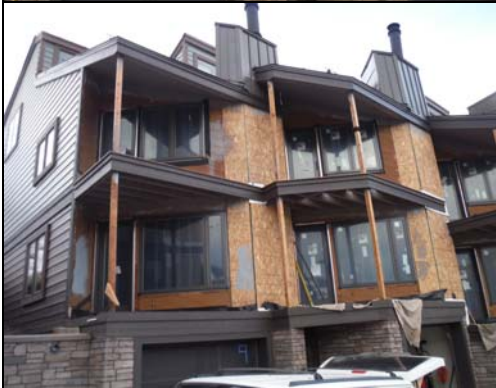
<p>11/13/13 – Photo 10 Units 9 &amp; 10</p> <p>Deck installation on Building A has just begun.</p>	<p>Note</p>

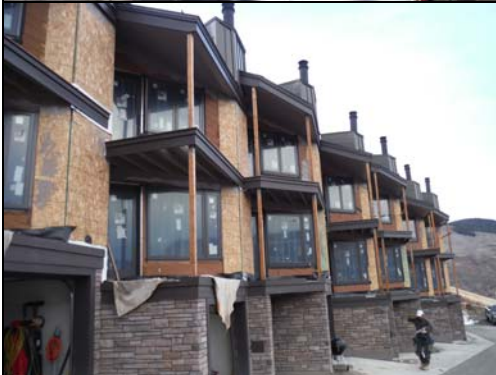
<p>11/13/13 – Photo 11 Remaining Units on Building A</p> <p>Units awaiting new decks.</p>	<p>Note</p>

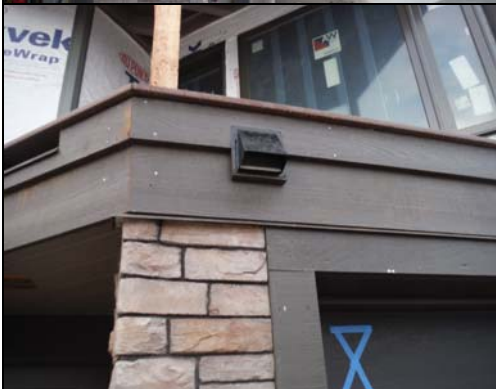
<p>11/13/13 – Photo 12 Dryer Vent Installation on Unit 8</p> <p>Note small piece of trim around the base of the dryer vent for flush installation. The Address Number will be installed to the lower right of the vent cap.</p>	<p>Note</p>
