ARCHITECT'S FIELD REPORT

115

PROJECT	Eagle's Nest Townhouses 11 Morning Glory Way & 31 Marcellina Lane Mt. Crested Butte, CO 81225	DATE	7/24/13
----------------	--	-------------	---------

WORK OBSERVED	
Phase IV Construction	
TRADES PRESENT	
Holgate Construction Co.

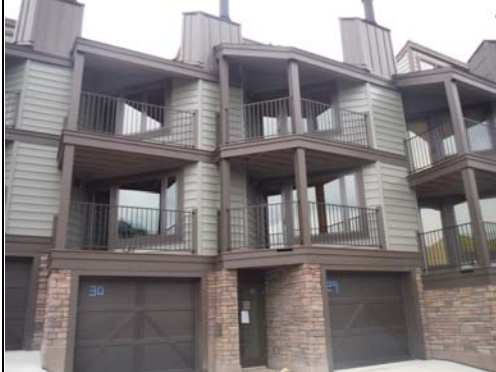
<p>7/24/13 – Photo 8 Units 30 & 29</p> <p>Work is substantially complete on Building C.</p>	<p>Note</p>

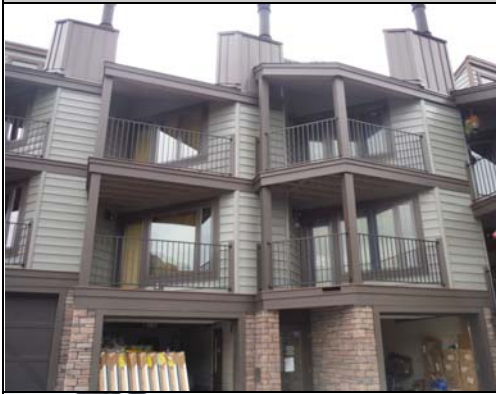
<p>7/24/13 – Photo 9 Units 28 & 27</p> <p>Work is substantially complete on Building C.</p>	<p>Note</p>

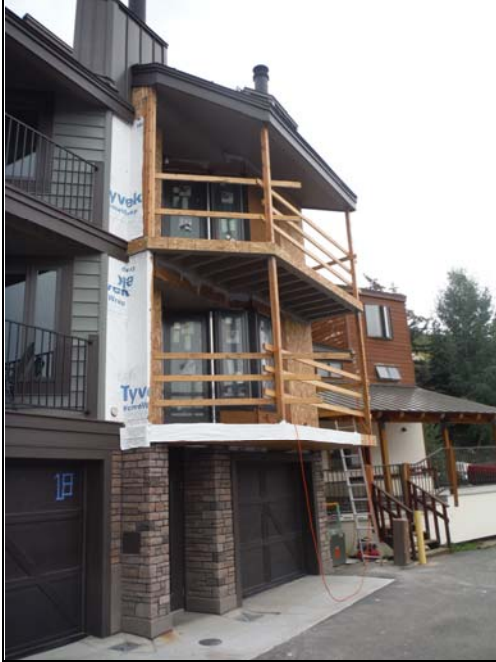
<p>7/24/13 – Photo 10 Unit 17 Looking North</p> <p>Completed demolition and repair work. Windows and doors have been exchanged. Soffit and deck joists have been painted.</p> <p>Interior trim work is underway.</p>	<p>Note</p>

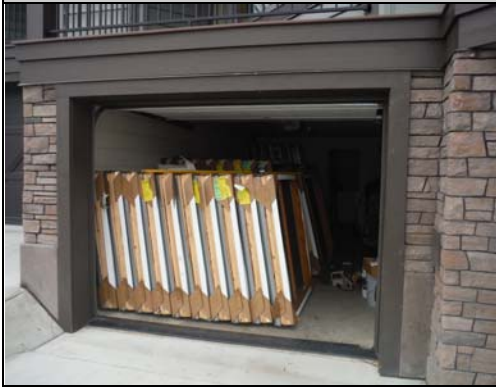
<p>7/24/13 – Photo 12 Windows Stored in Unit 28</p> <p>Access to the laundry room has been maintained.</p>	<p>Note</p>

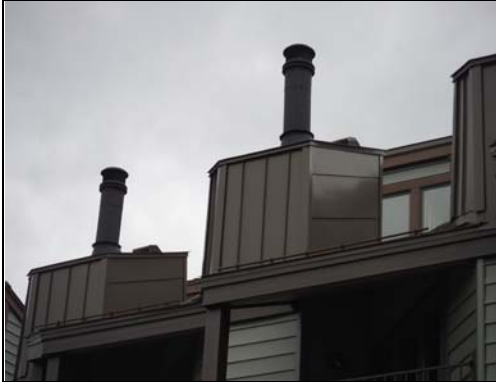
<p>7/24/13 – Photo 13 Example North Facing Chimney Siding</p> <p>Note horizontal siding along the back face of the chimneys.</p>	<p>Note</p>

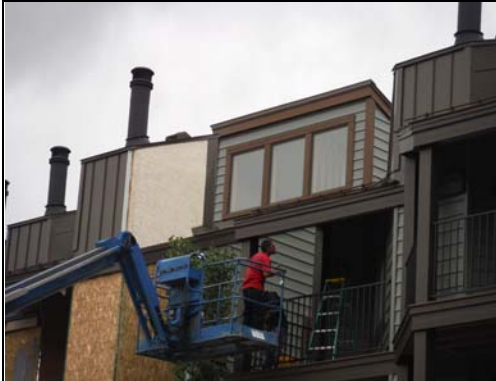
<p>7/24/13 – Photo 14 Location of New Metal Chimney Siding</p> <p>MH has asked about considering horizontal siding along the north elevation of the exposed chimney.</p>	<p>Note</p>

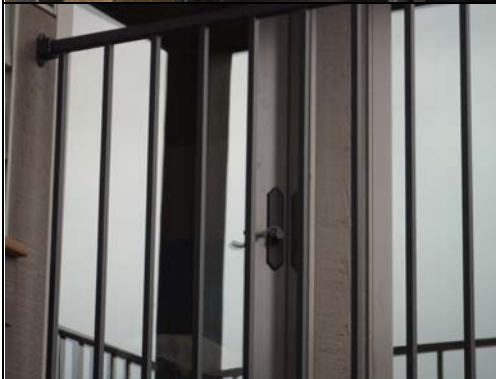
<p>7/24/13 – Photo 15 Example Door Hardware Without Key</p>	<p>Note</p>
