ARCHITECT'S FIELD REPORT

PROJECT	Eagle's Nest Townhouses 11 Morning Glory Way & 31 Marcellina Lane Mt. Crested Butte, CO 81225	DATE	6/19/13
----------------	--	-------------	---------

WORK OBSERVED	
Sloped Roof Construction on Units 25 & 26	
TRADES PRESENT	
None

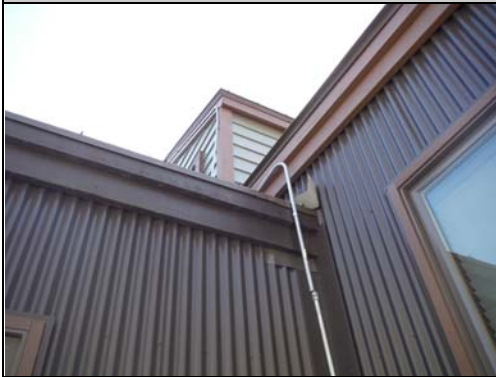
<p>6/19/13 – Photo 9 Junction at Unit 18 & 19</p> <p>Roof snowmelt conduit is not attached.</p>	<p>Note</p>

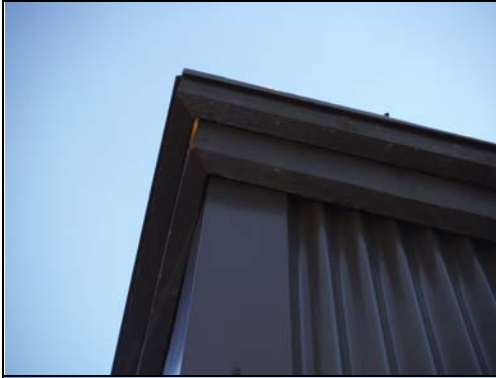
<p>6/19/13 – Photo 10 Unit 17 Fascia</p> <p>Touch up work is still pending.</p>	<p>Note</p>

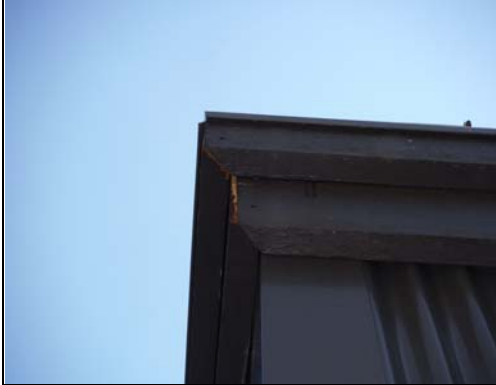
<p>6/19/13 – Photo 11 Unit 18 Fascia</p> <p>Touch up work is still pending.</p>	<p>Note</p>
