# ARCHITECT'S FIELD REPORT

079

<b>PROJECT</b>	<b>Eagle's Nest Townhouses</b> 11 Morning Glory Way & 31 Marcellina Lane Mt. Crested Butte, CO 81225	<b>DATE</b>	6/26/12
----------------	--	-------------	---------

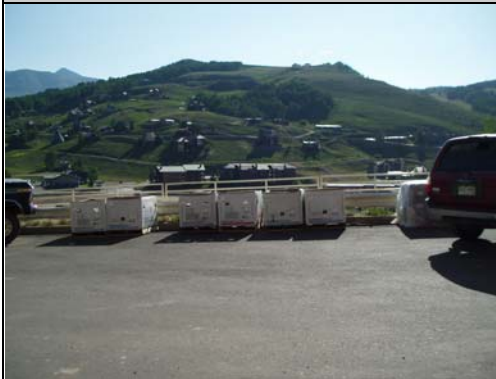
<p>6/13/12 – Photo 9 Upper Level</p> <p>Stone stored on site.</p>	<p>Note</p>

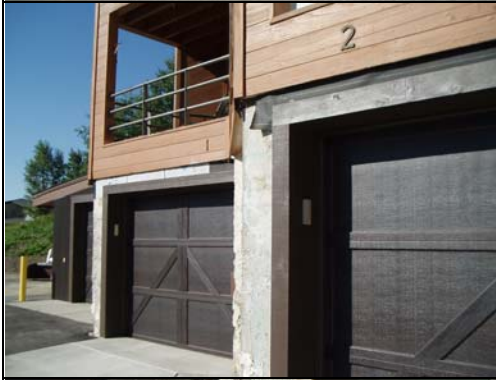
<p>6/13/12 – Photo 10 Units 1 &amp; 2</p> <p>Key pad garage door openers have been installed.</p>	<p>Note</p>

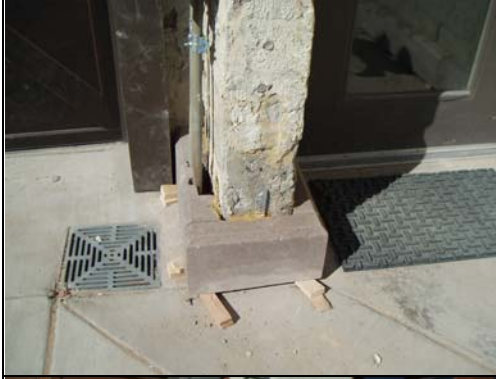
<p>6/13/12 – Photo 11 Entry at Unit 31 &amp; 32</p> <p>Precast base is set to accommodate snow melt lines.</p>	<p>Note</p>

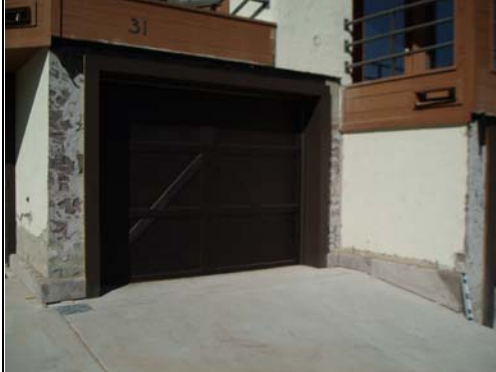
<p>6/13/12 – Photo 12 Unit 31</p> <p>Extend of precast base installation.</p>	<p>Note</p>

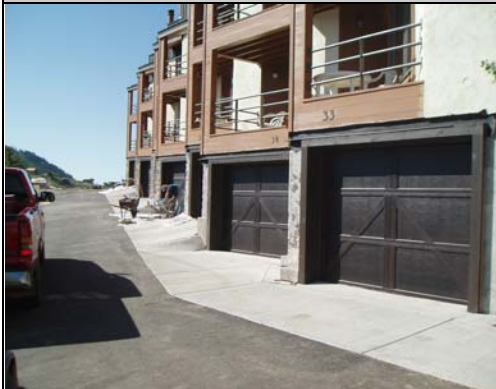
<p>6/13/12 – Photo 13 Upper Level Building 'E' Looking South</p> <p>Stone work underway.</p>	<p>Note</p>

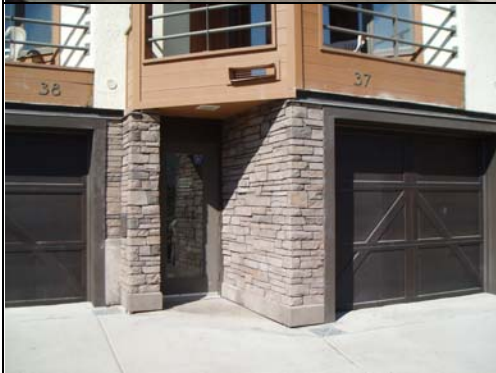
<p>6/13/12 – Photo 14 Units 37 &amp; 38</p> <p>Completed stone work. Awaiting sealant between precast and concrete apron.</p>	<p>Note</p>

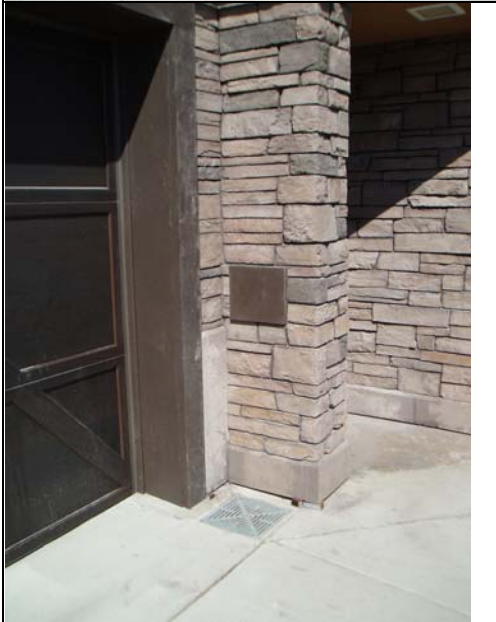
<p>6/13/12 – Photo 15 Unit 37 &amp; 38 Entry</p> <p>Detail of garage door, trim, precast, snow melt cover and stone.</p>	<p>Note</p>

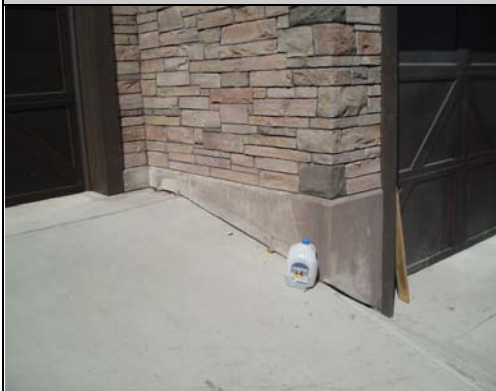
<p>6/13/12 – Photo 16 Unit 38 South Corner</p> <p>Note precast follows the slope of the concrete apron. Excellent attention to detail.</p>	<p>Note</p>

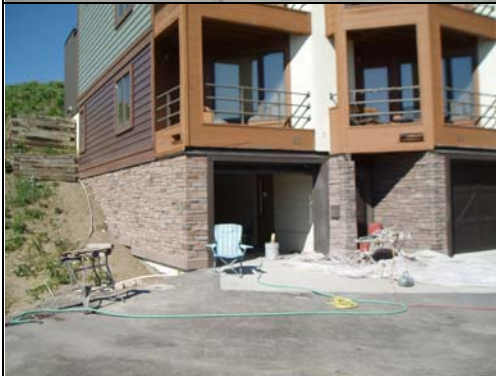
<p>6/13/12 – Photo 17 Unit 40</p> <p>Stone work complete.</p>	<p>Note</p>

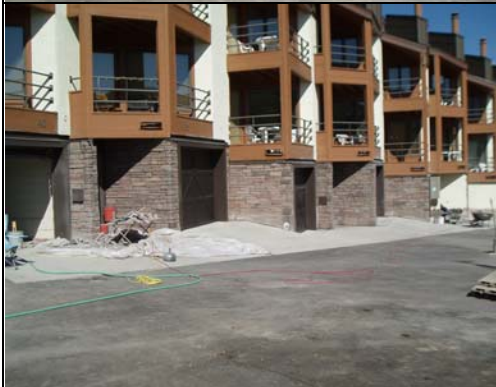
<p>6/13/12 – Photo 18 Units 36, 37, 38, &amp; 39</p> <p>Extent of completed stone work.</p>	<p>Note</p>

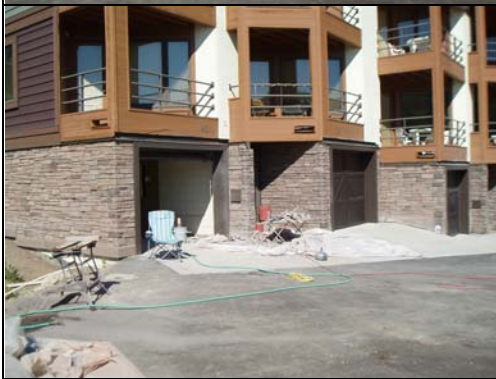
<p>6/13/12 – Photo 19 Units 38, 39, &amp; 40</p> <p>Stone work complete.</p>	<p>Note</p>

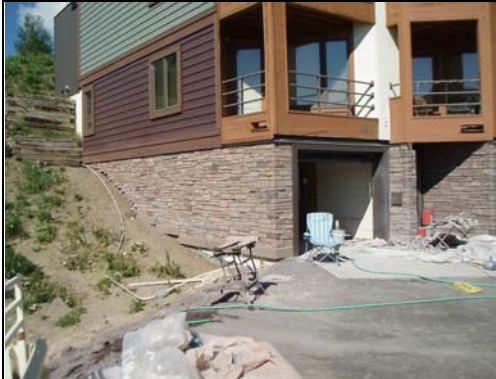
<p>6/13/12 – Photo 20 Unit 40</p> <p>Showing the end elevation.</p>	<p>Note</p>

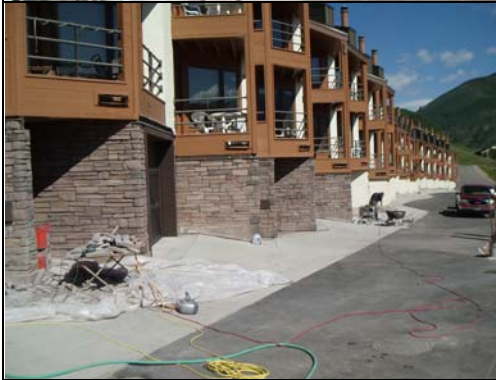
<p>6/13/12 – Photo 21 Building 'E' Looking North</p> <p>Extent of stone work and general working area.</p>	<p>Note</p>

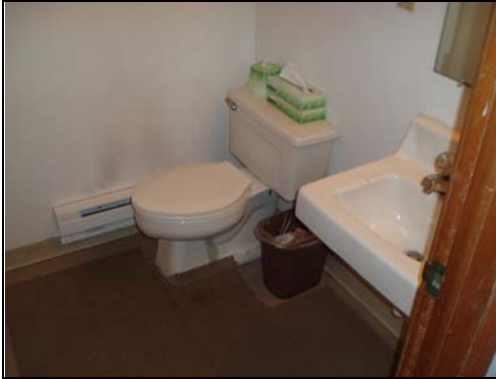
<p>6/13/12 – Photo 22 Lower Level Hot Tub Restroom</p> <p>Restroom is clean.</p>	<p>Note</p>
