ARCHITECT'S FIELD REPORT

129

PROJECT	Eagle's Nest Townhouses 11 Morning Glory Way & 31 Marcellina Lane Mt. Crested Butte, CO 81225	DATE	10/30/13
----------------	--	-------------	----------

WORK OBSERVED	
Phase IV Construction – Upper Level Renovations	
TRADES PRESENT	
Holgate Construction Co.

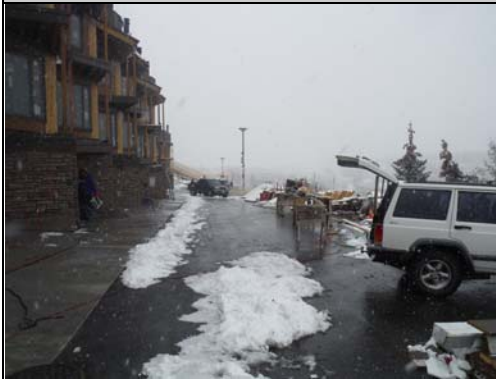
<p>10/30/13 – Photo 1 Upper Level Looking North</p> <p>Note recent snowfall.</p>	<p>Note</p>

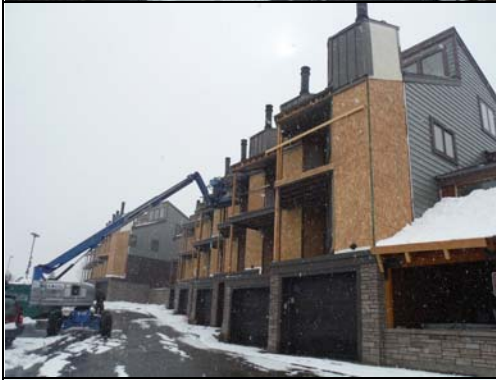
<p>10/30/13 – Photo 2 Upper Level Looking South</p> <p>Fascia installation underway on Unit 13.</p>	<p>Note</p>

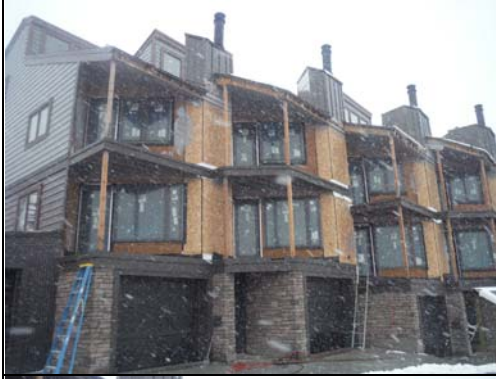
<p>10/30/13 – Photo 3 Units 1, 2, 3, & 4</p> <p>Window and door installation is complete. 2nd Floor deck membranes are in place.</p> <p>Shim spaces on the windows and doors are being foamed. Interior trim will start tomorrow.</p>	<p>Note</p>

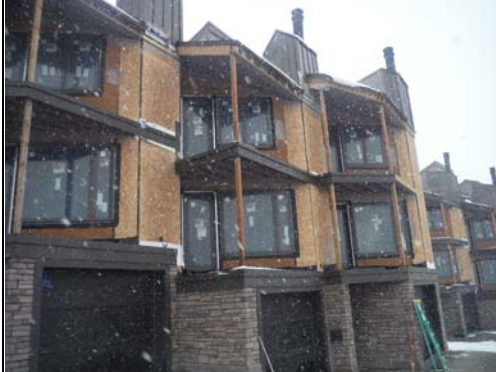
<p>10/30/13 – Photo 4 Units 6, 7 & 8</p> <p>Window and door installation is complete. 2nd Floor deck membranes are in place.</p>	<p>Note</p>

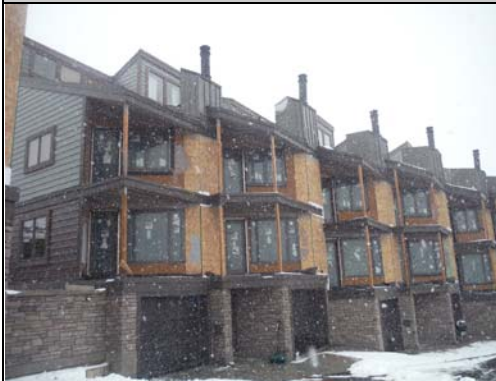
<p>10/30/13 – Photo 5 Units 9, 10, 11, & 12</p> <p>Window and door installation is complete. 2nd Floor deck membranes are in place. Fascia and chimney trim is complete.</p>	<p>Note</p>

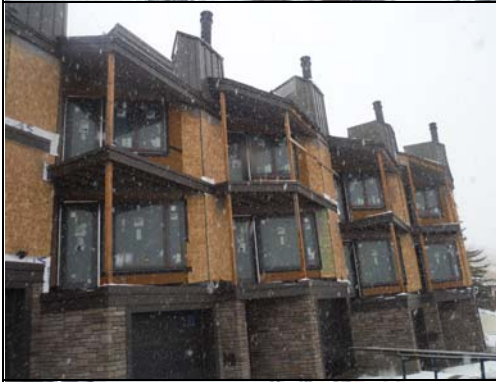
<p>10/30/13 – Photo 6 Unit 13, 14, 15 & 16</p> <p>Window and door installation is complete. 2nd Floor deck membranes are in place. Fascia trim is underway.</p>	<p>Note</p>

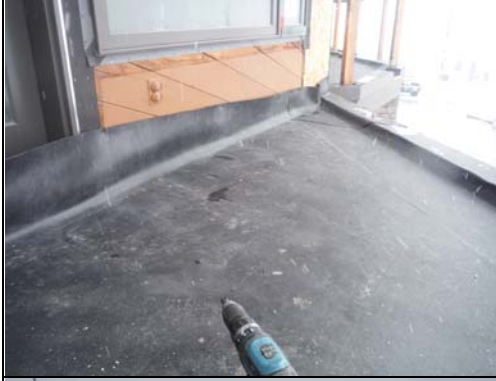
<p>10/30/13 – Photo 7 Deck Membrane Installation</p> <p>Membranes were set in mid-40 degree temperatures. Warmer temperatures are required to finalize seam sealing.</p>	<p>Note</p>

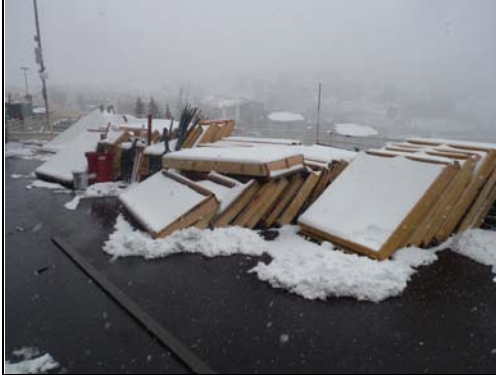
<p>10/30/13 – Photo 8 Stock Piled Windows and Doors</p> <p>Windows and doors are being donated by Holgate Construction.</p>	<p>Note</p>
