ARCHITECT'S FIELD REPORT

065

PROJECT	Eagle's Nest Townhouses 11 Morning Glory Way & 31 Marcellina Lane Mt. Crested Butte, CO 81225	DATE	11/18/11
----------------	--	-------------	----------

WORK OBSERVED	
Sloped Roof Replacements – Units 19 & 20; Phase II – Snow Melt Aprons	
TRADES PRESENT	
None

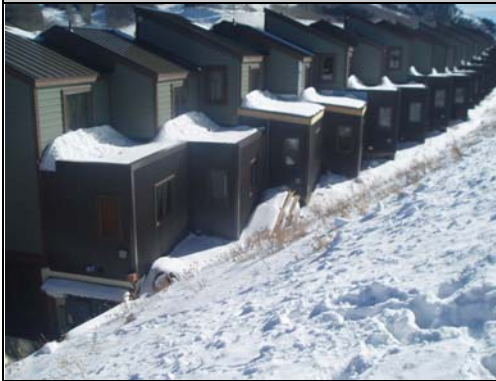
<p>11/18/11 – Photo 1 Unit 19 & 20 Mid Photo</p> <p>Roofs remain unfinished.</p>	<p>TR</p>

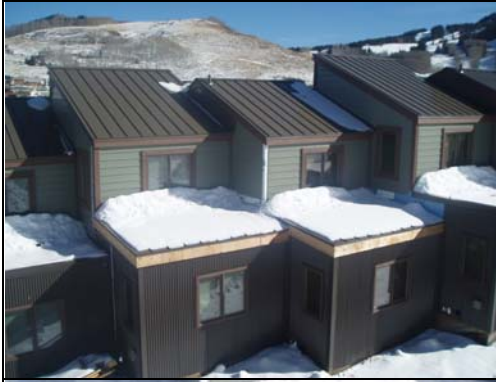
<p>11/18/11 – Photo 2 Units 19 & 20</p> <p>Metal standing seam roof has been installed.</p>	<p>Note</p>

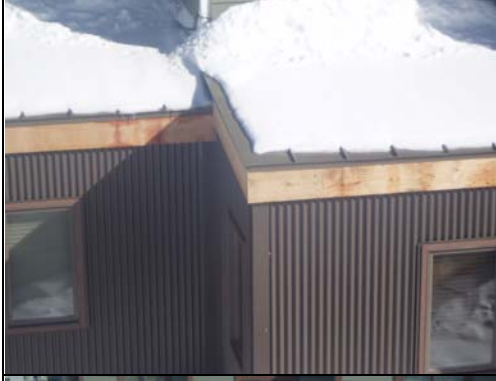
<p>11/18/11 – Photo 3 Units 19 & 20</p> <p>Fascia detail has been altered.</p>	<p>Note</p>

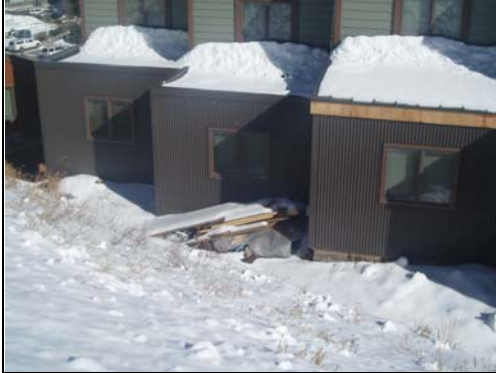
<p>11/18/11 – Photo 4 Units 18 & 19</p> <p>Demolition debris has not yet been removed.</p>	<p>TR</p>
