ARCHITECT'S FIELD REPORT

134

PROJECT	Eagle's Nest Townhouses 11 Morning Glory Way & 31 Marcellina Lane Mt. Crested Butte, CO 81225	DATE	12/04/13
---------	--	------	----------

WORK OBSERVED	
Phase IV Construction – Upper Level Renovations	
TRADES PRESENT	
None

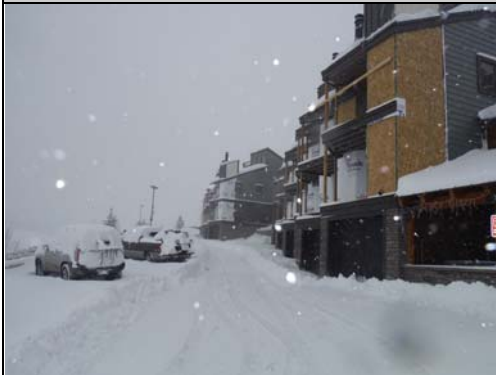
<p>12/04/13 – Photo 1 Upper Level Looking South</p> <p>Approximately 12” of snow as accumulated.</p>	<p>Note</p>

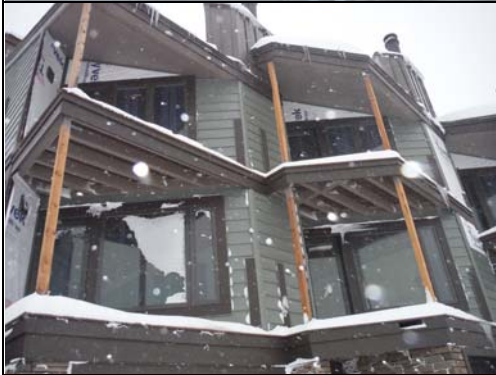
<p>12/04/13 – Photo 4 Units 1 & 2</p> <p>Green siding installation is underway.</p>	<p>Note</p>

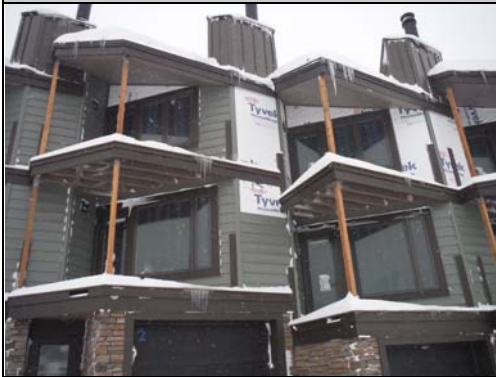
<p>12/04/13 – Photo 5 Units 3 & 4</p> <p>Green siding installation is underway.</p>	<p>Note</p>

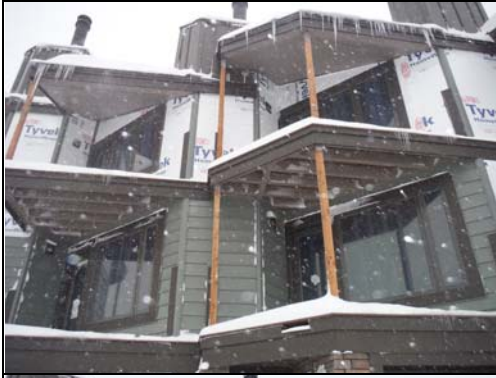
<p>12/04/13 – Photo 6 Units 5 & 6</p> <p>Green siding installation is underway.</p>	<p>Note</p>

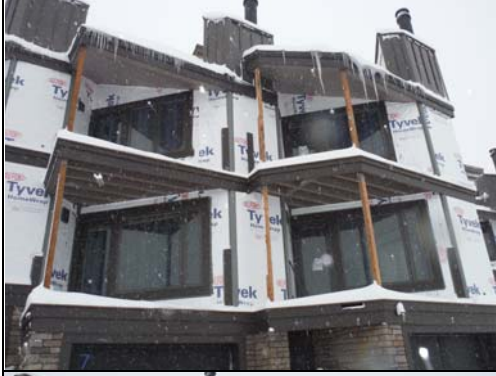
<p>12/04/13 – Photo 7 Units 7 & 8</p> <p>Units are awaiting siding.</p>	<p>Note</p>

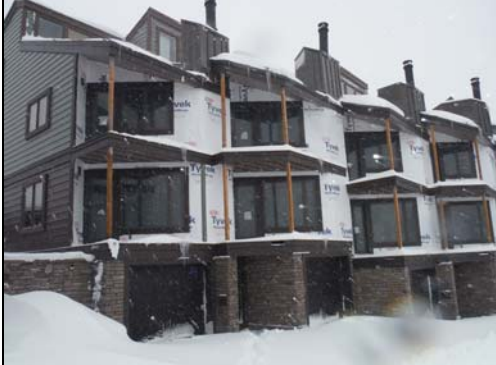
<p>12/04/13 – Photo 8 Building B</p> <p>No additional work has been done on Building B.</p>	<p>Note</p>
