# ARCHITECT'S FIELD REPORT

120

<b>PROJECT</b>	<b>Eagle's Nest Townhouses</b> 11 Morning Glory Way & 31 Marcellina Lane Mt. Crested Butte, CO 81225	<b>DATE</b>	8/28/13
----------------	--	-------------	---------

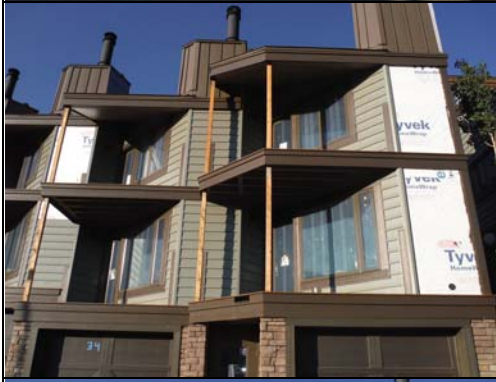
<p>8/28/13 – Photo 2 Units 33 &amp; 34</p> <p>Metal siding is about 75% complete.</p>	<p>Note</p>

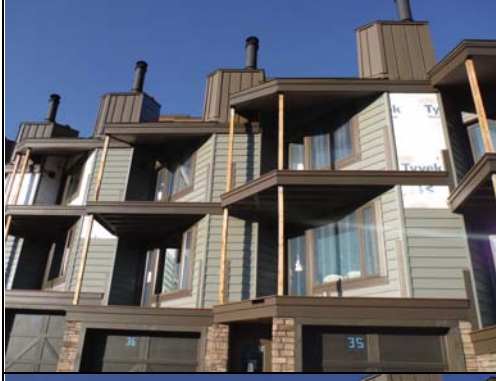
<p>8/28/13 – Photo 3 Units 35 &amp; 36</p> <p>Metal siding is about 90% complete.</p>	<p>Note</p>

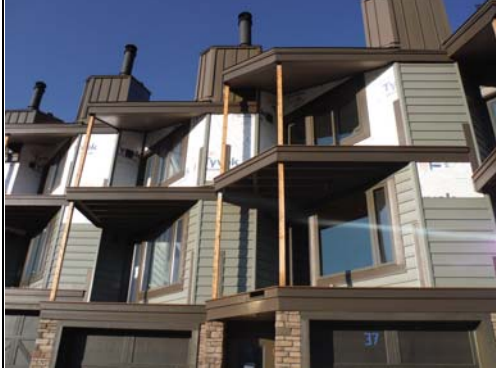
<p>8/28/13 – Photo 4 Units 37 &amp; 38</p> <p>Metal siding is about 60% complete</p>	<p>Note</p>

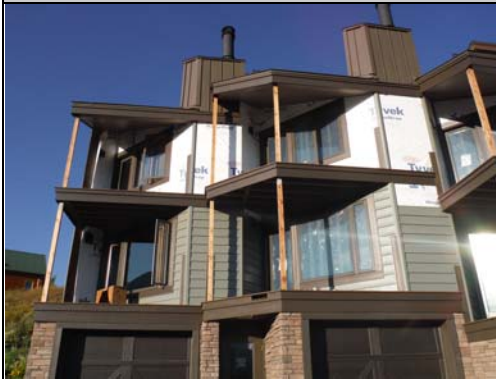
<p>8/28/13 – Photo 5 Unit 39 &amp; 40</p> <p>Metal siding is about 50% complete.</p>	<p>Note</p>

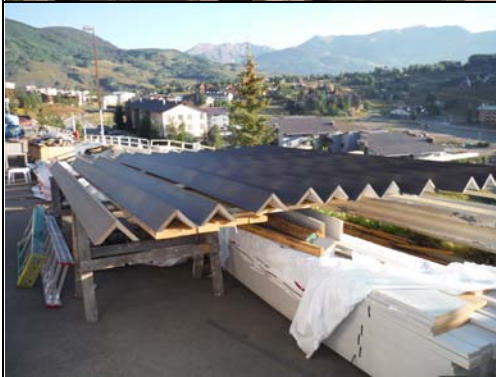
<p>8/28/13 – Photo 6 Lower Level Work Area</p> <p>Assembled corner trim pieces ready for installation.</p>	<p>Note</p>
