ARCHITECT'S FIELD REPORT

PROJECT	<b>Eagle's Nest Townhouses</b> 11 Morning Glory Way & 31 Marcellina Lane Mt. Crested Butte, CO 81225	DATE	7/9/13
---------	--	------	--------

CONDITIONS			
DATE	7/9/13	TIME	8:30 am
WEATHER	Clear, Sunny	TEMP	63 deg

WORK OBSERVED	
Phase IV Construction	
TRADES PRESENT	
Holgate Construction Co.

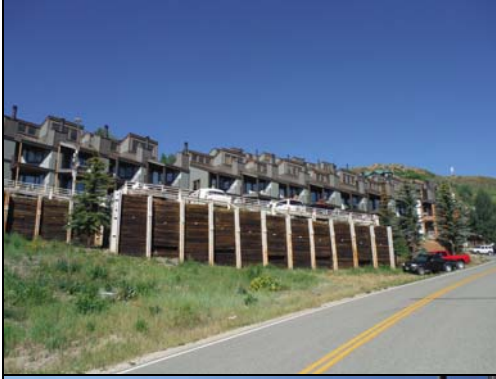
<p>7/9/13 – Photo 3 Lower Level Building C</p> <p>Note some overflow parking below Building C. The trucks did not appear to be Holgate employees.</p>	<p>Note</p>

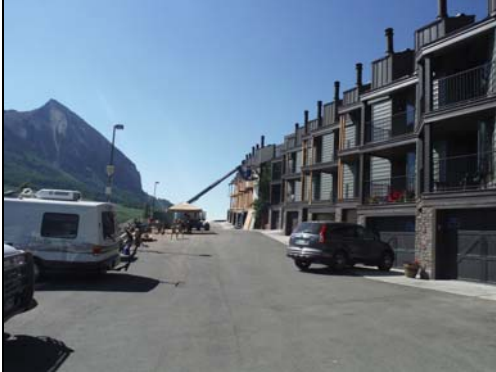
<p>7/9/13 – Photo 4 Lower Level Looking South</p> <p>Work area has been moved to Building E.</p>	<p>Note</p>

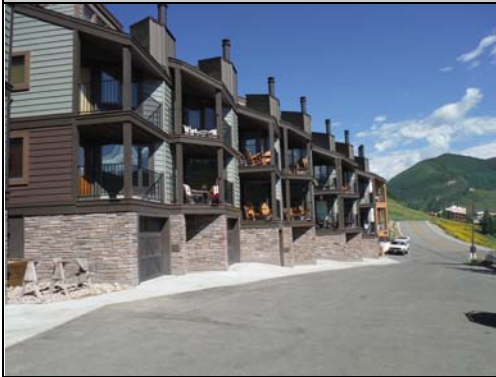
<p>7/9/13 – Photo 5 Lower Level Looking North Building C</p> <p>Site is clean in front of Building C &amp; D.</p>	<p>Note</p>

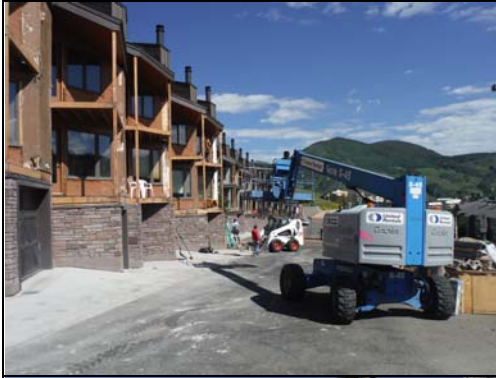
<p>7/9/13 – Photo 6 Lower Level Looking North.</p> <p>Work area in front of Building E. Demolition is complete and clean-up efforts are underway.</p>	<p>Note</p>

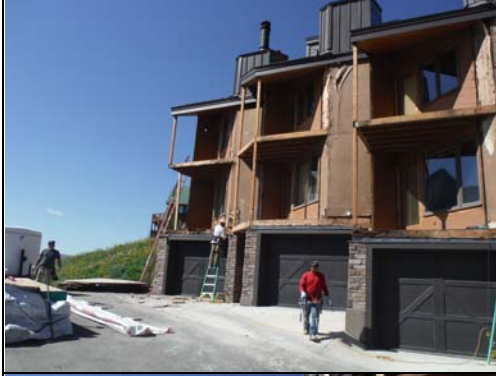
<p>7/9/13 – Photo 7 Units 40 &amp; 39</p> <p>Demolition is complete.</p>	<p>Note</p>

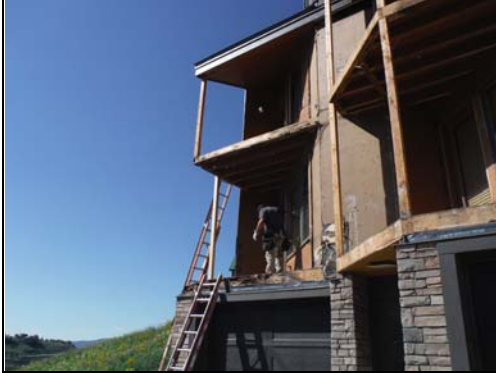
COMMENTS & OBSERVATIONS
<ol style="list-style-type: none"> <li>1. Observed completed demolition work on Building E.</li> <li>2. Units 40 &amp; 38 showed severe structural damage to the outside joists and columns on the 2<sup>nd</sup> Floor decks. Repair work is underway.</li> <li>3. Units 33 &amp; 34 showed serve structural damage to the outside joists on the 3<sup>rd</sup> floor decks. The outside joists will need to be replaced. Repair work is underway.</li> <li>4. Observed completed work on Building D. Remaining post wraps and guardrail installation will be complete by Wednesday. Punch List Inspection is scheduled for 7/12/13.</li> <li>5. (8) Workers were on site today including Mick.</li> <li>6. The project has experienced <b>4 days weather delay</b> due to snowfall on 4/9/13, 4/15/13, 5/8/13, and rain on 5/29/13.</li> </ol>

<p>7/9/13 – Photo 8 Unit 40 2<sup>nd</sup> Floor Deck</p> <p>2<sup>nd</sup> Floor deck and column were complete degraded. Repair work is underway.</p> <p>Note column has been removed and 3<sup>rd</sup> Floor Deck has been shored.</p>	<p>Note</p>

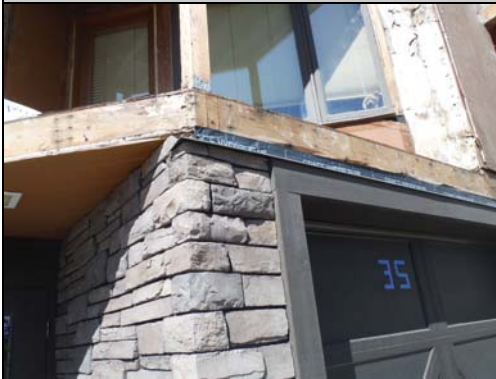
<p>7/9/13 – Photo 13 Unit 35 2<sup>nd</sup> Floor Deck Condition</p> <p>Deck condition is good.</p>	<p>Note</p>

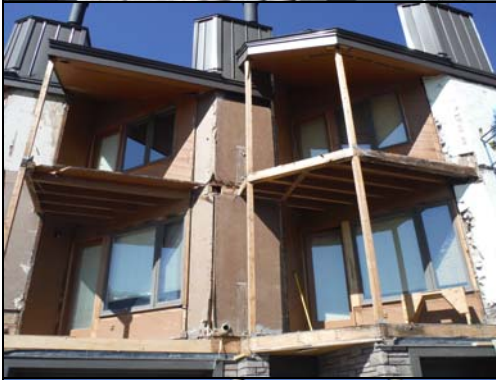
<p>7/9/13 – Photo 14 Units 34 &amp; 33</p> <p>3<sup>rd</sup> Floor Deck joists are degraded. Unit 35 joists have been removed. Unit 34 joists are awaiting replacement.</p>	<p>Note</p>

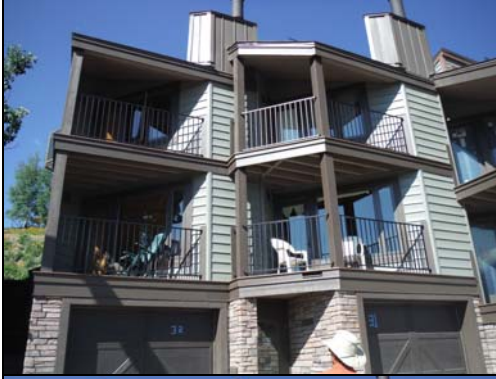
<p>7/9/13 – Photo 15 Units 32 &amp; 31</p> <p>Completed construction. Units are ready for a Punch List inspection.</p>	<p>Note</p>

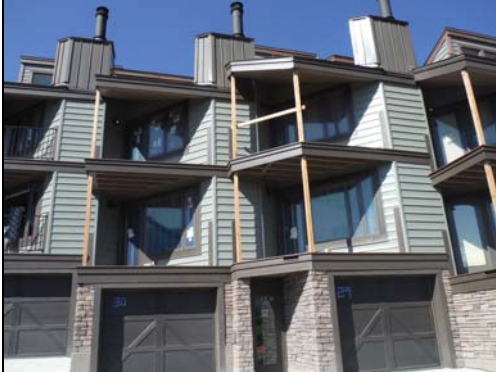
<p>7/9/13 – Photo 16 Units 30 &amp; 29</p> <p>Units are awaiting post wraps and guardrails. Work should be complete by 7/10/13 and ready for Punch List inspection.</p>	<p>Note</p>

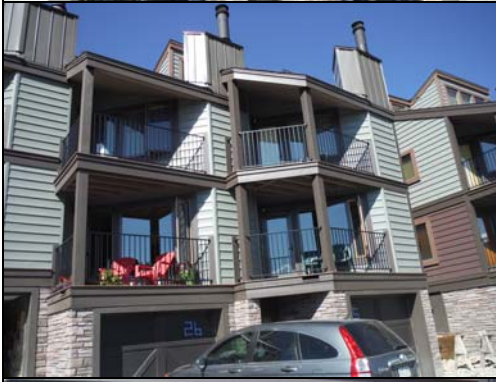
<p>7/9/13 – Photo 18 Units 26 &amp; 25</p> <p>Completed construction. Units are ready for a Punch List inspection.</p>	<p>Note</p>
 	<p>7/9/13 – Photo 19 Unit 27 Garage</p> <p>Material &amp; equipment storage condition.</p>	<p>Note</p>

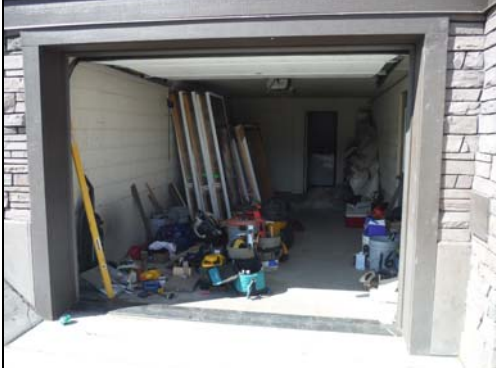
<p>7/9/13 – Photo 20 Unit 28 Garage</p> <p>Material &amp; equipment storage condition.</p>	<p>Note</p>
