**ARCHITECT'S FIELD REPORT**

<b>PROJECT</b>	<b>Eagle's Nest Townhouses</b> 11 Morning Glory Way & 31 Marcellina Lane Mt. Crested Butte, CO 81225	<b>DATE</b>	10/9/13
----------------	--	-------------	---------

<b>WORK OBSERVED</b>	
Phase IV Construction – Upper Level Renovations	
<b>TRADES PRESENT</b>	
Holgate Construction Co.

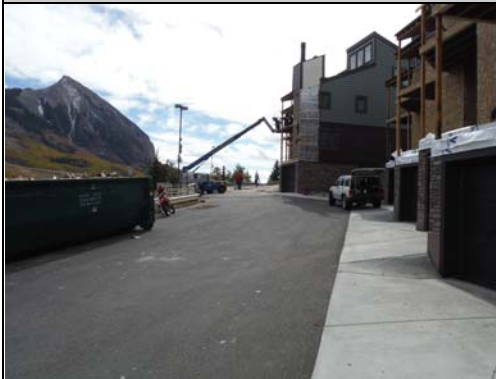
<p>10/9/13 – Photo 1 Upper Level Work Area Looking South</p> <p>Dumpster is staged in front of Building B. Construction work is concentrated on Building A.</p>	<p>Note</p>

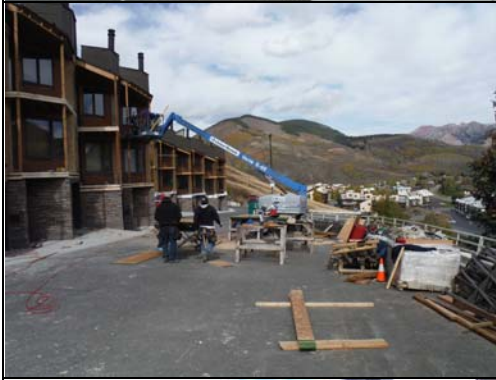
<p>10/9/13 – Photo 2 Upper Level Work Area Looking North</p> <p>Work area and material staging in front of Building A. Access is impeded. No occupants at this time.</p>	<p>Note</p>

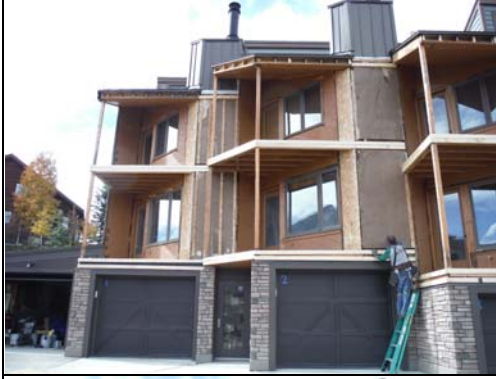
<p>10/9/13 – Photo 3 Units 1 &amp; 2</p> <p>Demolition is complete. Furring strips and sheathing are being installed.</p>	<p>Note</p>

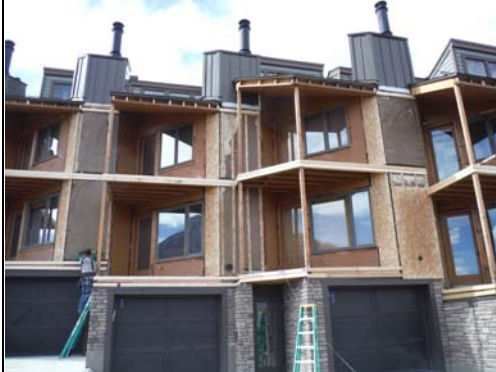
<p>10/9/13 – Photo 4 Units 3 &amp; 4</p> <p>Demolition is complete. Furring strips and sheathing are being installed.</p>	<p>Note</p>

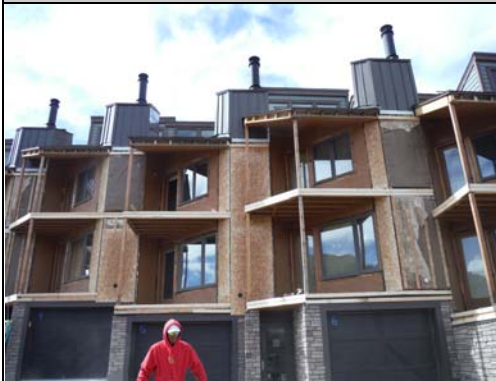
<p>10/9/13 – Photo 5 Units 5 &amp; 6</p> <p>Demolition and repairs complete.</p>	<p>Note</p>

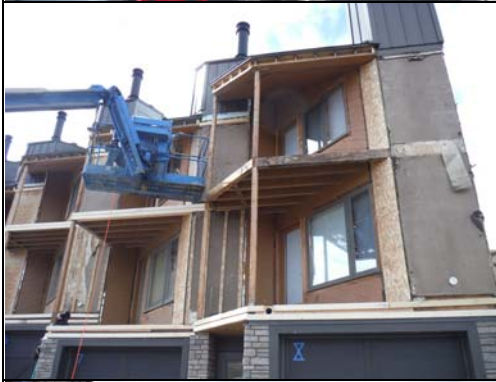
<p>10/9/13 – Photo 6 Units 6 &amp; 7</p> <p>Furr strips and sheathing underway.</p>	<p>Note</p>

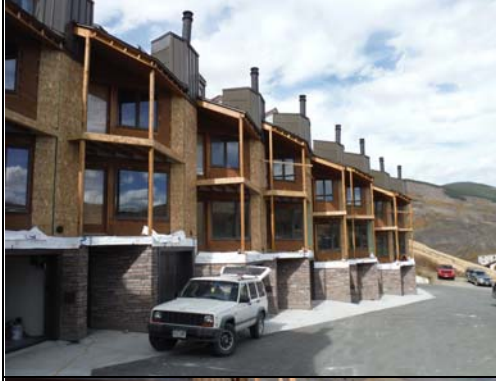
<p>10/9/13 – Photo 7 Building B Looking North</p> <p>Minimal construction work on Building B.</p>	<p>Note</p>

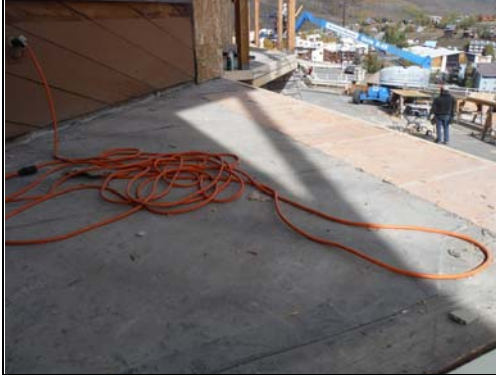
<p>10/9/13 – Photo 8 Unit 3 2<sup>nd</sup> Floor Deck</p> <p>Minor deck replacement on leading edge of deck.</p>	<p>Note</p>

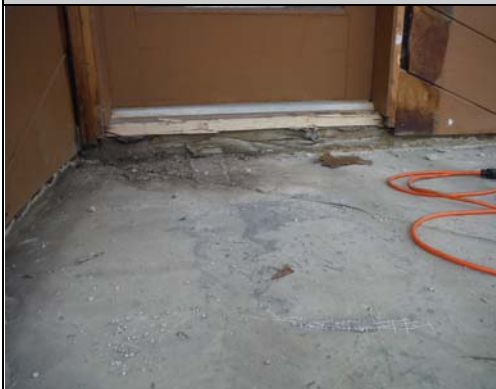
<p>10/9/13 – Photo 9 Unit 3 Door Threshold</p> <p>Threshold and floor to wall connection appears to be in good condition.</p>	<p>Note</p>

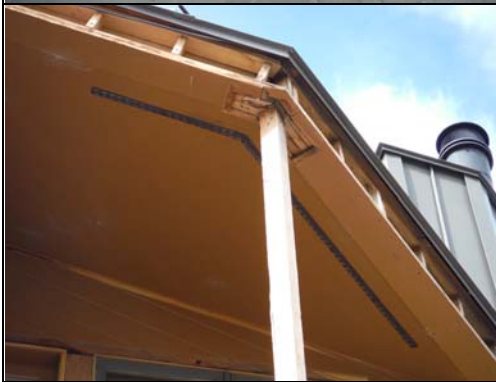
<p>10/9/13 – Photo 10 Typical Soffit Vent Installation</p> <p>All soffit vents have been installed.</p>	<p>Note</p>

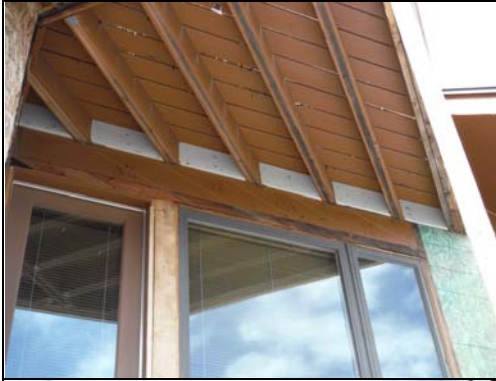
<p>10/9/13 – Photo 11 Building B, 3<sup>rd</sup> Floor Blocking</p> <p>Trim blocking has been started on Building B.</p>	<p>Note</p>

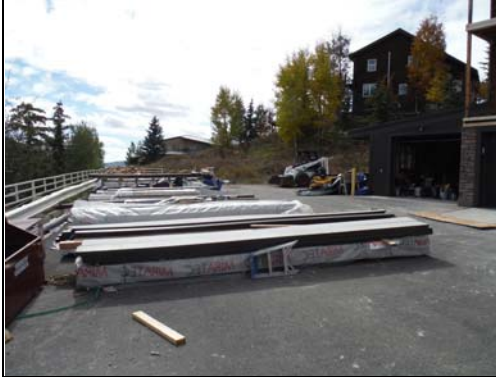
<p>10/9/13 – Photo 12 North Parking Lot</p> <p>Materials on site.</p>	<p>Note</p>

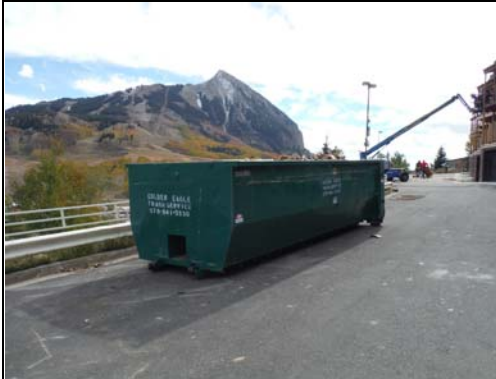
<p>10/9/13 – Photo 13 Dumpster</p> <p>Dumpster is full.</p>	<p>Note</p>

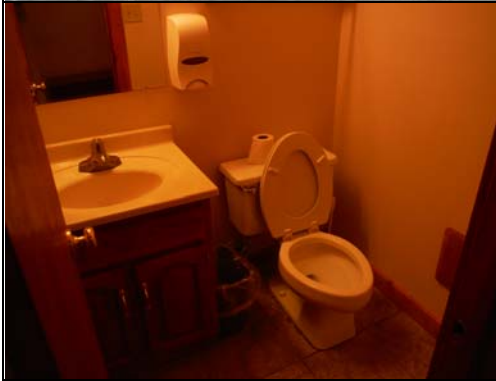
<p>10/9/13 – Photo 14 Upper Level Hot Tub Restroom</p> <p>Restroom is clean and in good order.</p>	<p>Note</p>
