# ARCHITECT'S FIELD REPORT

103

<b>PROJECT</b>	<b>Eagle's Nest Townhouses</b> 11 Morning Glory Way & 31 Marcellina Lane Mt. Crested Butte, CO 81225	<b>DATE</b>	4/24/13
----------------	--	-------------	---------

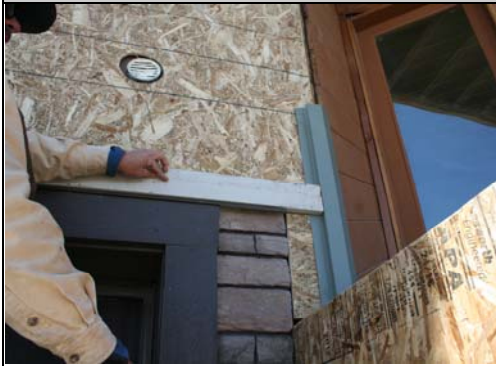
<p>4/19/13 – Photo 5 Unit 22, Belly Band</p> <p>Mock-up &amp; coordination of 2<sup>nd</sup> Floor belly band at unit level drop.</p> <p>Belly band can end at new corner strip.</p>	<p>Note</p>

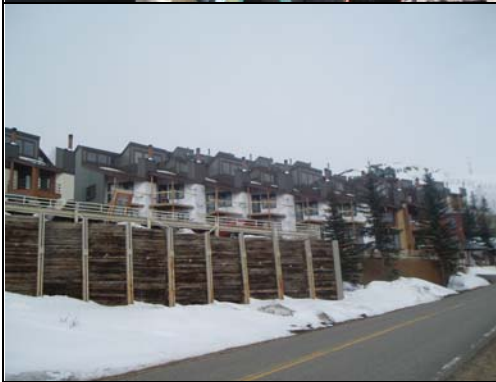
<p>4/24/13 – Photo 7 Building C from the East</p> <p>House wrap has been installed on 6 units.</p>	<p>Note</p>

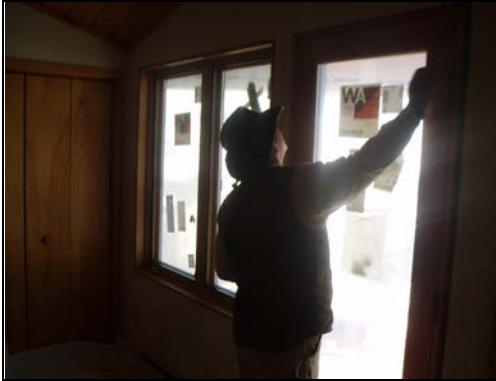
<p>4/24/13 – Photo 8 Unit 24, 3<sup>rd</sup> Floor</p> <p>Completed door and window installation. Bare trim has been installed.</p>	<p>Note</p>

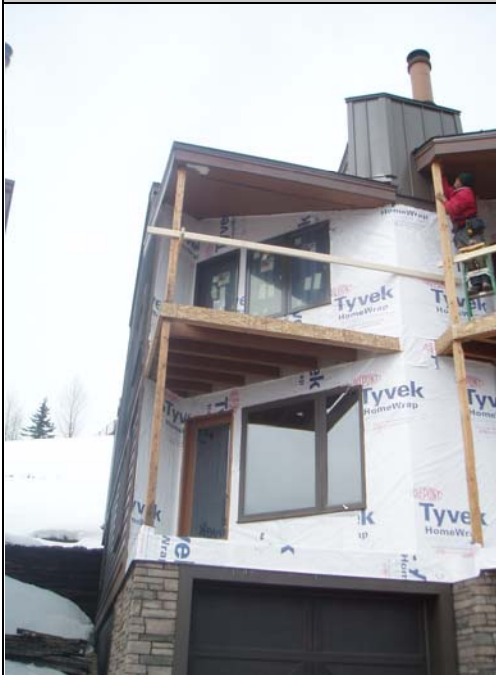
<p>4/24/13 – Photo 9 Unit 24</p> <p>Completed house wrap and soffit vent on Unit 24.</p>	<p>Note</p>

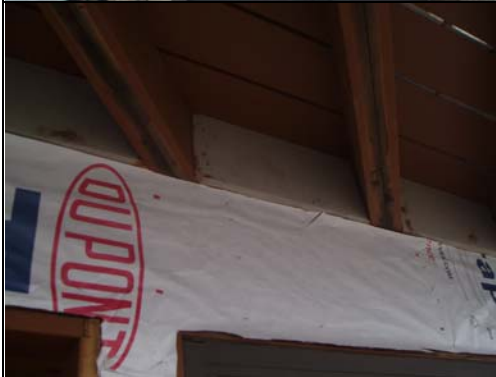
<p>4/24/13 – Photo 10 Unit 24 Underside of 3<sup>rd</sup> Floor Deck</p> <p>Miratec trim boards have been installed in between deck joists. Boards will be painted.</p>	<p>Note</p>

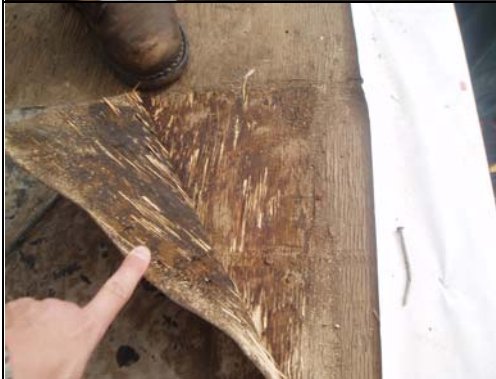
<p>4/24/13 – Photo 11 Unit 24 2<sup>nd</sup> Floor Deck Condition</p> <p>Plywood deck surface is in good condition. In some instances the existing membrane can be left in place and covered over with new deck membrane.</p>	<p>Note</p>

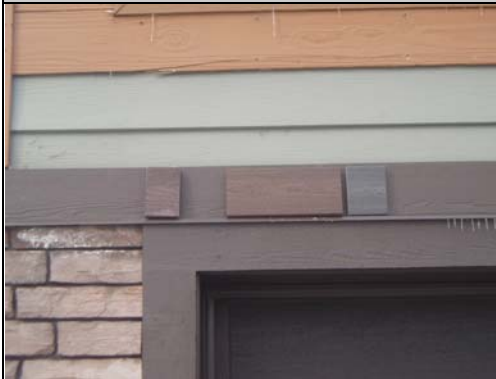
<p>4/24/13 – Photo 12 Fiberon “Espresso” &amp; “Earl Grey”</p> <p>Sample to the left is Trex “Woodland Brown”</p>	<p>Note</p>

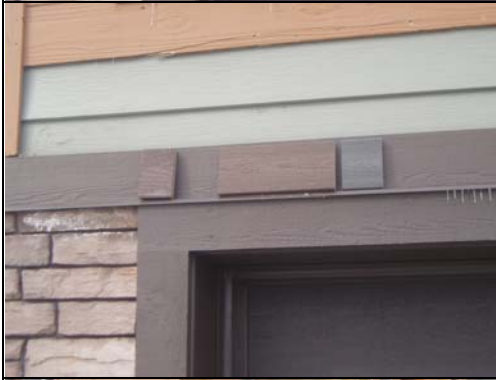
<p>4/24/13 – Photo 13 Fiberon “Espresso” &amp; “Earl Grey”</p> <p>Sample to the left is Trex “Woodland Brown”</p>	<p>Note</p>

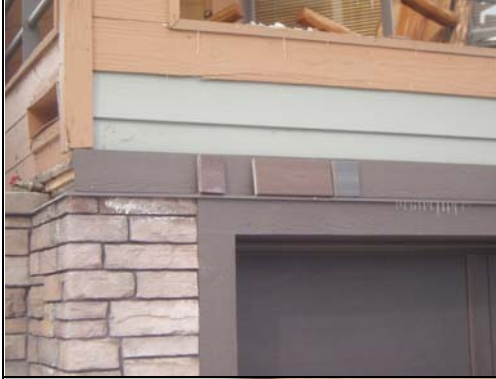
<p>4/24/13 – Photo 14 Fiberon “Espresso” &amp; “Earl Grey”</p> <p>Sample to the left is Trex “Woodland Brown”</p>	<p>Note</p>

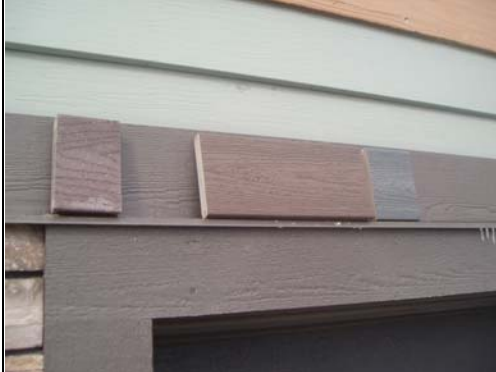
<p>4/24/13 – Photo 15 Fiberon “Espresso” &amp; “Earl Grey”</p> <p>Sample to the left is Trex “Woodland Brown”</p>	<p>Note</p>
