**ARCHITECT'S FIELD REPORT**

**004**

**PROJECT**      **Eagle's Nest Townhouses**  
11 Morning Glory Way & 31 Marcellina Lane  
Mt. Crested Butte, CO 81225

**DATE**      4/8/10

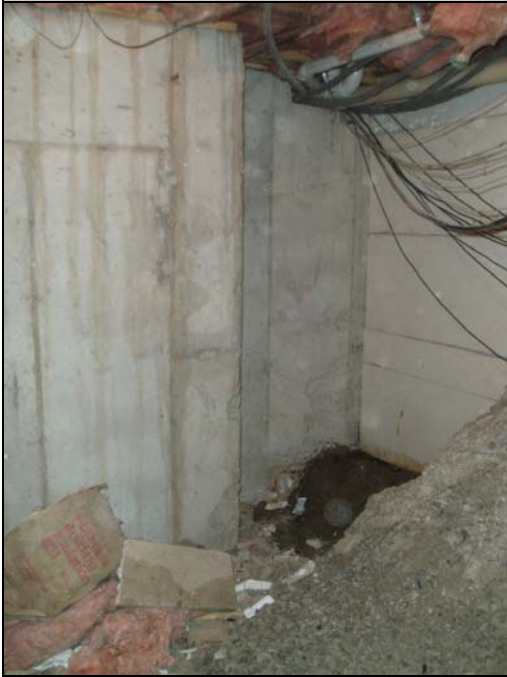
<p>4/7/10 – Photo 1 Unit 17 Southwest corner. Note damp area of dark soil.</p>	<p>None</p>

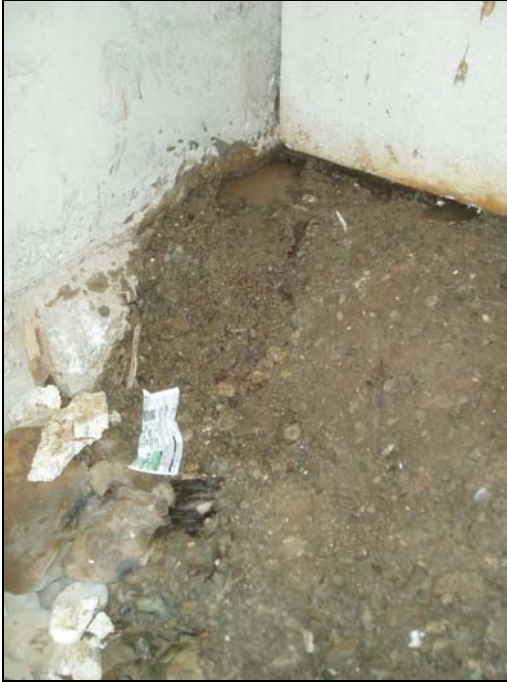
<p>4/7/10 – Photo 2 Unit 17 Southwest corner. With minimal digging, water did pool in this area.</p>	<p>None</p>

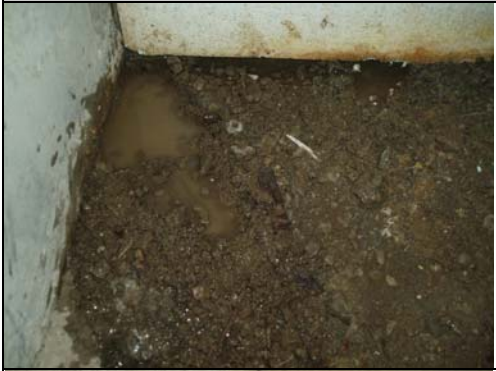
<p>4/7/10 – Photo 3 Unit 17 Southwest corner. Detail photo of pooled water.</p>	<p>None</p>

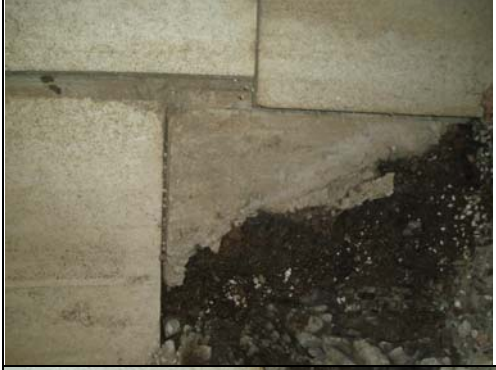
<p>4/7/10 – Photo 4 Unit 15 Moisture present along junction between foundation wall and bedrock. White panels are Styrofoam insulation glued to the foundation walls.</p>	<p>None</p>

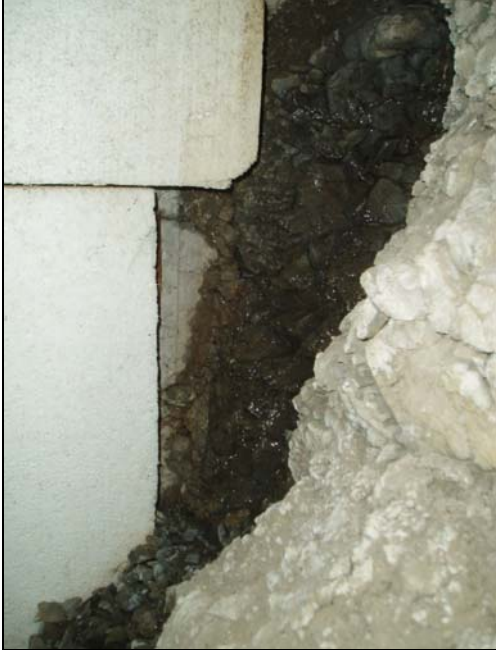
<p>4/7/10 – Photo 5 Unit 15 Close inspection revealed concrete foundation walls poured against bedrock. Moisture appears between the two.</p>	<p>None</p>

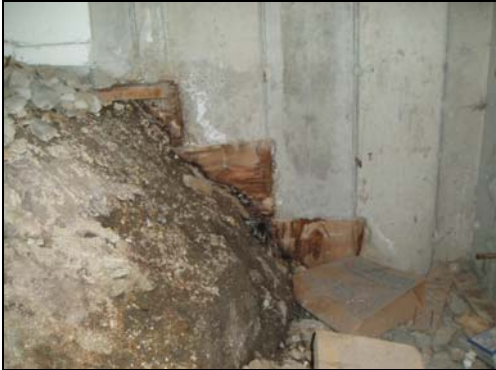
<p>4/7/10 – Photo 6 Unit 9 North foundation wall. Plywood forms are still present. Dark areas indicate moisture.</p>	<p>None</p>

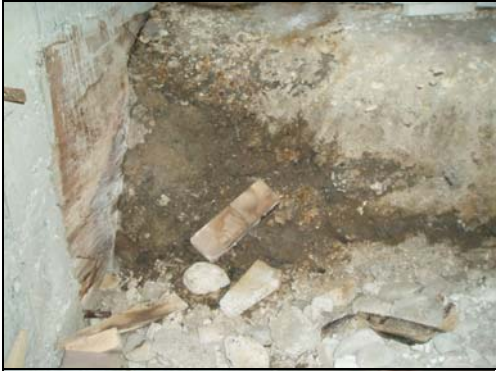
<p>4/7/10 – Photo 7 Unit 9 South Foundation Wall. Moist soil noted at similar level of bottom of foundation wall.</p>	<p>None</p>

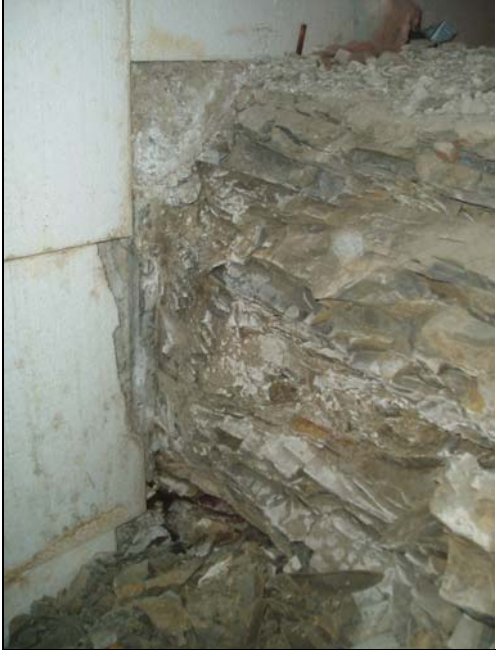
<p>4/7/10 – Photo 8 Unit 24 Relatively dry conditions. Note foundation wall set directly on bedrock.</p>	<p>None</p>

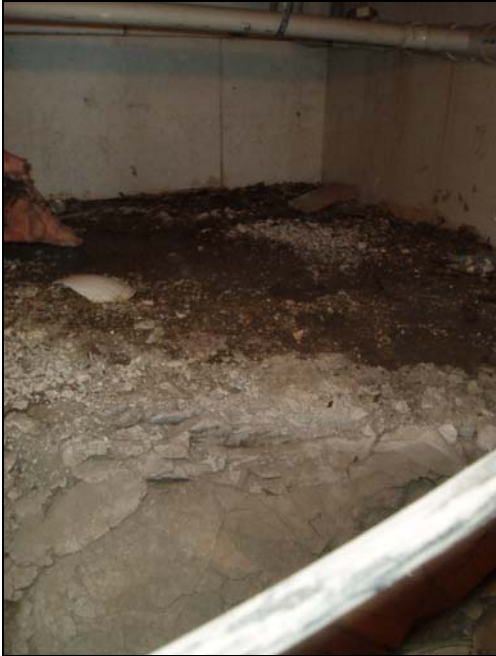
<p>4/7/10 – Photo 9 Unit 9 Northwest corner. Dark areas are moist soil. Moisture appeared to be isolated and not percolating through the bedrock below.</p>	<p>None</p>

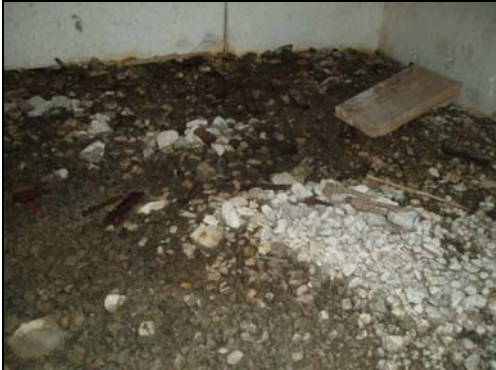
<p>4/7/10 – Photo 10 Unit 9 Detail – dark areas are moist.</p>	<p>None</p>

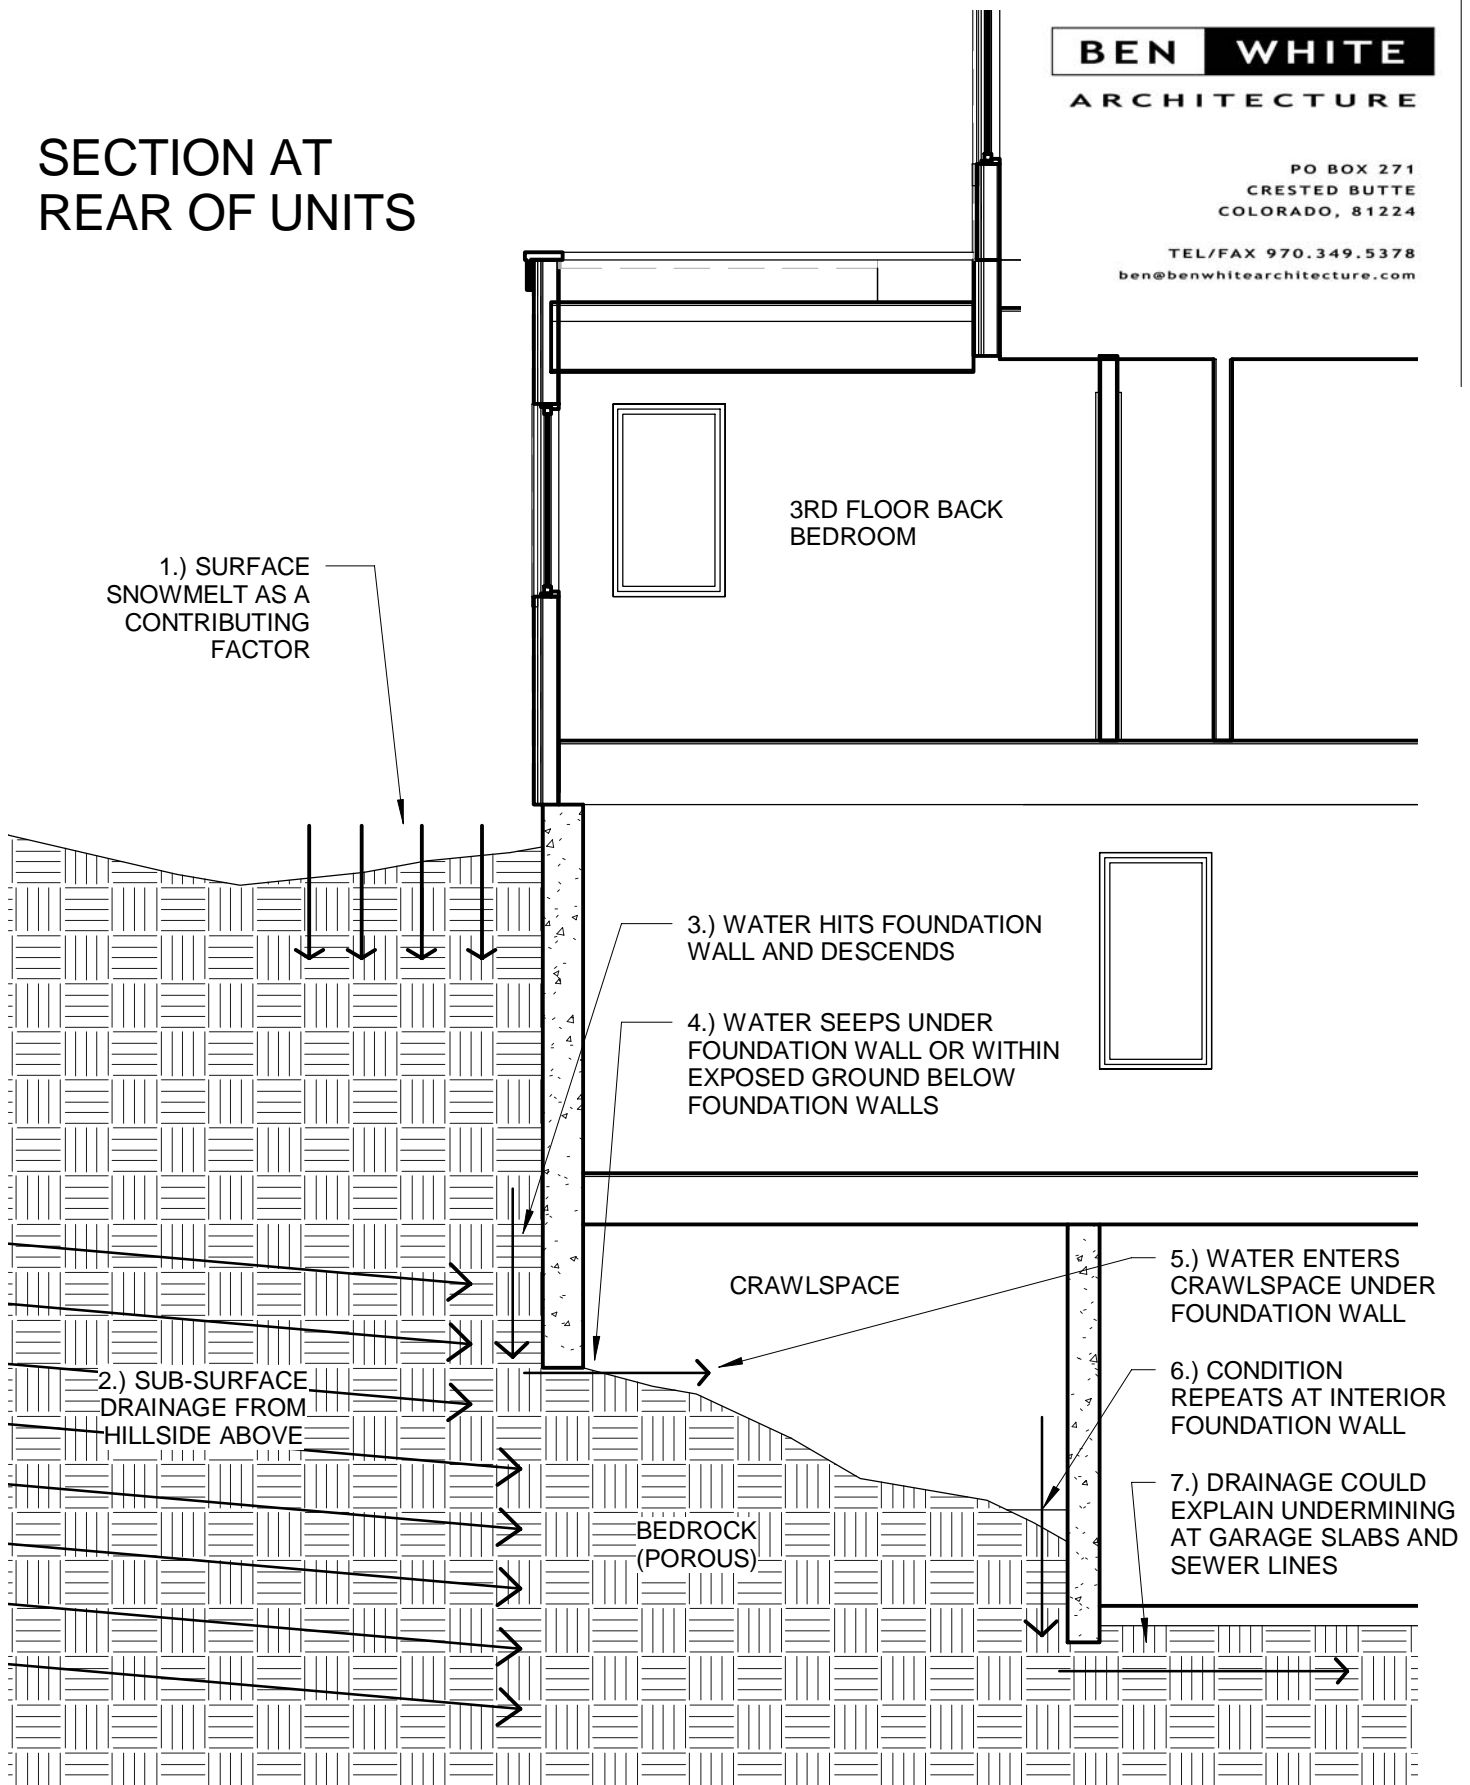
# SECTION AT REAR OF UNITS

1.) SURFACE  
SNOWMELT AS A  
CONTRIBUTING  
FACTOR

3.) WATER HITS FOUNDATION  
WALL AND DESCENDS

4.) WATER SEEPS UNDER  
FOUNDATION WALL OR WITHIN  
EXPOSED GROUND BELOW  
FOUNDATION WALLS

5.) WATER ENTERS  
CRAWLSPACE UNDER  
FOUNDATION WALL

6.) CONDITION  
REPEATS AT INTERIOR  
FOUNDATION WALL

7.) DRAINAGE COULD  
EXPLAIN UNDERMINING  
AT GARAGE SLABS AND  
SEWER LINES

2.) SUB-SURFACE  
DRAINAGE FROM  
HILLSIDE ABOVE
