ARCHITECT'S FIELD REPORT

132

PROJECT	Eagle's Nest Townhouses 11 Morning Glory Way & 31 Marcellina Lane Mt. Crested Butte, CO 81225	DATE	11/20/13
----------------	--	-------------	----------

WORK OBSERVED	
Phase IV Construction – Upper Level Renovations	
TRADES PRESENT	
Holgate Construction Co.

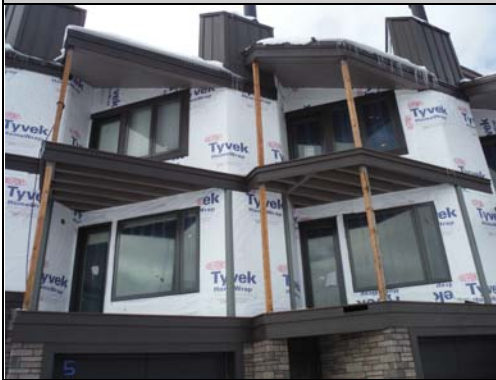
<p>11/20/13 – Photo 5 Units 5 & 6</p> <p>Window and Door trim installation underway.</p>	<p>Note</p>

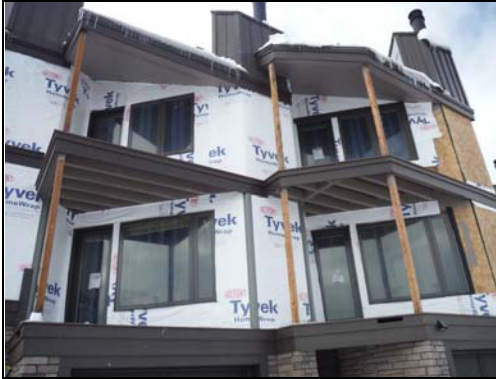
<p>11/20/13 – Photo 6 Units 7 & 8</p> <p>Units awaiting trim work.</p>	<p>Note</p>

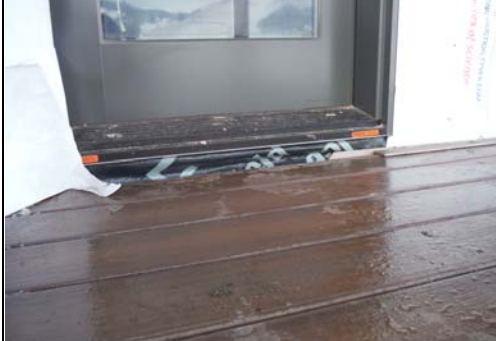
<p>11/20/13 – Photo 12 Typical 2nd Floor Deck</p> <p>Note waterproof membrane under door sill.</p>	<p>Note</p>

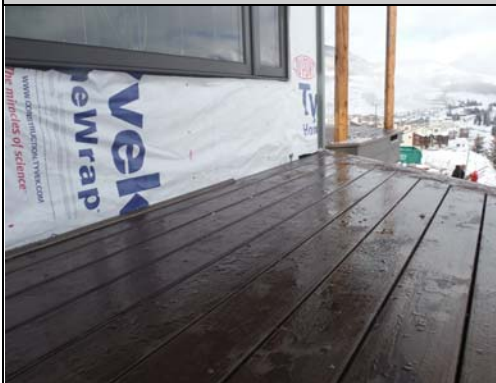
<p>11/20/13 – Photo 13 Typical 2nd Floor Deck</p> <p>Tyvek house wrap is lapped over the top of the EPDM deck membrane.</p>	<p>Note</p>

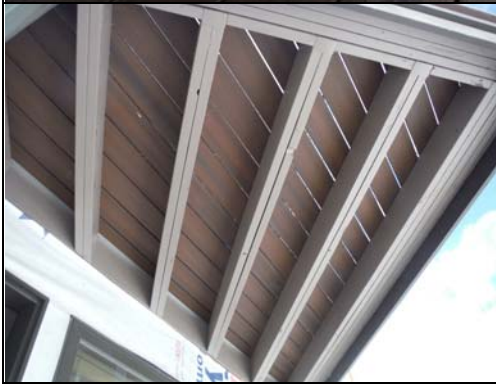
<p>11/20/13 – Photo 14 Looking Up at the 3rd Floor Deck</p> <p>New Fiberon decking, infill trim pieces (between the deck joists) and flashing are in place.</p>	<p>Note</p>

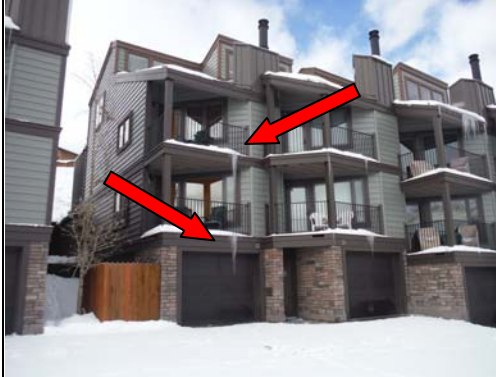
<p>11/20/13 – Photo 16 Phase IV Components in Winter Conditions</p> <p>Red arrows show the icicles detailed below.</p>	<p>Note</p>

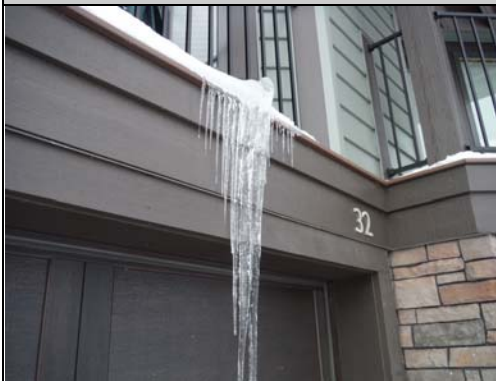
<p>11/20/13 – Photo 17 Typical 2nd Floor Deck Ice Conditions</p> <p>Drip condition is freezing at the edge of the Fiberon deck. The drip in this condition does not touch the MiraTec belly band.</p>	<p>Note</p>

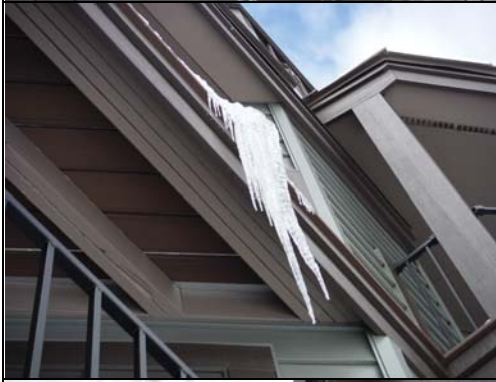
<p>11/20/13 – Photo 18 Typical 3rd Floor Deck Ice Conditions</p> <p>Similar condition occurring at the 3rd floor deck. The belly band is free of ice.</p>	<p>Note</p>

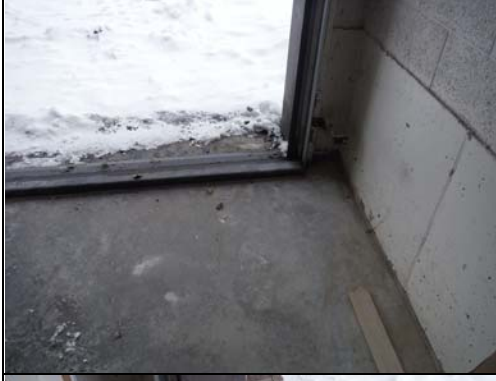
<p>11/20/13 – Photo 19 Unit 30 Threshold</p> <p>Threshold is dry.</p>	<p>Note</p>

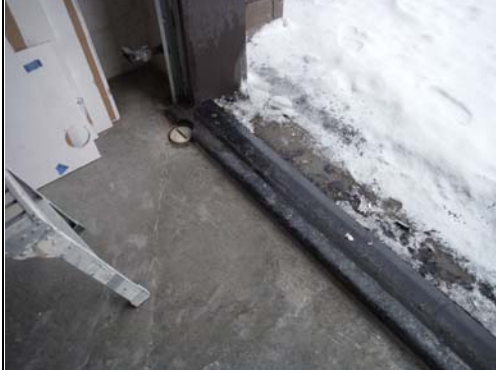
<p>11/20/13 – Photo 20 Unit 30 Threshold</p> <p>Threshold is dry.</p>	<p>Note</p>

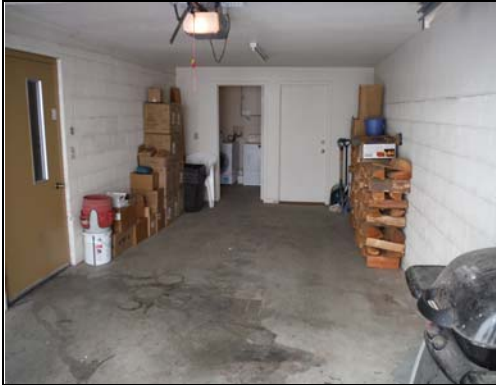
<p>11/20/13 – Photo 21 Unit 27 Garage</p> <p>Garage is clean and in good order.</p>	<p>Note</p>

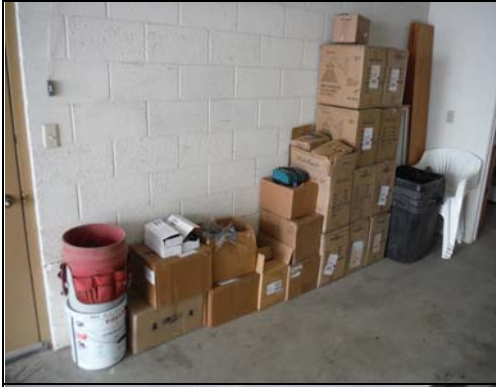
<p>11/20/13 – Photo 22 Unit 27 Garage</p> <p>Light fixtures, door handles, and light bulbs remain.</p>	<p>Note</p>

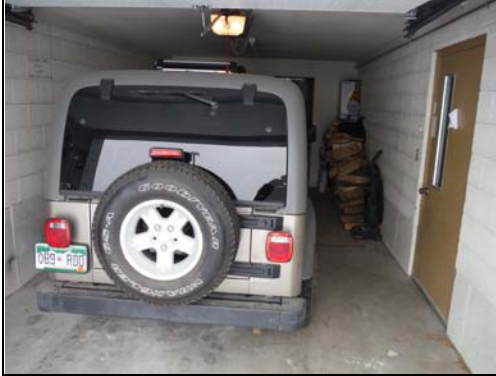
<p>11/20/13 – Photo 23 Unit 28 Garage</p> <p>Jeep has been moved.</p>	<p>Note</p>

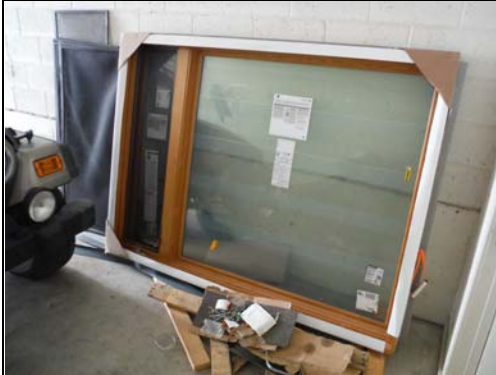
<p>11/20/13 – Photo 24 Unit 28 Garage</p> <p>Remaining Window Unit has yet to be moved. A small amount of debris remains.</p>	<p>Note</p>
