ARCHITECT'S FIELD REPORT

076

PROJECT	Eagle's Nest Townhouses 11 Morning Glory Way & 31 Marcellina Lane Mt. Crested Butte, CO 81225	DATE	6/13/12
----------------	--	-------------	---------

WORK OBSERVED	
Phase III Construction	
TRADES PRESENT	
Holgate Construction

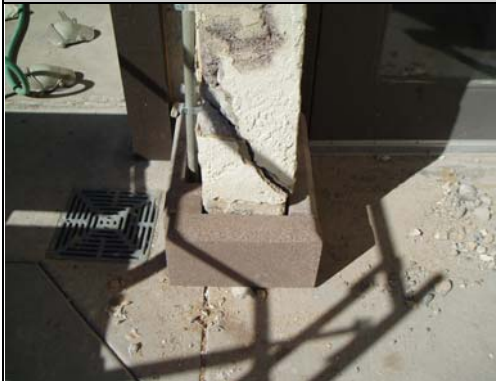
<p>6/13/12 – Photo 4 Unit 40</p> <p>Precast base around column to the left of the entry door. Note the thicker precast on the left-hand side to accommodate the snowmelt pipes.</p>	<p>Note</p>

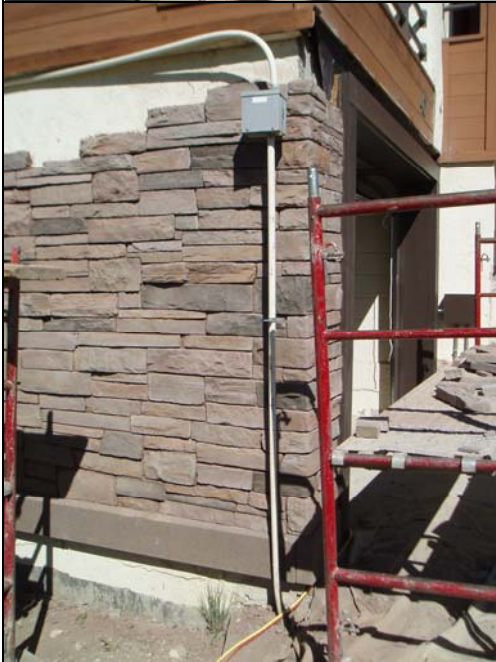
<p>6/13/12 – Photo 5 Unit 40</p> <p>Stone and precast base on the south face of Unit 40. Note electrical lines will be relocated.</p>	<p>Note</p>

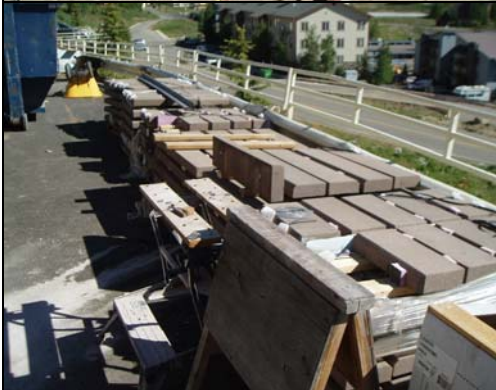
<p>6/13/12 – Photo 6 Lower Level</p> <p>Precast base is on-site.</p>	<p>Note</p>

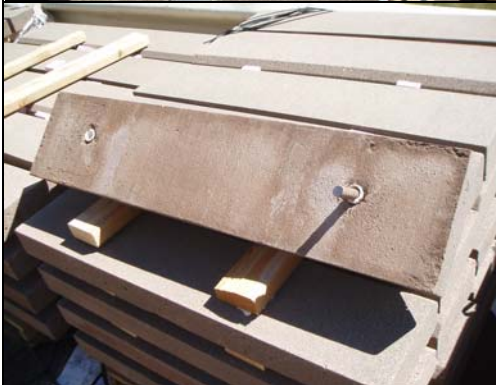
<p>6/13/12 – Photo 8 Detail of Precast Base</p> <p>Back of precast showing dowel holes. MH is using 5/8' rebar and construction adhesive to mount the precast.</p>	<p>Note</p>

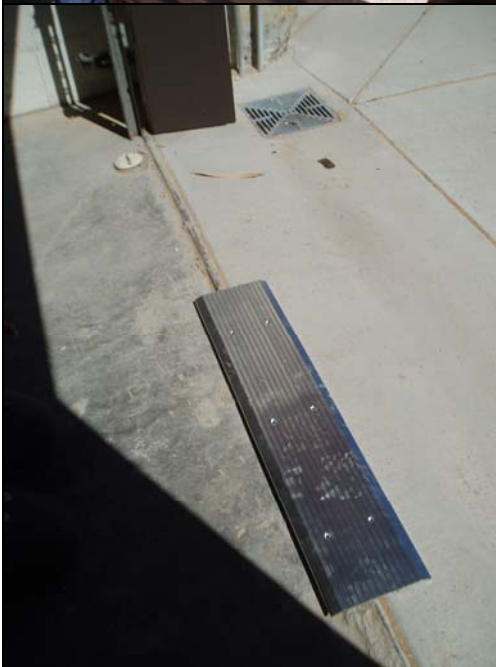
<p>6/13/12 – Photo 9 Aluminum Threshold Example</p> <p>BW & MH discussed possible threshold installation.</p>	<p>BWA MHC</p>
