ARCHITECT'S FIELD REPORT

067

PROJECT	Eagle's Nest Townhouses 11 Morning Glory Way & 31 Marcellina Lane Mt. Crested Butte, CO 81225	DATE	1/14/12
----------------	--	-------------	---------

WORK OBSERVED	
Sloped Roof Design Units 19 & 20	
TRADES PRESENT	
None

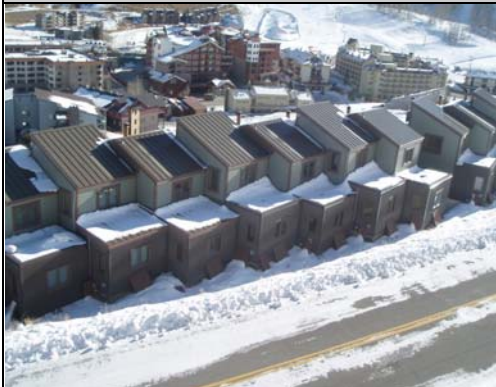
<p>1/13/12 – Photo 1 View of Lower Level Roofs</p> <p>Note Snow Levels at Third Floor Windows at Units 19 & 20 (second and third roofs from left).</p>	<p>Note</p>

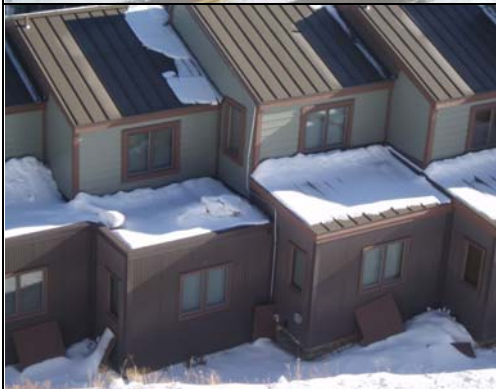
<p>1/13/12 – Photo 2 Units 19</p> <p>Complete roof.</p>	<p>Note</p>

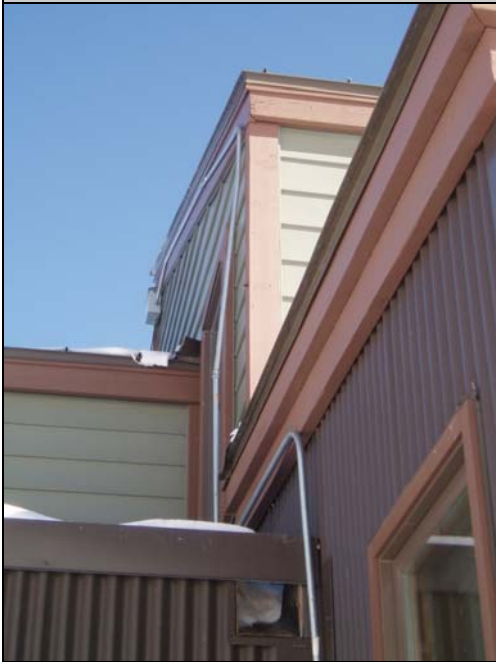
<p>1/13/12 – Photo 9 Unit 19 Conduit</p> <p>Snowmelt conduit on Unit 19 may need to be reattached.</p>	<p>Note</p>

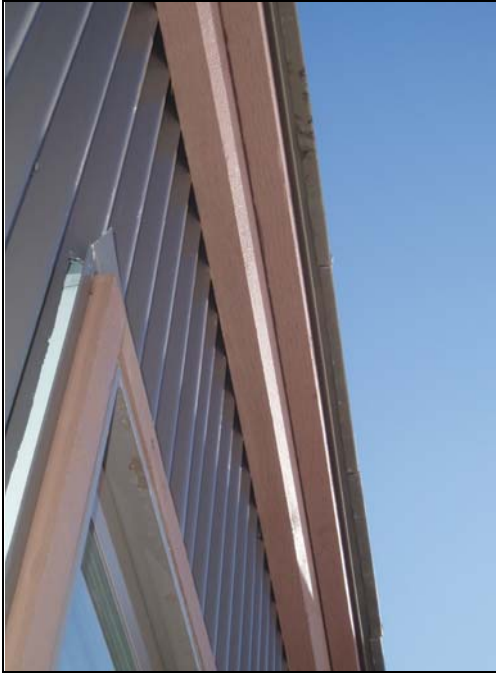
<p>1/13/12 – Photo 10 Example Photo</p> <ol style="list-style-type: none"> 1. Additional clearance allows for roof to drip clear of the window below. 2. All paint drips and over-painting have been removed. 	<p>Note</p>
