ARCHITECT'S FIELD REPORT

083

PROJECT	Eagle's Nest Townhouses 11 Morning Glory Way & 31 Marcellina Lane Mt. Crested Butte, CO 81225	DATE	7/24/12
----------------	--	-------------	---------

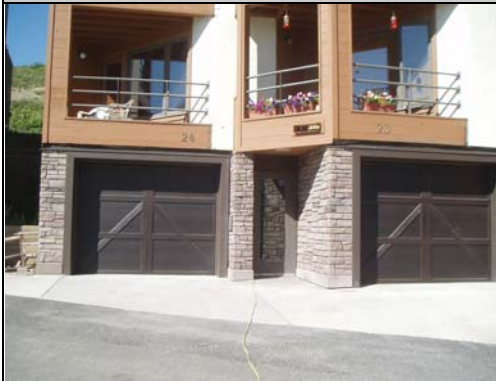
<p>7/24/12 – Photo 1 Units 23 & 24</p> <p>Precast base and stone installation complete. Waiting on final cleaning.</p>	<p>Note</p>

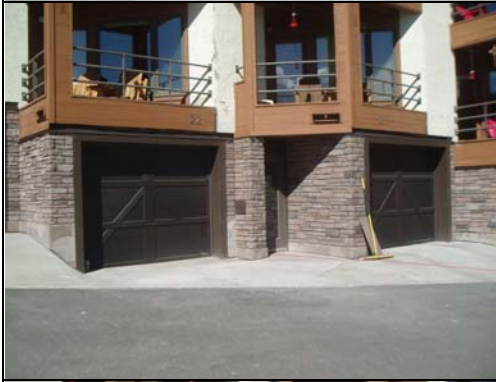
<p>7/24/12 – Photo 2 Units 21 & 22</p> <p>Precast base and stone installation complete. Waiting on final cleaning.</p>	<p>Note</p>

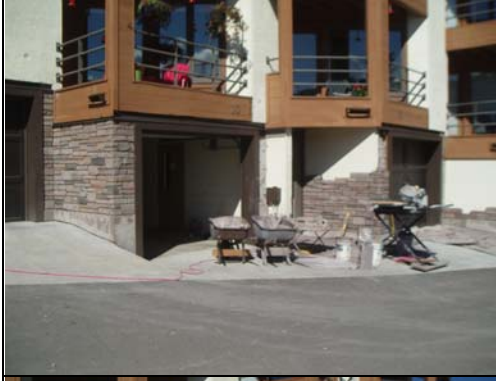
<p>7/24/12 – Photo 3 Units 19 & 20</p> <p>Stone installation underway.</p>	<p>Note</p>

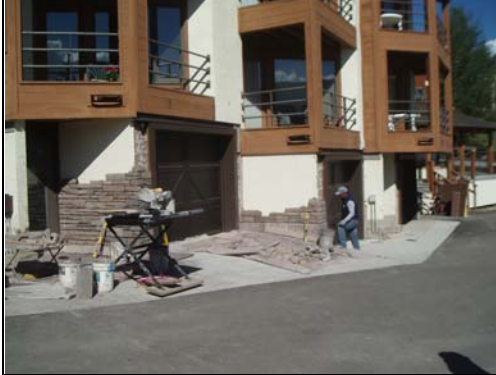
<p>7/24/12 – Photo 4 Units 17, 18 & 19</p> <p>Stone installation underway.</p>	<p>Note</p>

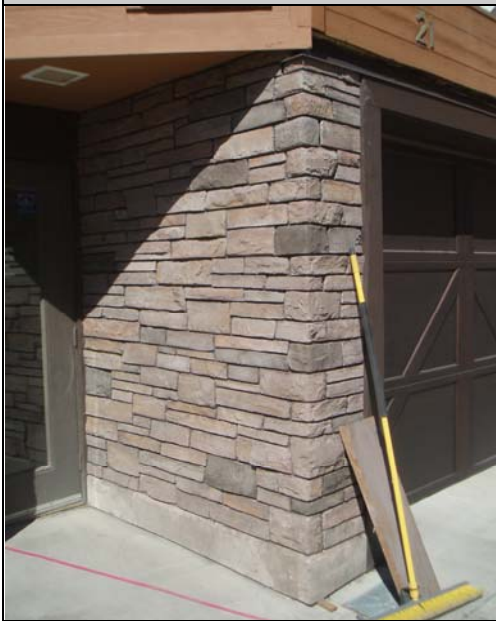
<p>7/24/12 – Photo 5 Detail Unit 21 Entry Wall</p> <p>Completed entry wall. Stone pattern, color, grout thickness and level grout lines are all within project standards.</p>	<p>Note</p>

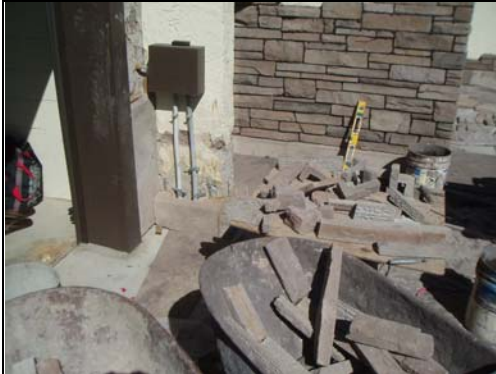
<p>7/24/12 – Photo 6 Detail Unit 20</p> <p>Stone installation underway.</p>	<p>Note</p>

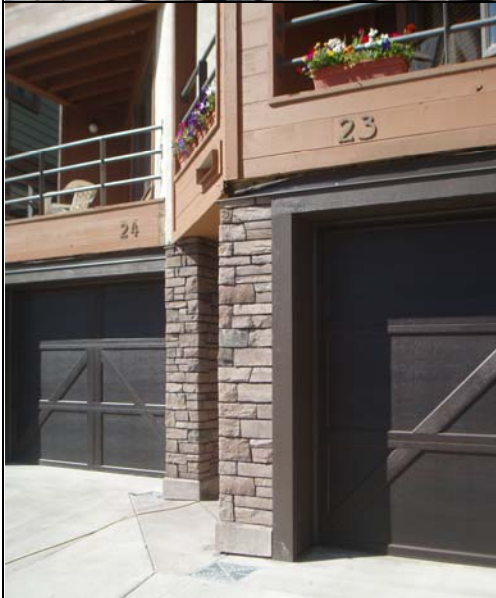
<p>7/24/12 – Photo 7 Detail of Corners at Unit 23</p> <p>Note corner lines at column and garage door corner fall within project standards.</p>	<p>Note</p>

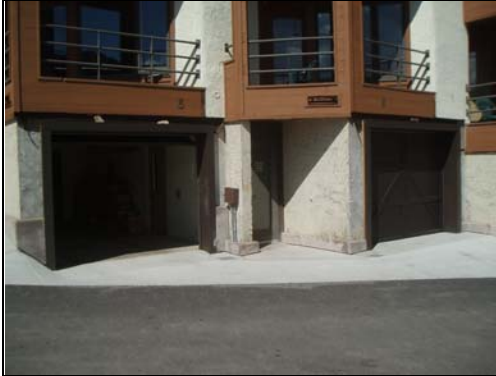
<p>7/24/12 – Photo 15 Units 5 & 6</p> <p>Precast base is installed.</p>	<p>Note</p>

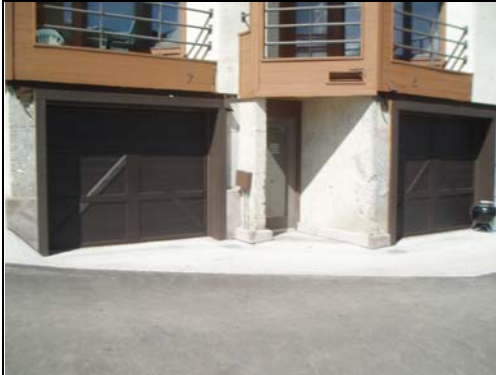
<p>7/24/12 – Photo 16 Units 7 & 8</p> <p>Precast base is installed. The north corner of Unit 8 is not yet complete.</p>	<p>Note</p>

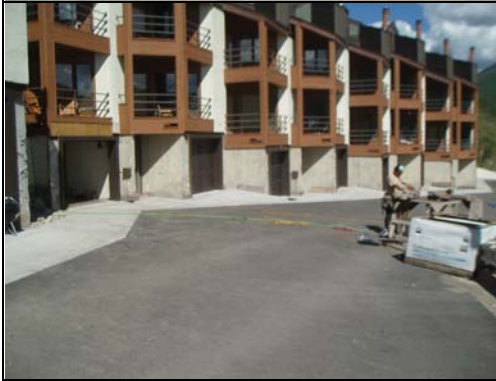
<p>7/24/12 – Photo 17 Building 'B' Looking North</p> <p>Precast base installation underway.</p>	<p>Note</p>

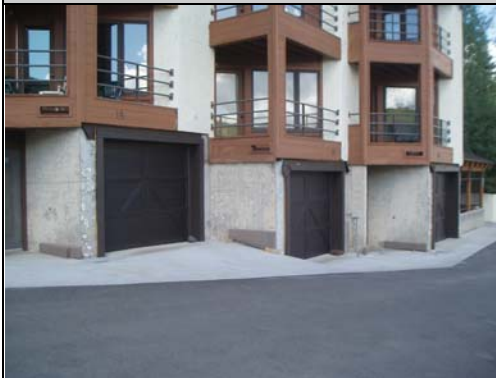
<p>7/24/12 – Photo 18 Units 14, 15 & 16</p> <p>Precast base installation underway.</p>	<p>Note</p>

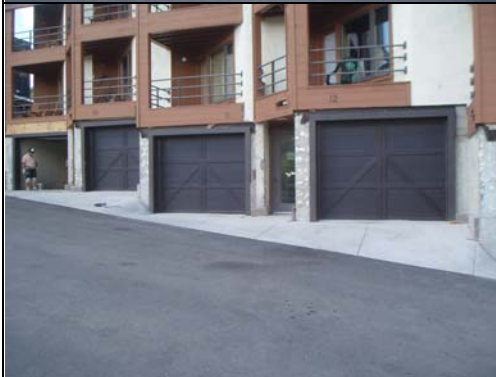
<p>7/24/12 – Photo 19 Units 9, 10, 11 & 12</p> <p>Precast base installation underway.</p>	<p>Note</p>
 	<p>7/24/12 – Photo 20 Unit 9 Area Drain Detail</p> <p>Note overlap of area drain and base. MH will cut the area drain cover to allow access to the drain clean-out.</p>	<p>Note</p>
