ARCHITECT'S FIELD REPORT

PROJECT	Eagle's Nest Townhouses 11 Morning Glory Way & 31 Marcellina Lane Mt. Crested Butte, CO 81225	DATE	5/9/11
----------------	--	-------------	--------

WORK OBSERVED
Phase II – Roof Audit, Existing Conditions Units 1 through 8

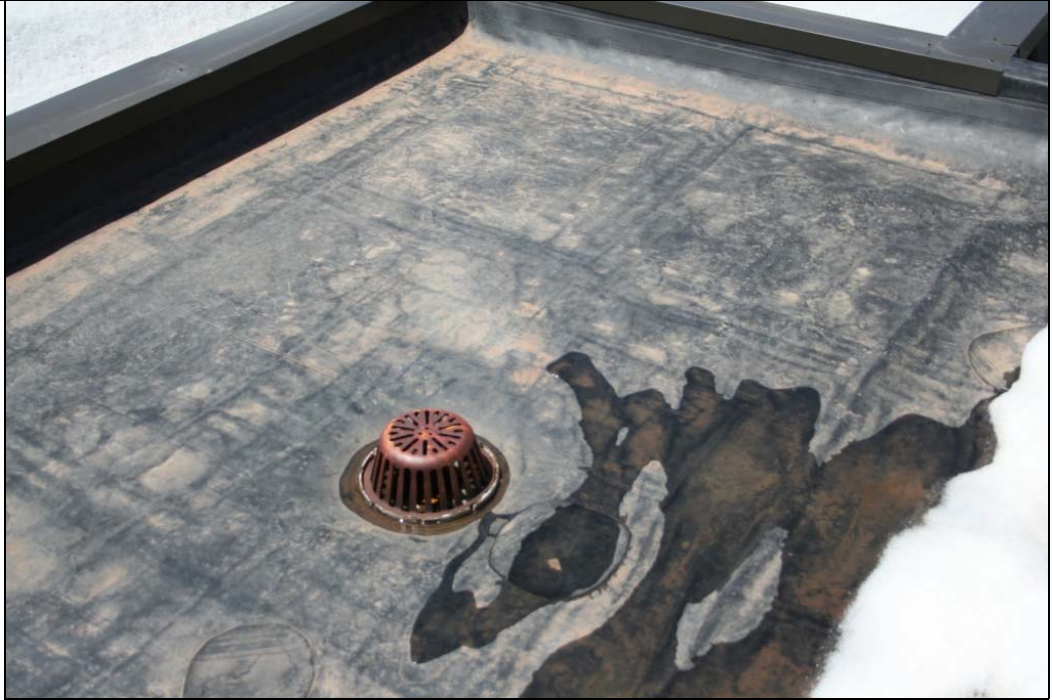
**Unit 1
Photo 1**

Notes: Roof Photo #1.

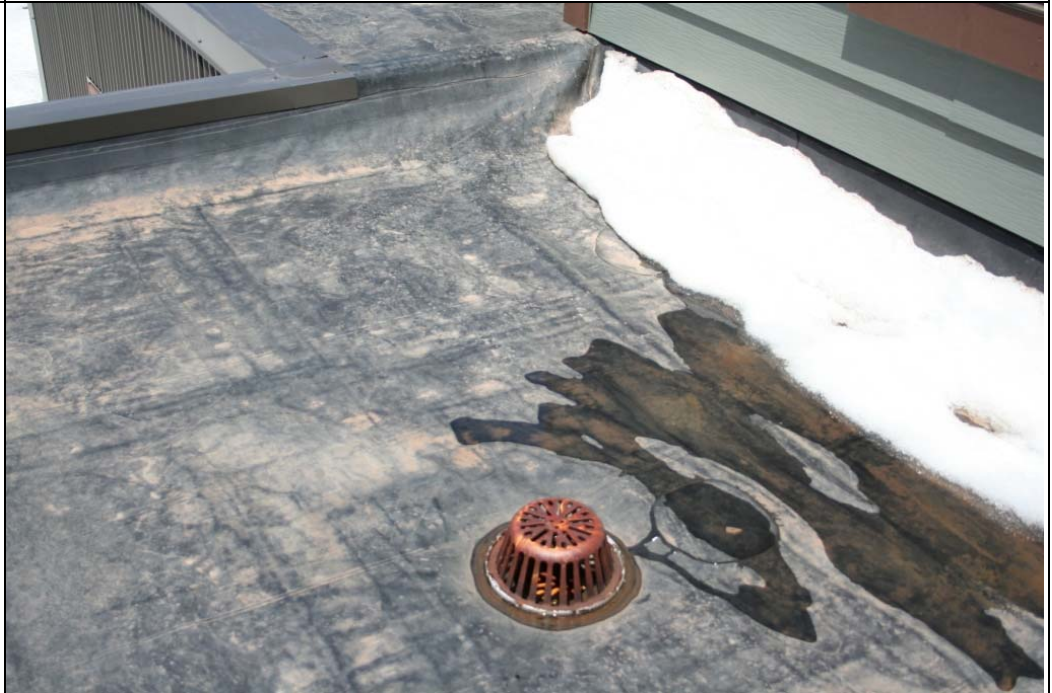
**Unit 1
Photo 2**

Notes: Roof Photo #2.

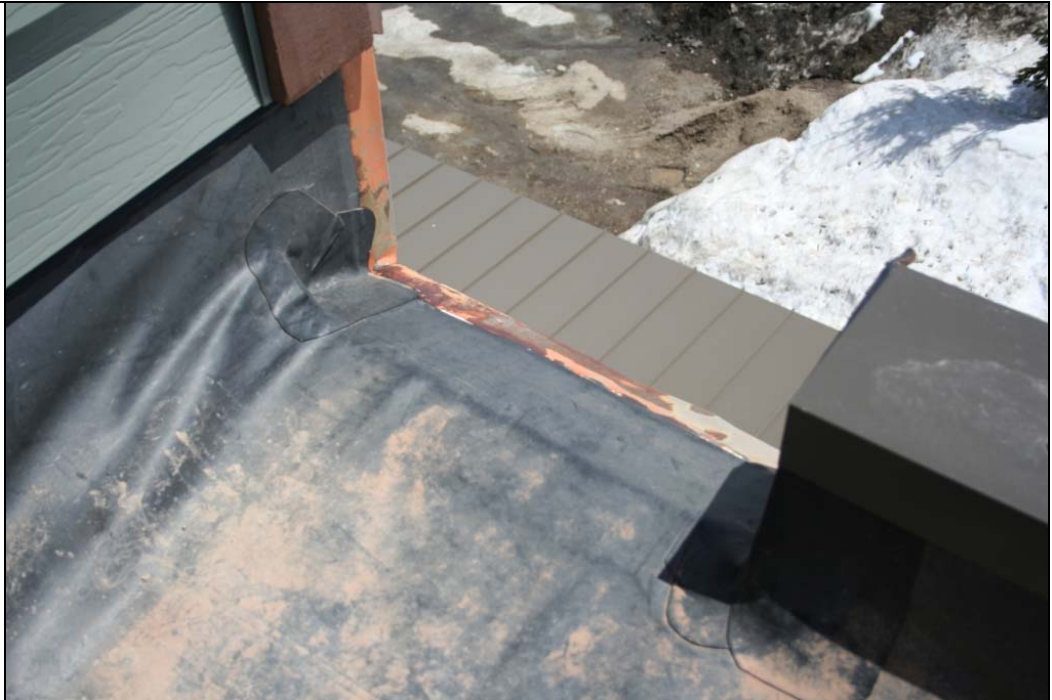
**Unit 1
Photo 3**

Notes: Detail of overflow scupper on south parapet wall.

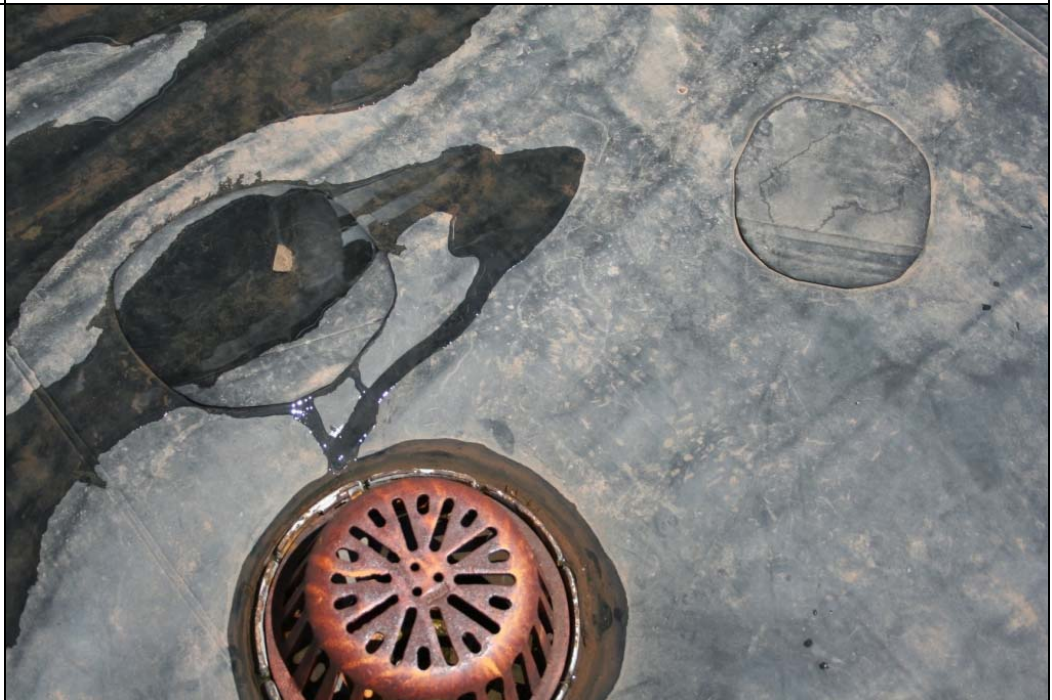
**Unit 1
Photo 4**

Notes: Detail of large patches south and southeast of drain.

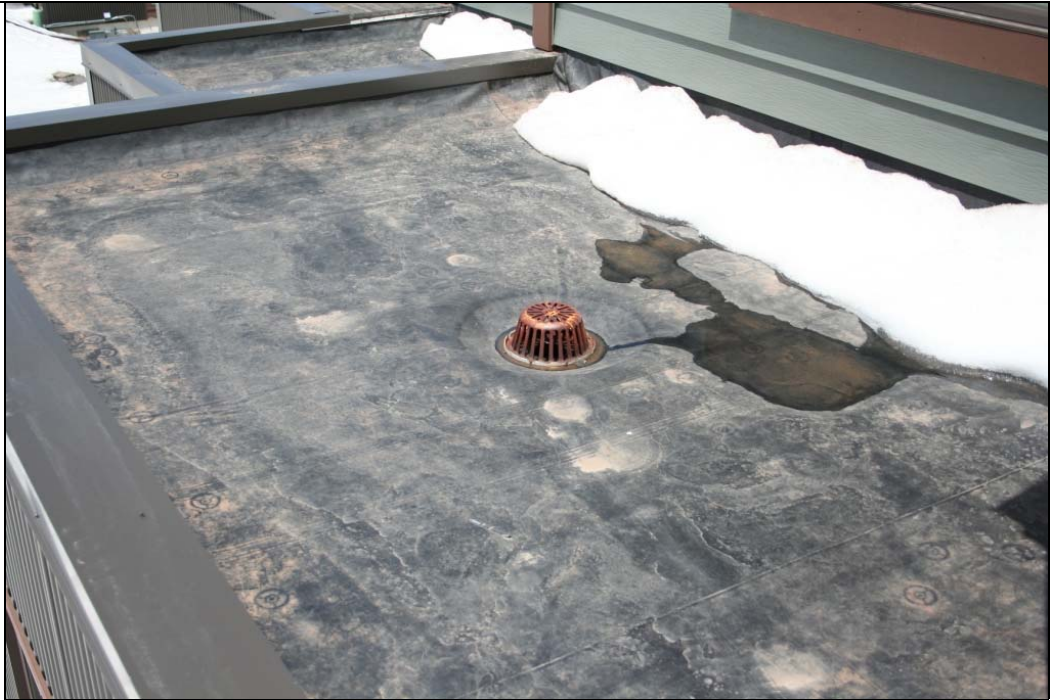
**Unit 2
Photo 1**

Notes: Roof Photo #1.

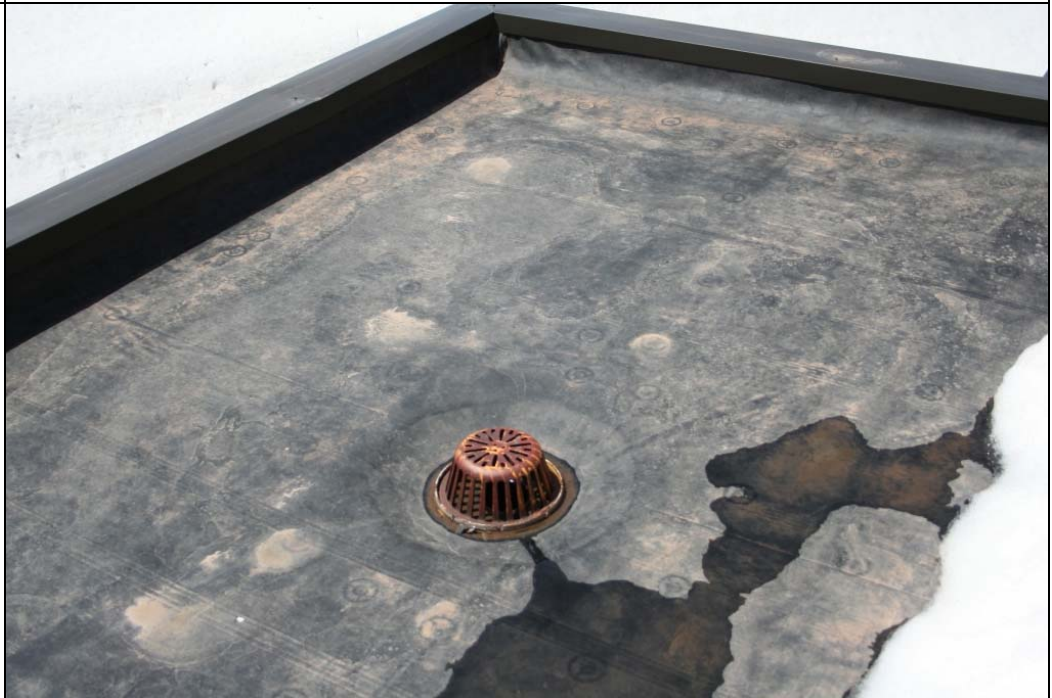
**Unit 2
Photo 2**

Notes: Roof Photo #2.

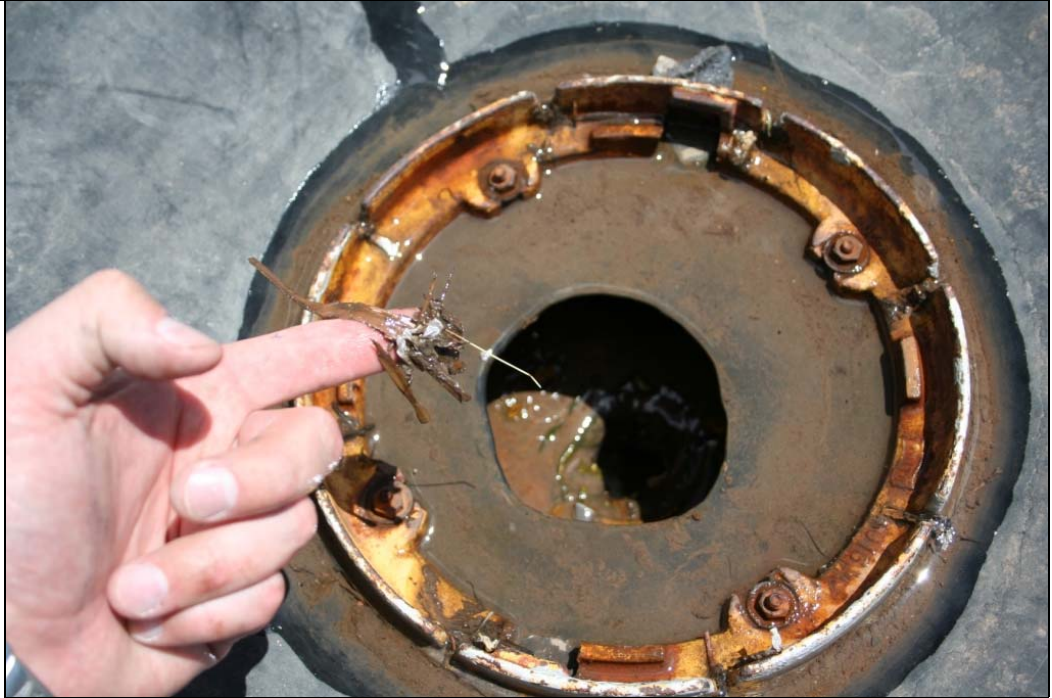
**Unit 2
Photo 3**

Notes: Debris in roof drain. Roof drain diameter is approximately 1-1/2".

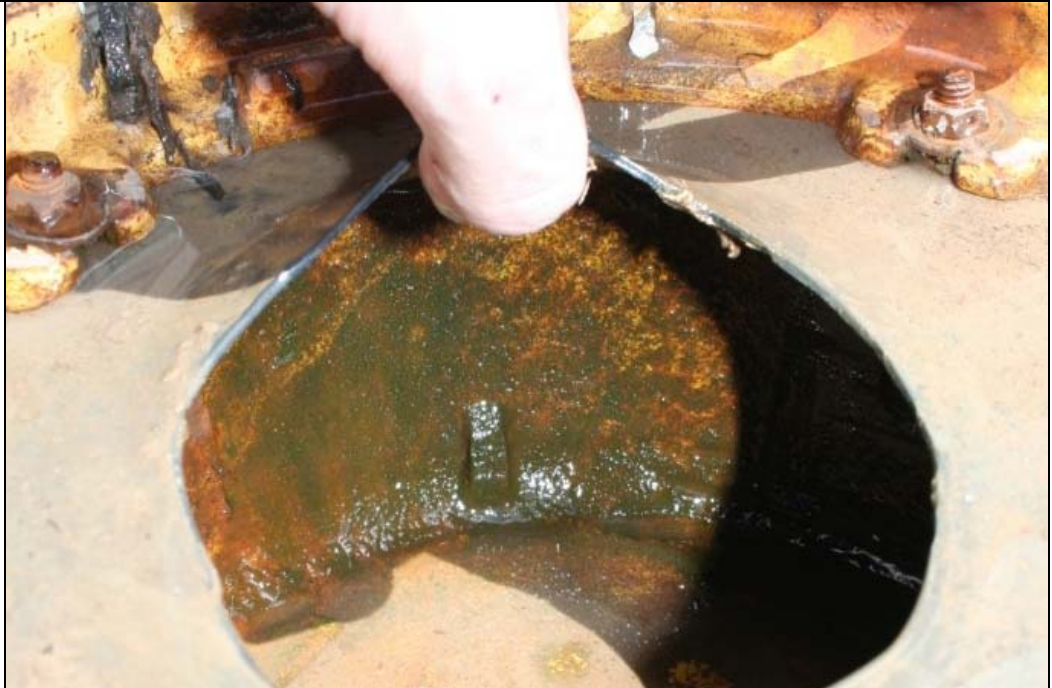
**Unit 2
Photo 4**

Notes: Detail of inside of roof drain.

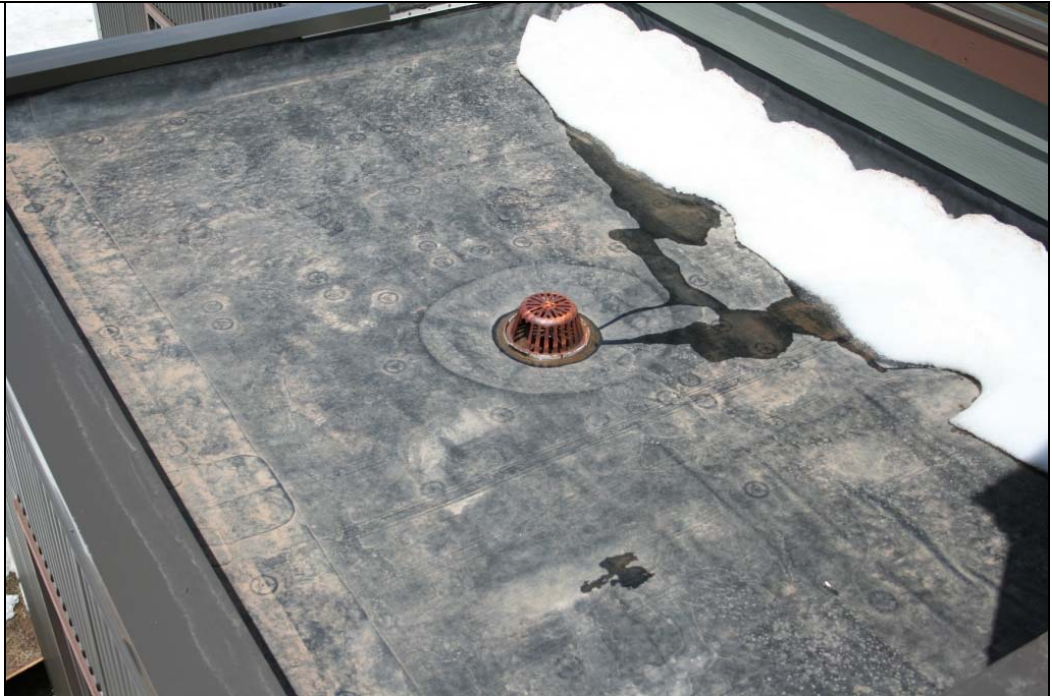
**Unit 3
Photo 1**

Notes: Roof Photo #1.

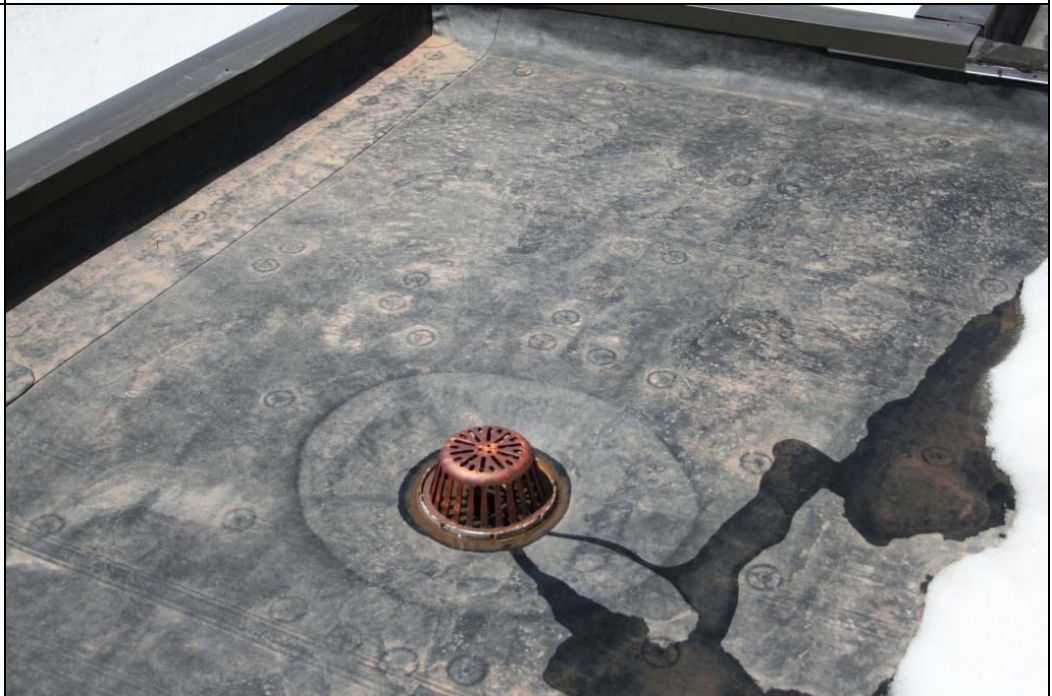
**Unit 3
Photo 2**

Notes: Roof Photo #2.

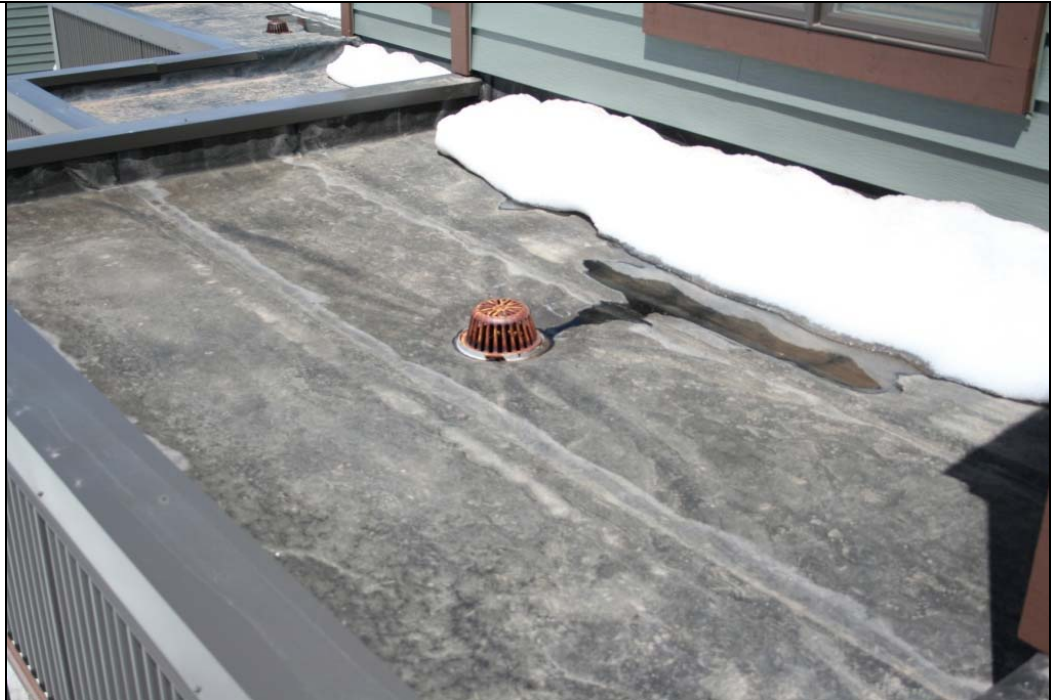
**Unit 4
Photo 1**

Notes: Roof Photo #1.

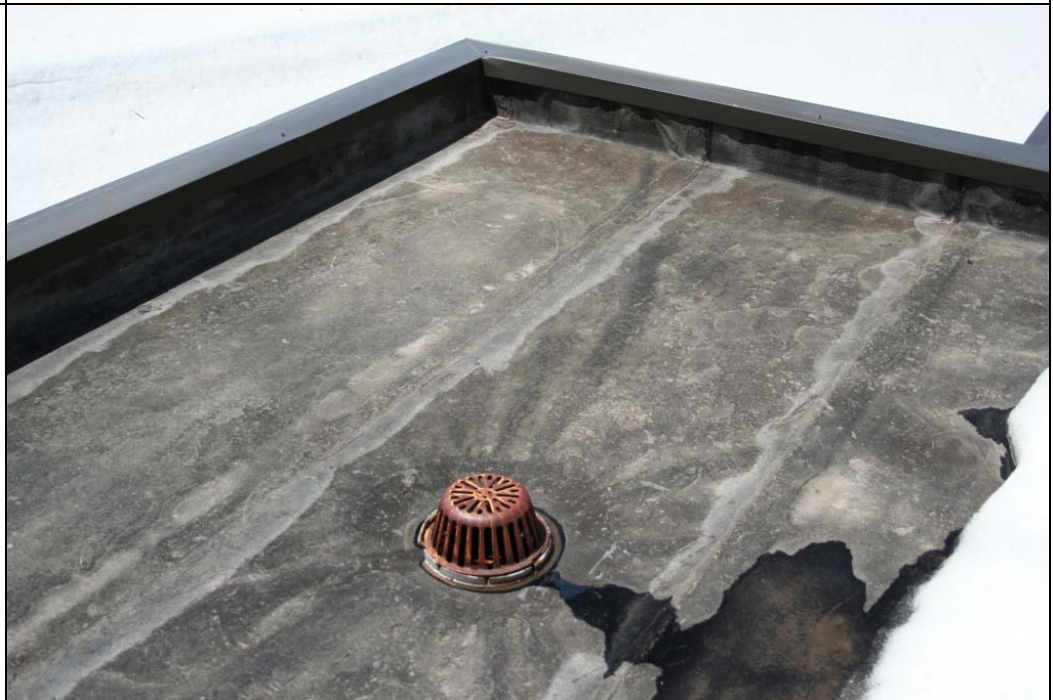
**Unit 4
Photo 2**

Notes: Roof Photo #2.

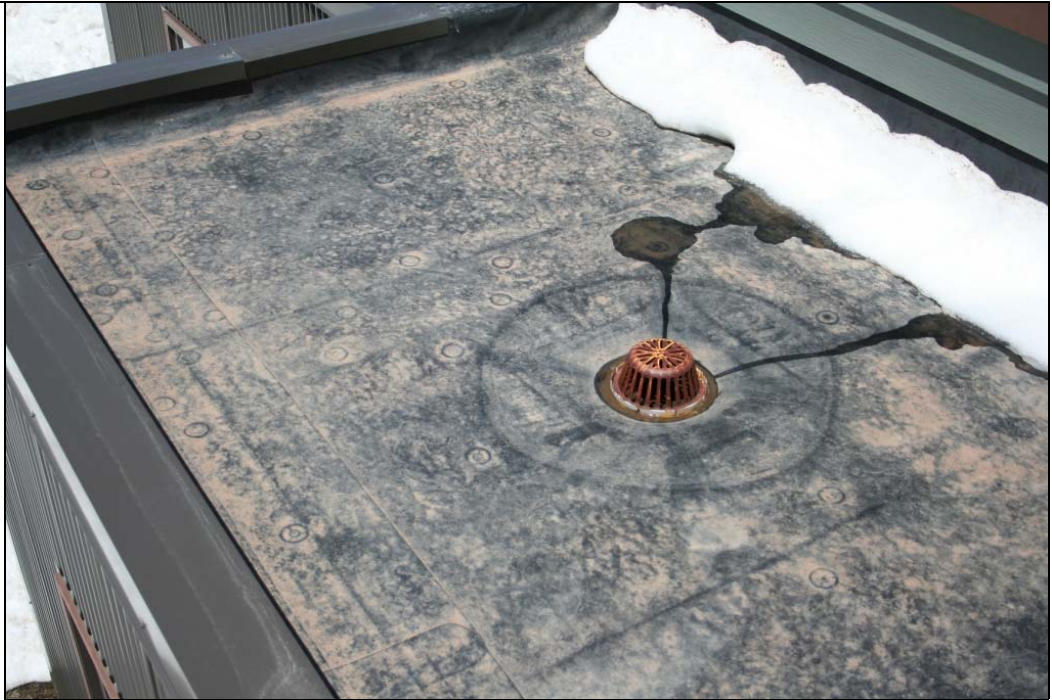
**Unit 5
Photo 1**

Notes: Roof Photo #1.

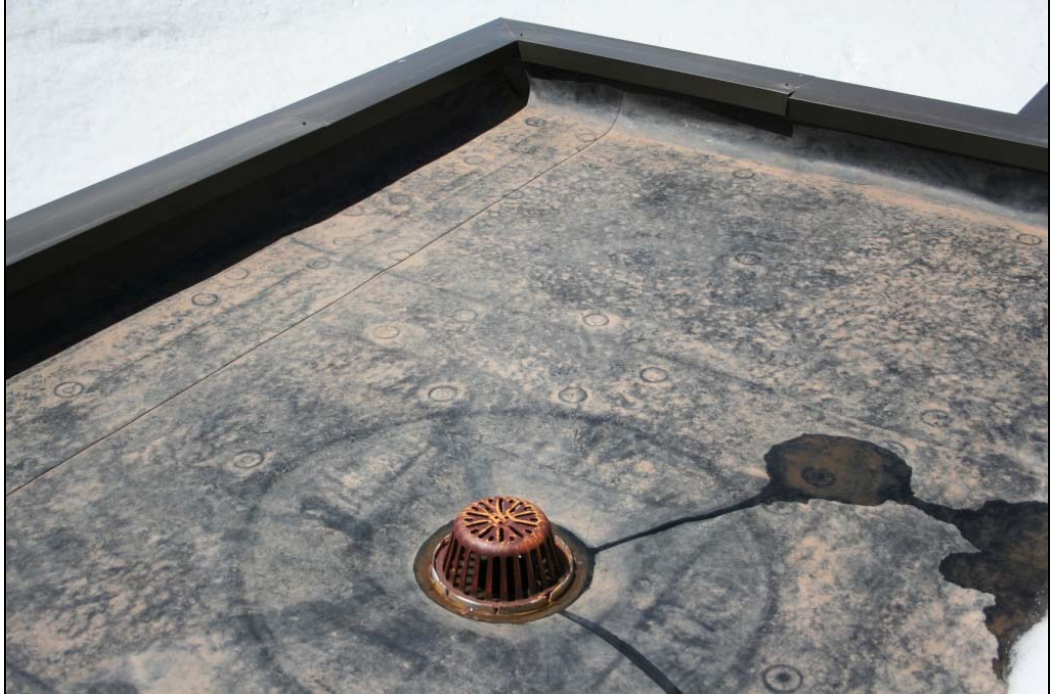
**Unit 5
Photo 2**

Notes: Roof Photo #2.

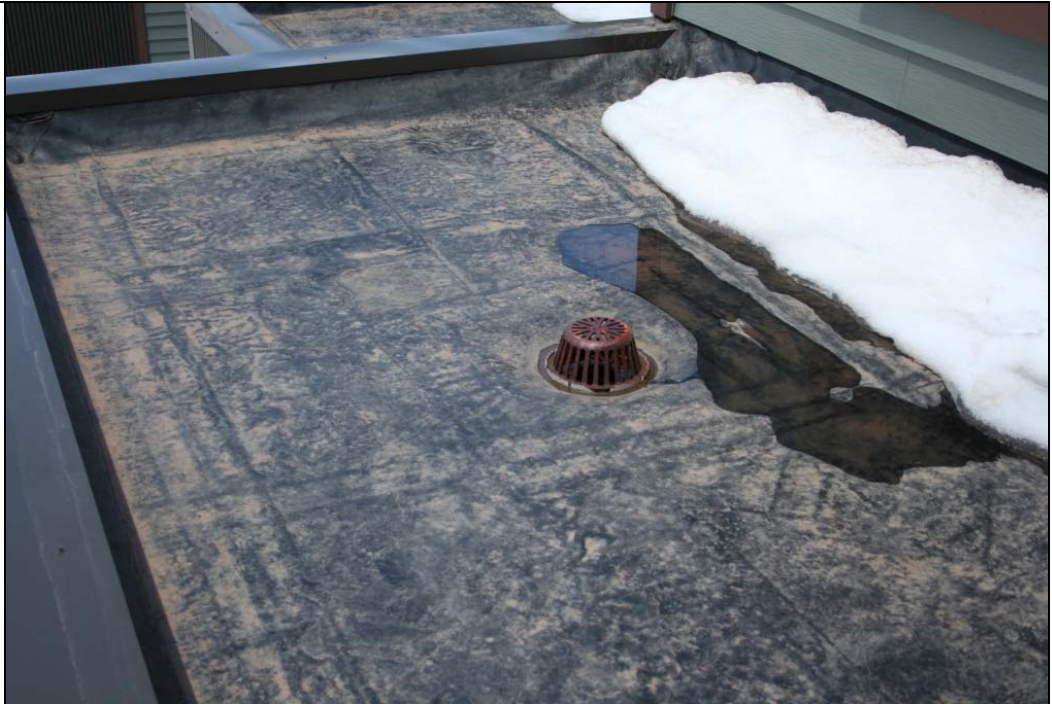
**Unit 6
Photo 1**

Notes: Roof Photo #1.

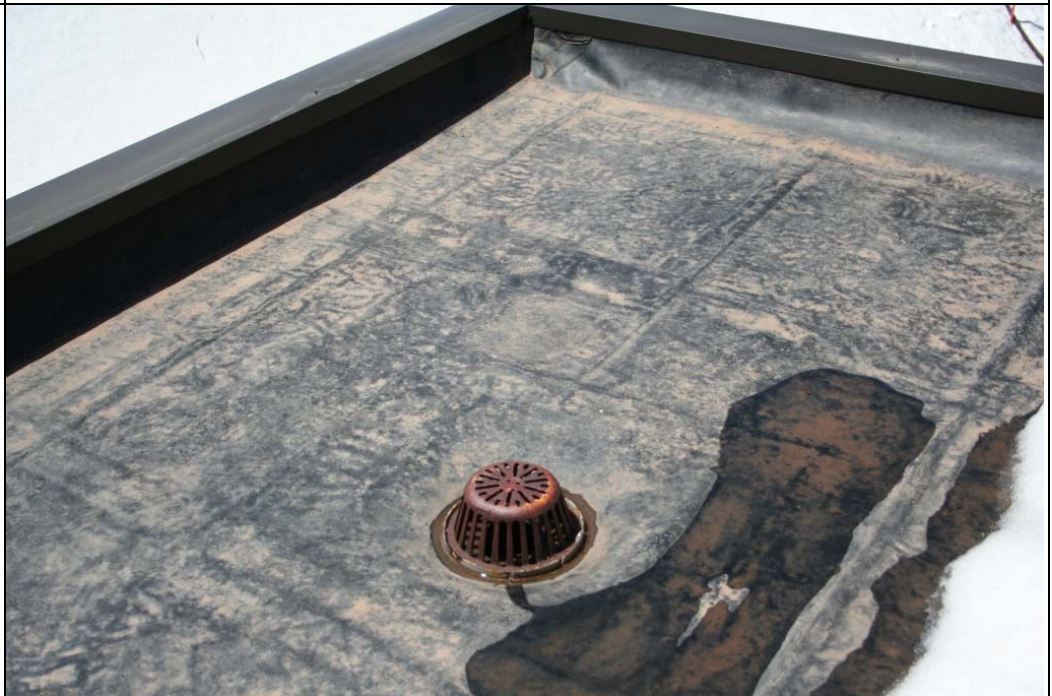
**Unit 6
Photo 2**

Notes: Roof Photo #2.

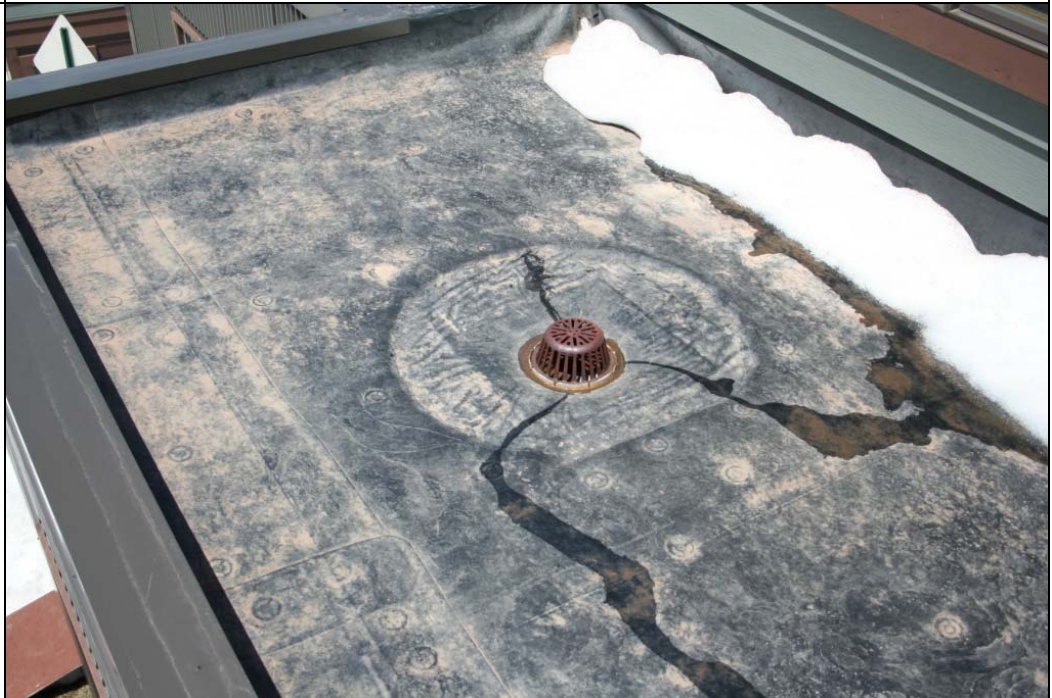
**Unit 7
Photo 1**

Notes: Roof Photo #1.

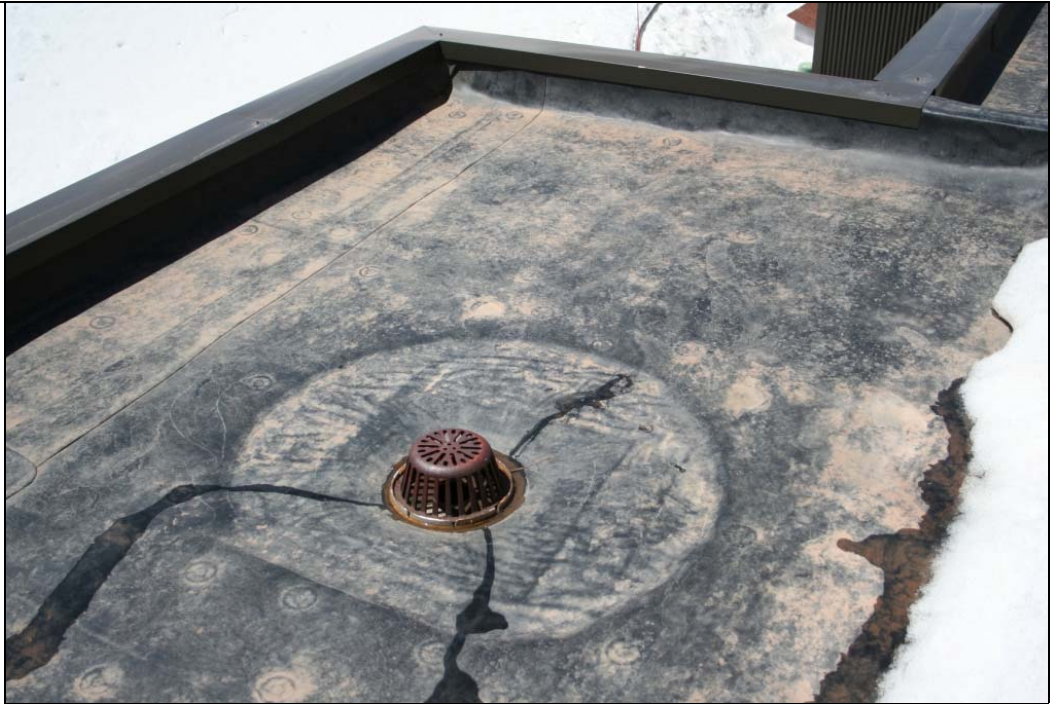
**Unit 7
Photo 2**

Notes: Roof Photo #2.

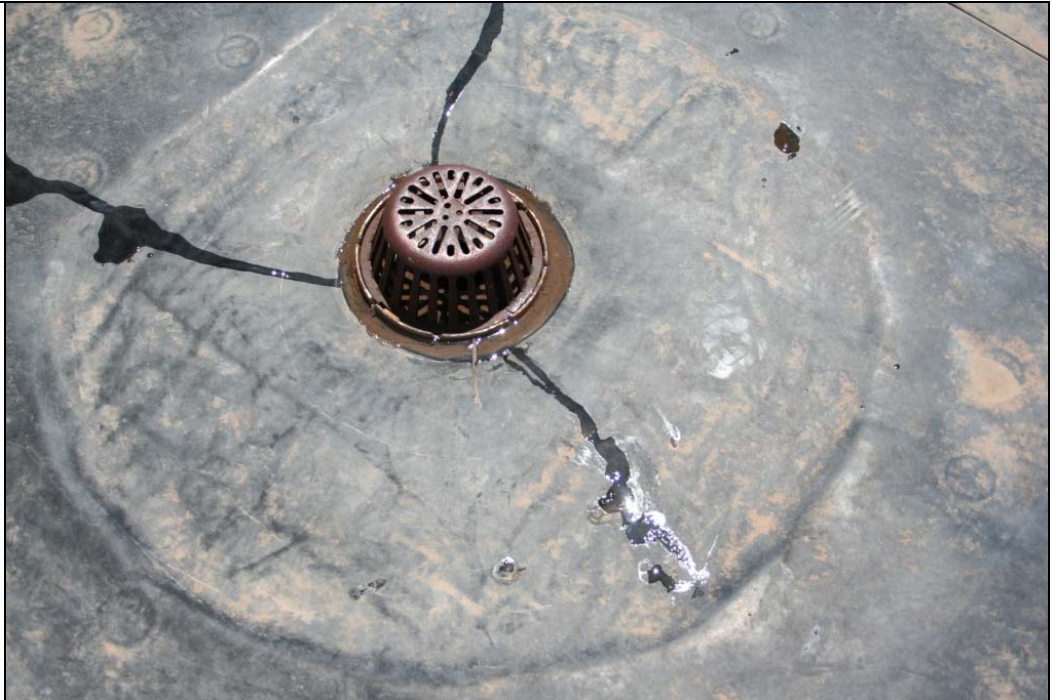
**Unit 7
Photo 3**

Notes: Location photo of holes and gash from previous photos.

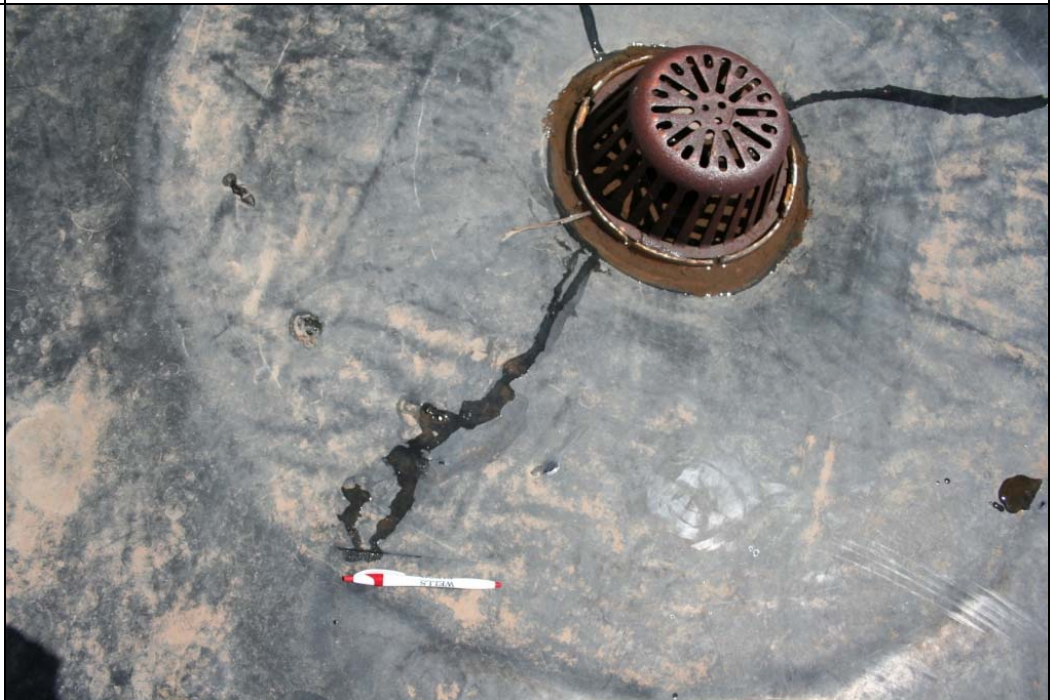
**Unit 7
Photo 4**

Notes: Location photo of holes and gash from previous photos. Pen marks location of gash. Note saturated substrate discharges water.

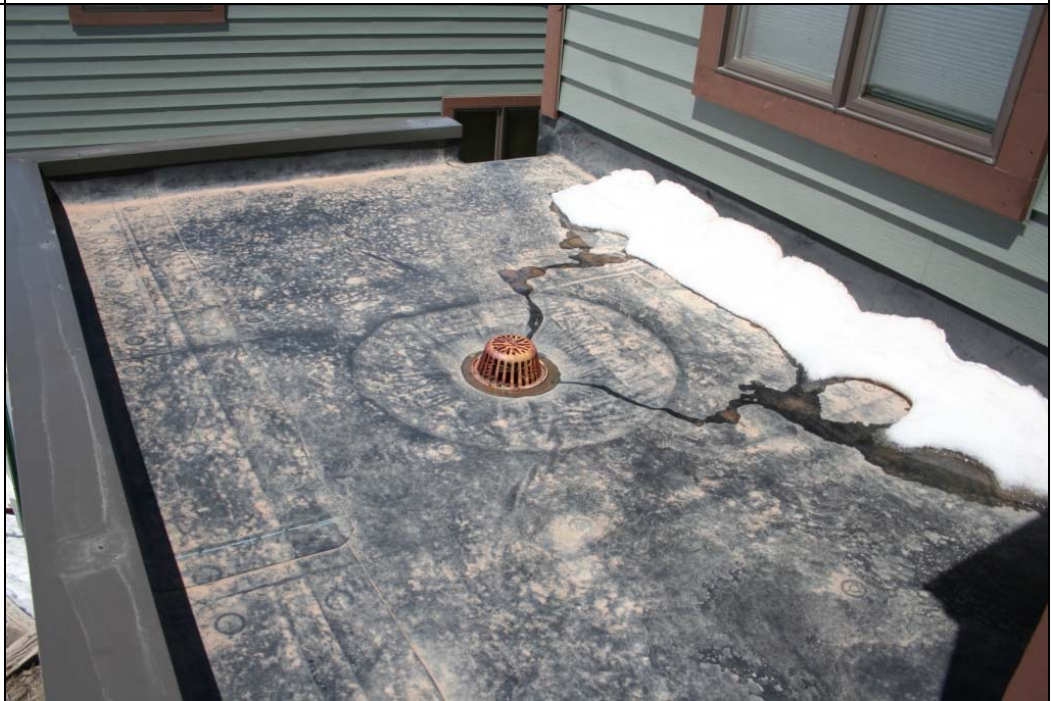
**Unit 8
Photo 1**

Notes: Roof Photo #1.

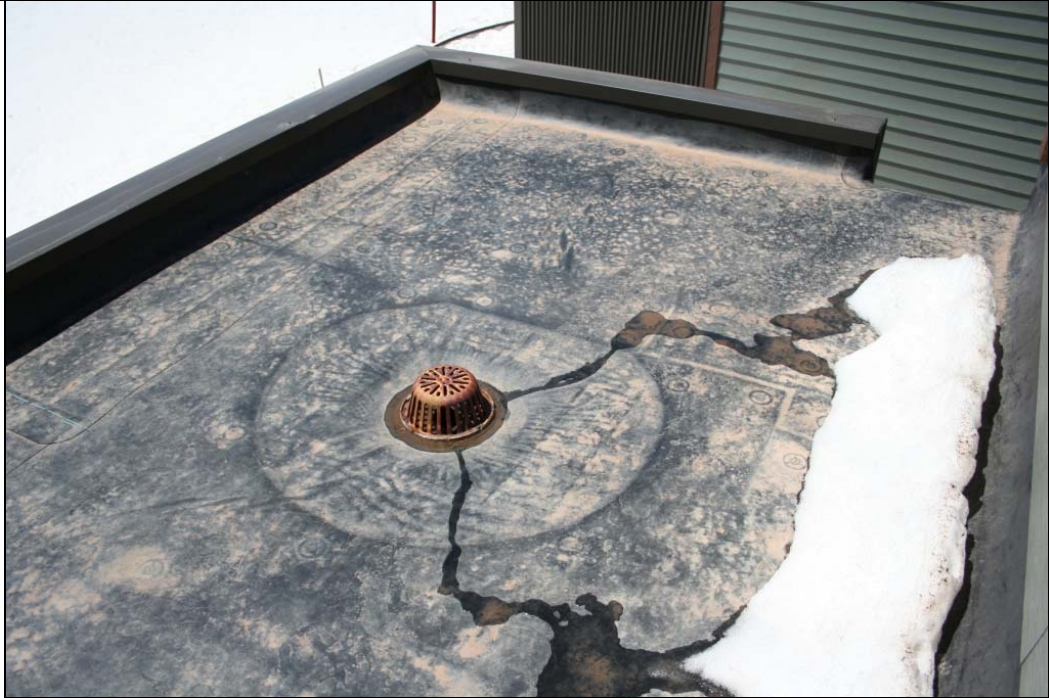
**Unit 8
Photo 2**

Notes: Roof Photo #2.

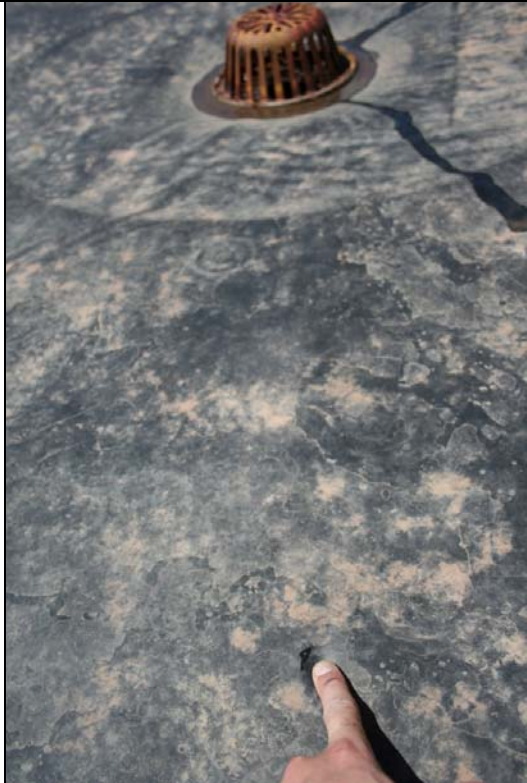
**Unit 8
Photo 3**

Notes: Location photo of hole 3' south of drain.

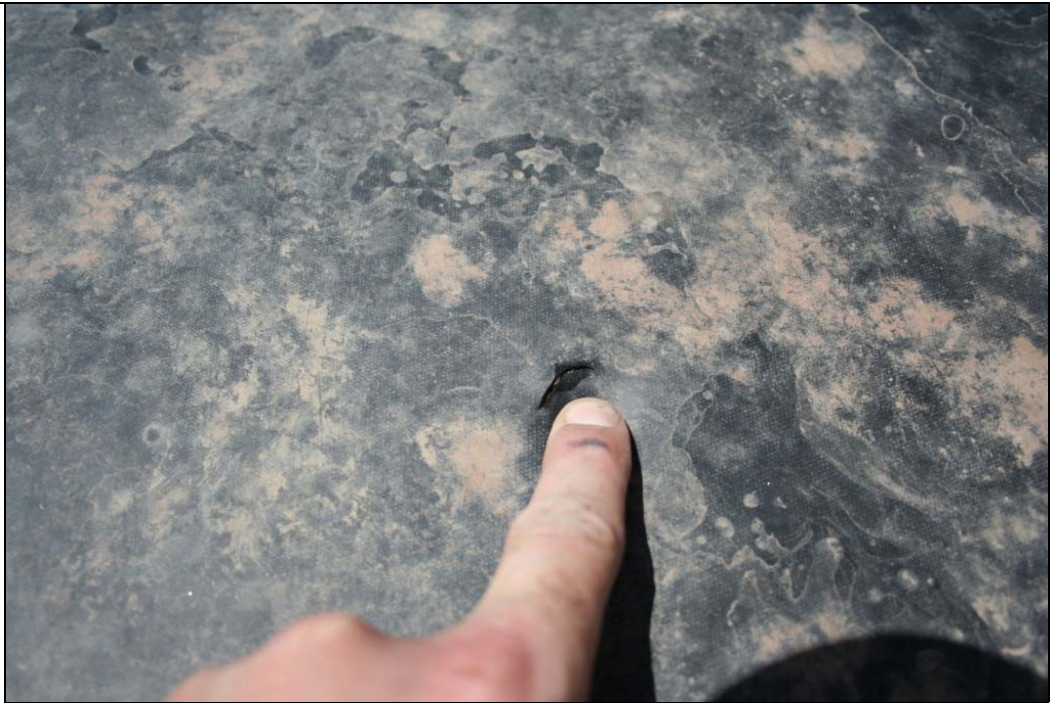
**Unit 8
Photo 4**

Notes: Detail of hole in membrane.

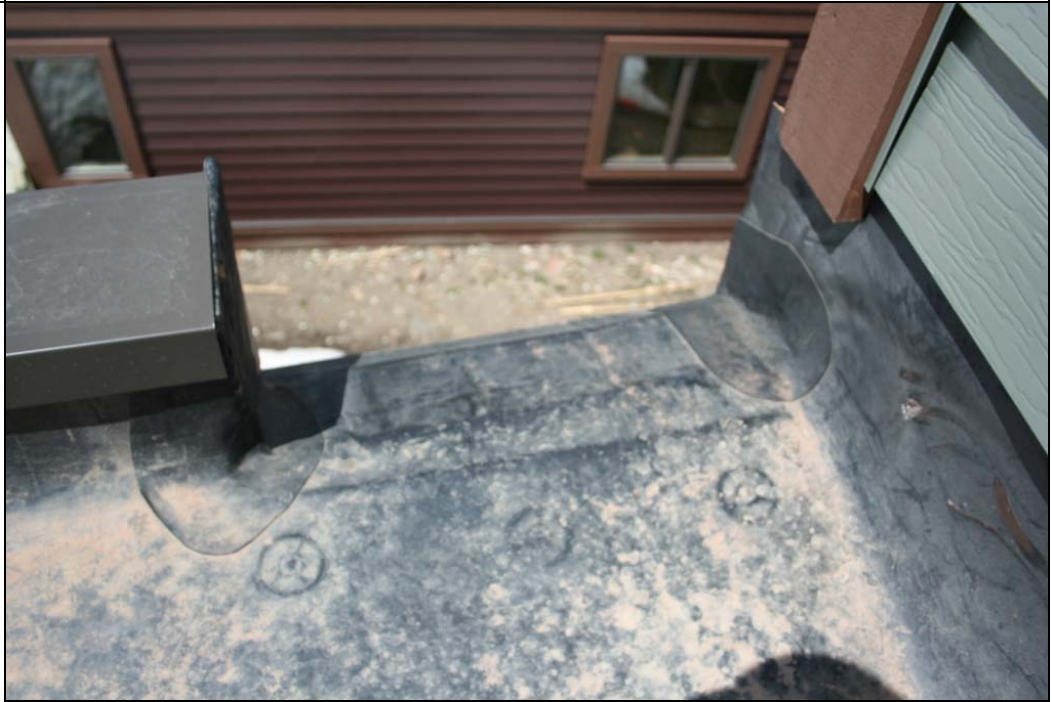
**Unit 8
Photo 5**

Notes: Detail of overflow scupper.

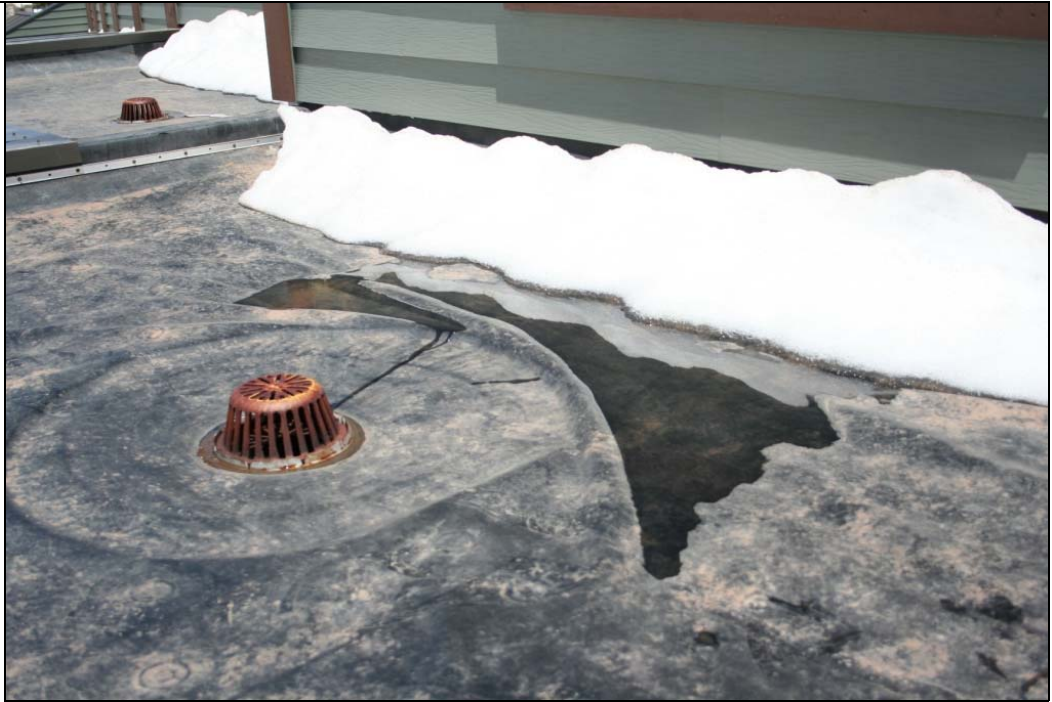
**Unit 9
Photo 1**

Notes: Roof Photo #1.

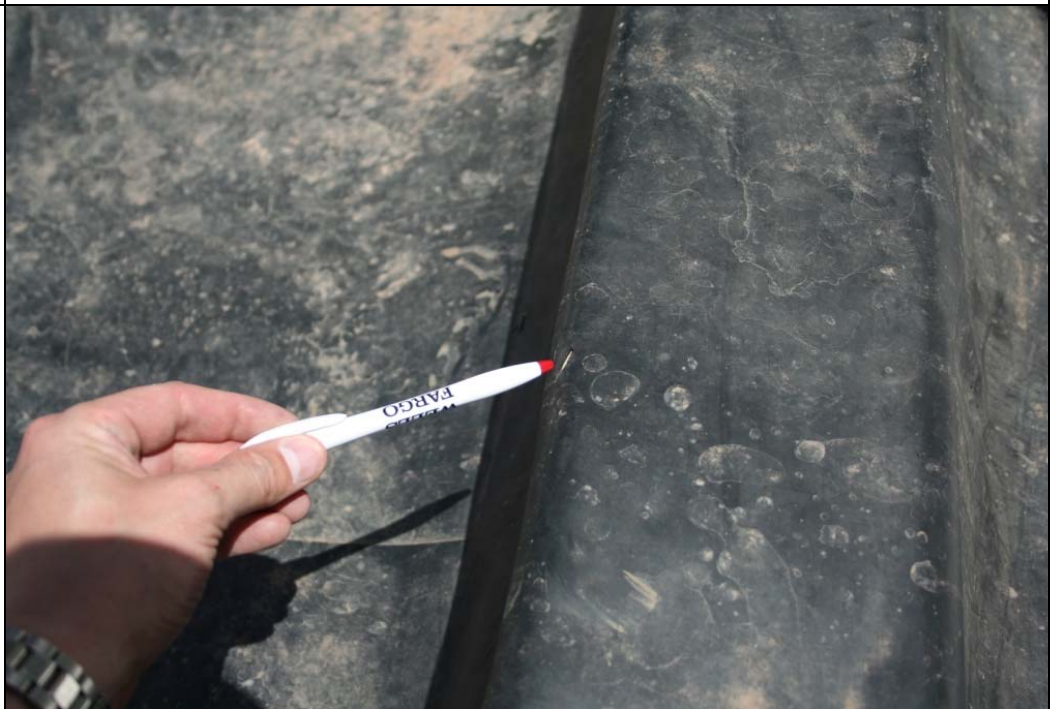
**Unit 11
Photo 4**

Notes: Gash at south parapet cap.

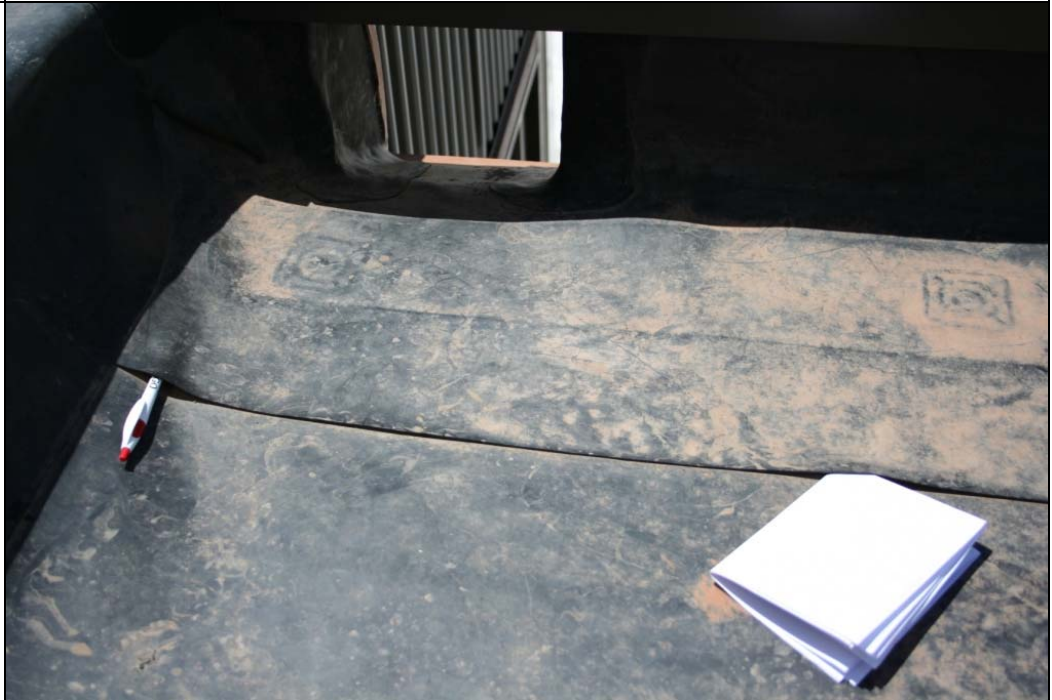
**Unit 12
Photo 3**

Notes: Seams not fully adhered at overflow scupper.

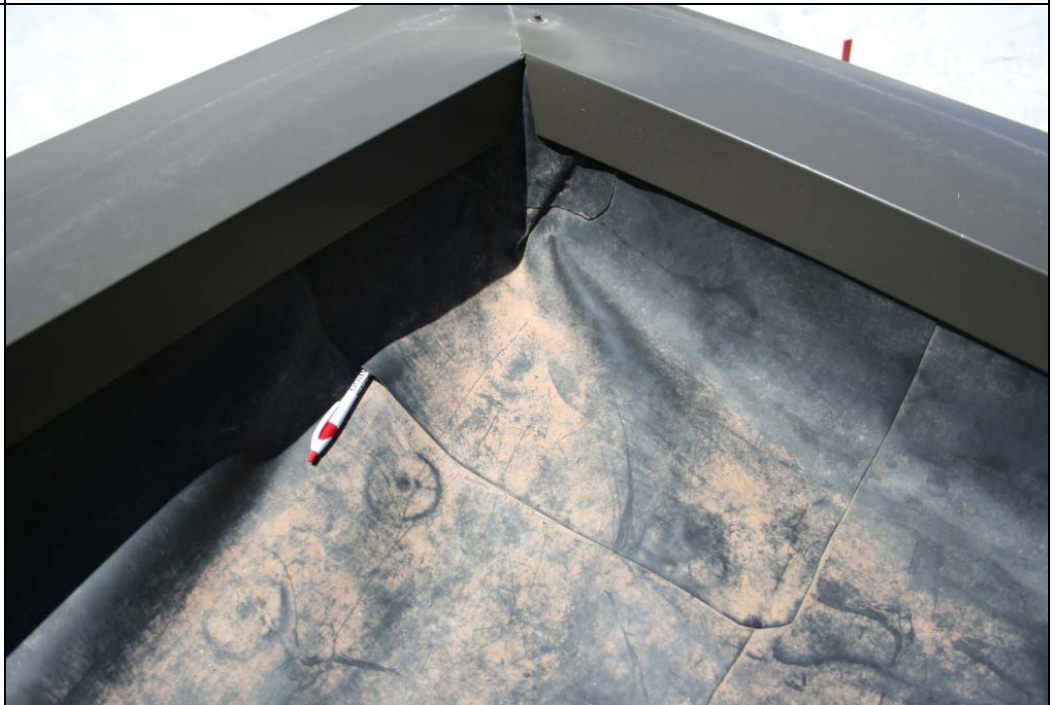
**Unit 13
Photo 3**

Notes: Seams not fully adhered at northwest corner.

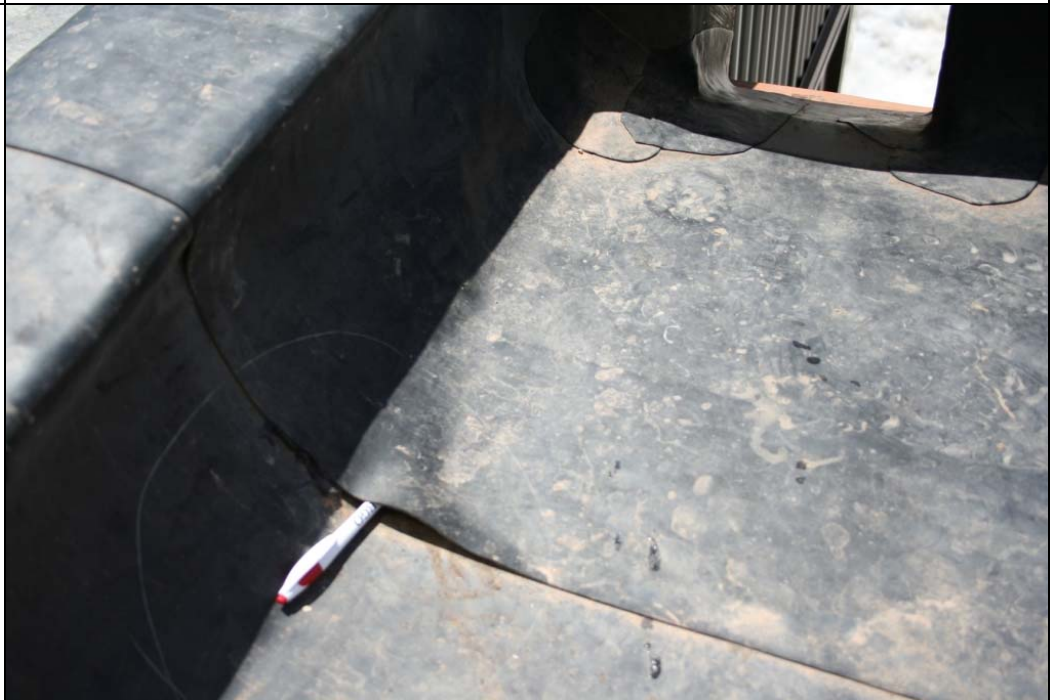
**Unit 16
Photo 3**

Notes: Seam not fully adhered at overflow scupper.

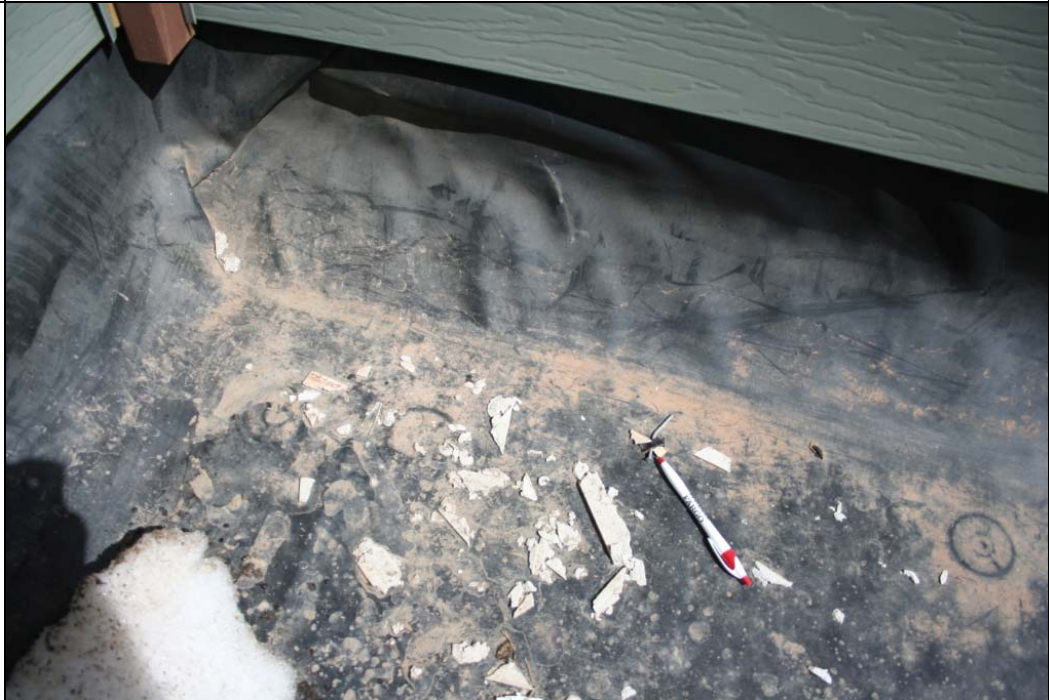
**Unit 18
Photo 3**

Notes: Construction debris and nail located in southeast corner. Nail removed.
