ARCHITECT'S FIELD REPORT

PROJECT	Eagle's Nest Townhouses 11 Morning Glory Way & 31 Marcellina Lane Mt. Crested Butte, CO 81225	DATE	5/9/11
----------------	--	-------------	--------

WORK OBSERVED
Phase II – Roof Audit, Existing Conditions Units 1 through 8

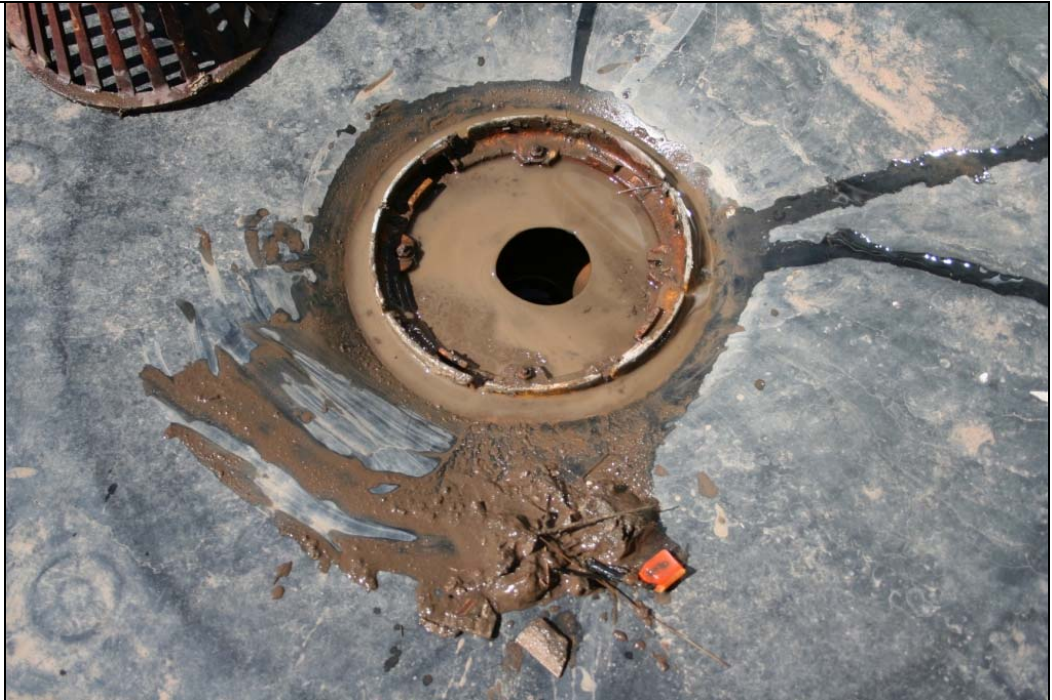
**Unit 18
Photo 6**

Notes: Debris removed from ring of roof drain.

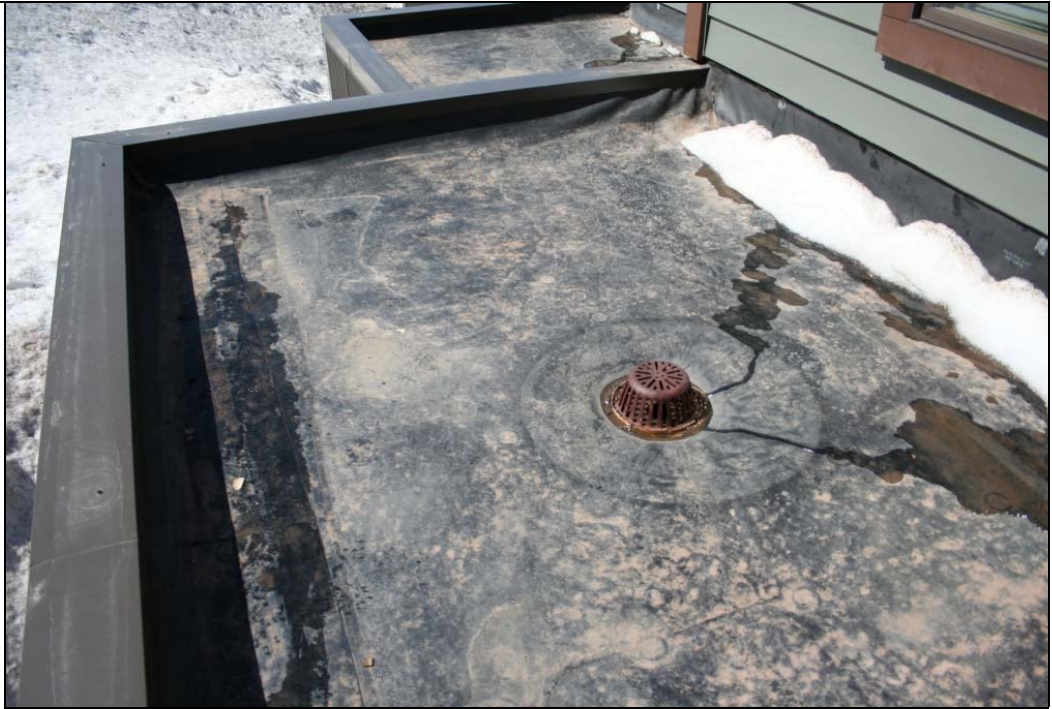
**Unit 19
Photo 1**

Notes: Roof Photo #1.

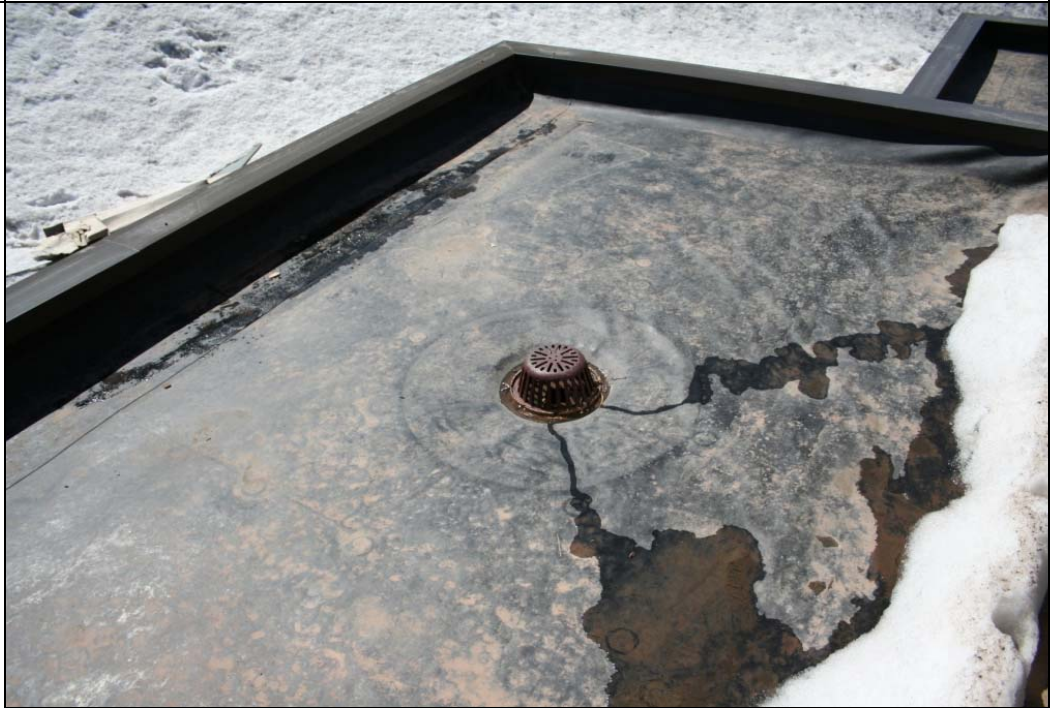
**Unit 19
Photo 2**

Notes: Roof Photo #2.

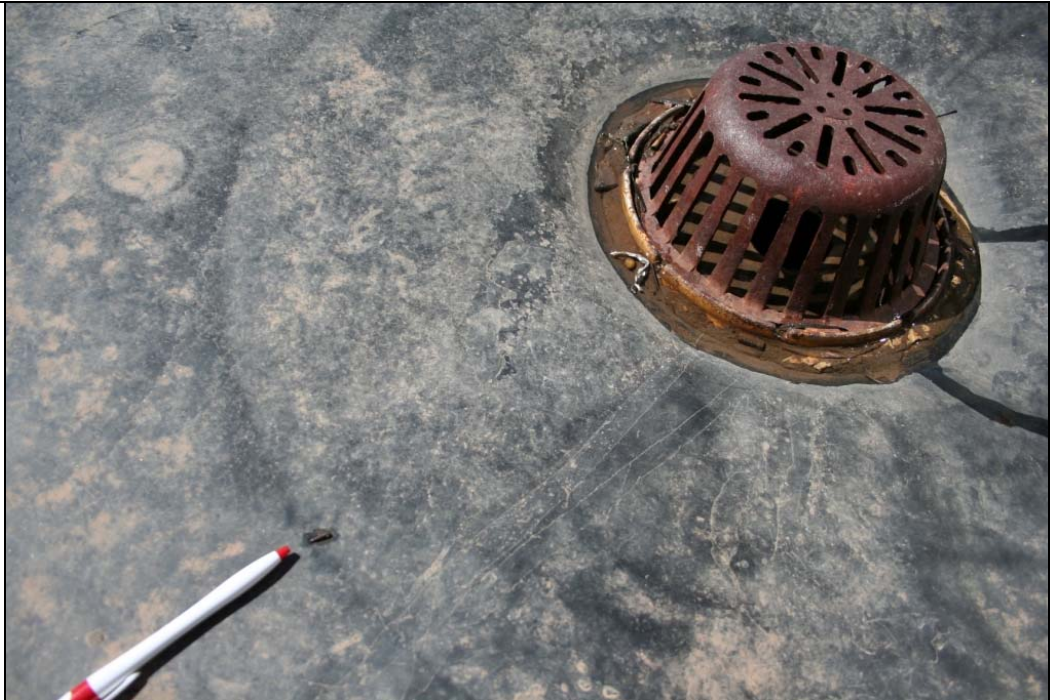
Unit 19
Photo 3

Notes: Staple has penetrated membrane southwest of roof drain.

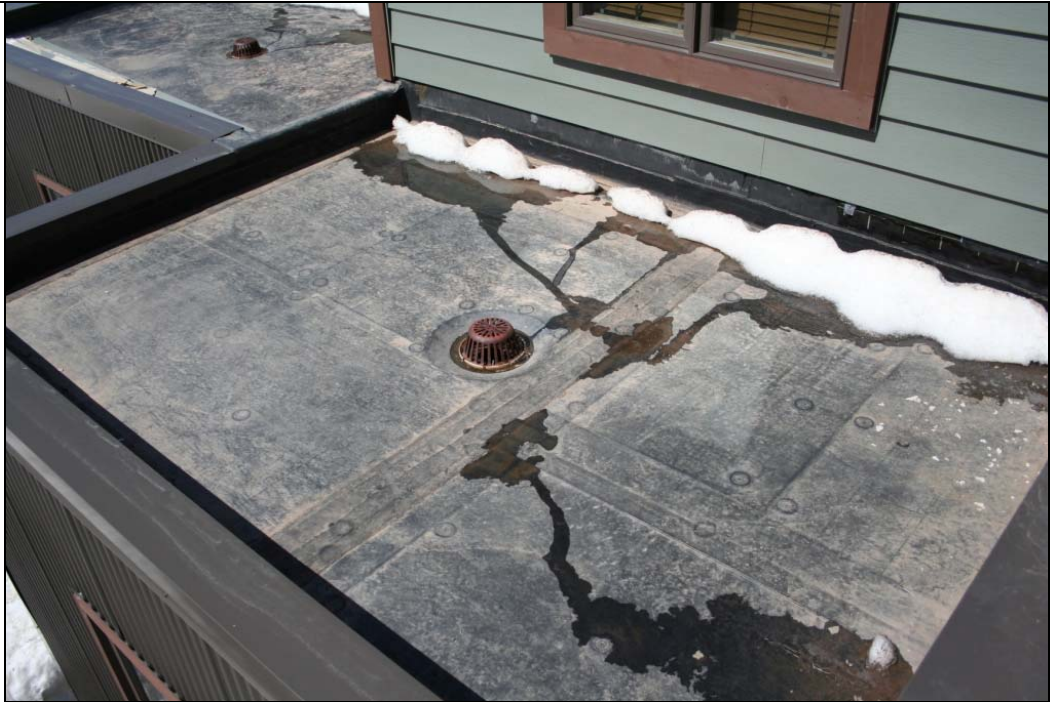
**Unit 20
Photo 1**

Notes: Roof Photo #1.

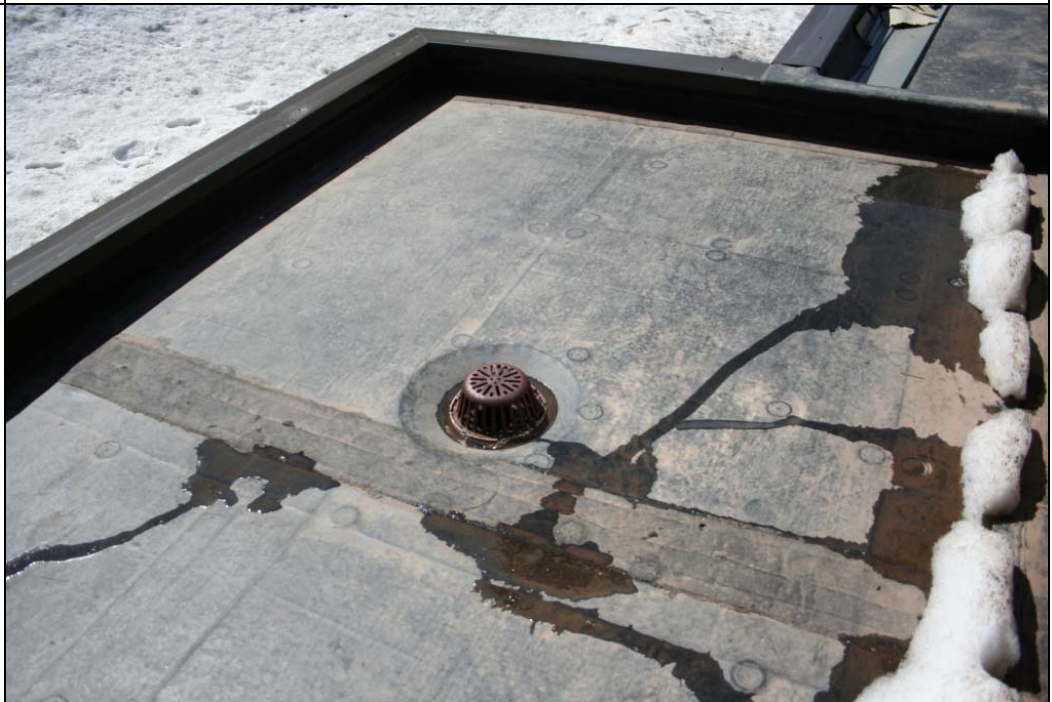
**Unit 20
Photo 2**

Notes: Roof Photo #2.

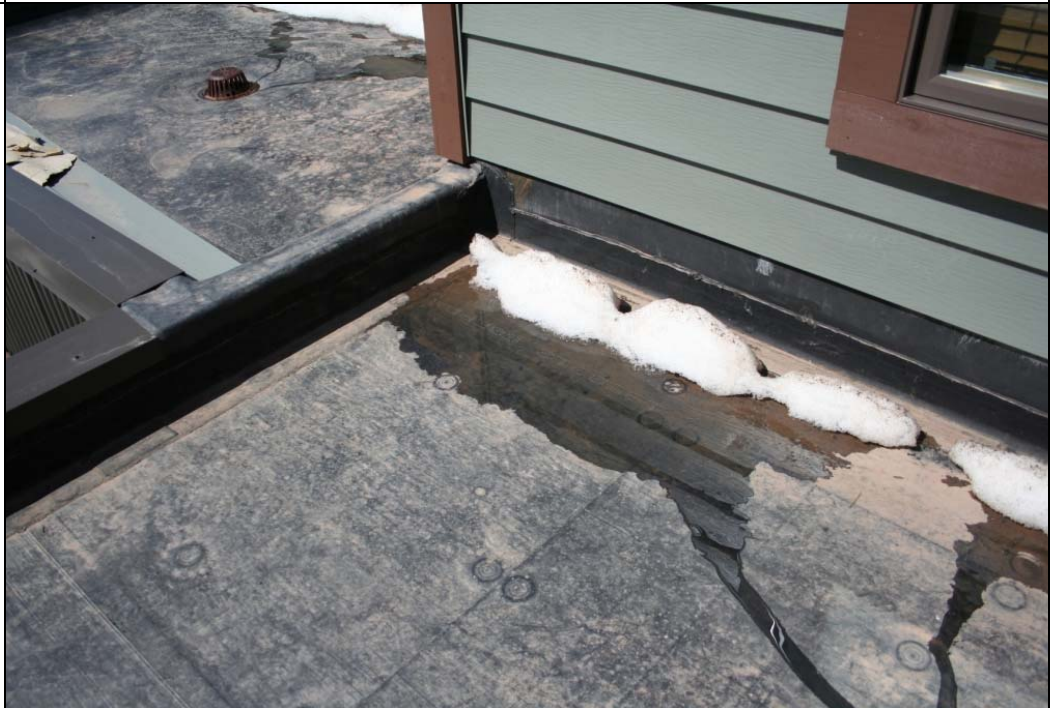
**Unit 20
Photo 8**

Notes: Ponding water visible in northeast corner.

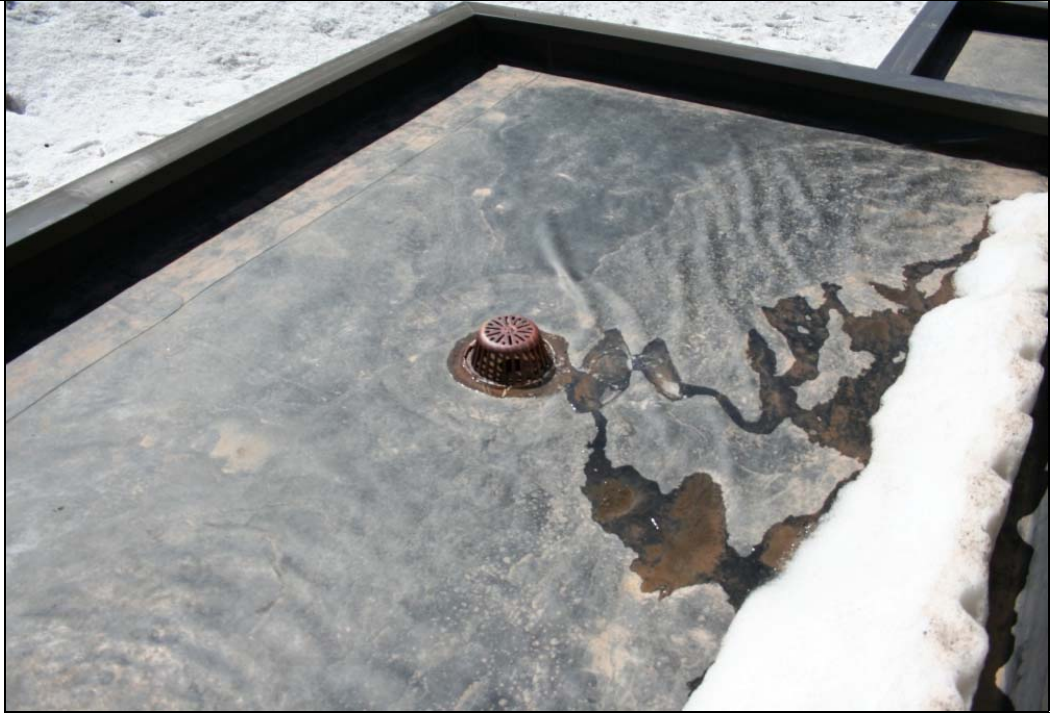
**Unit 21
Photo 2**

Notes: Roof Photo #2.

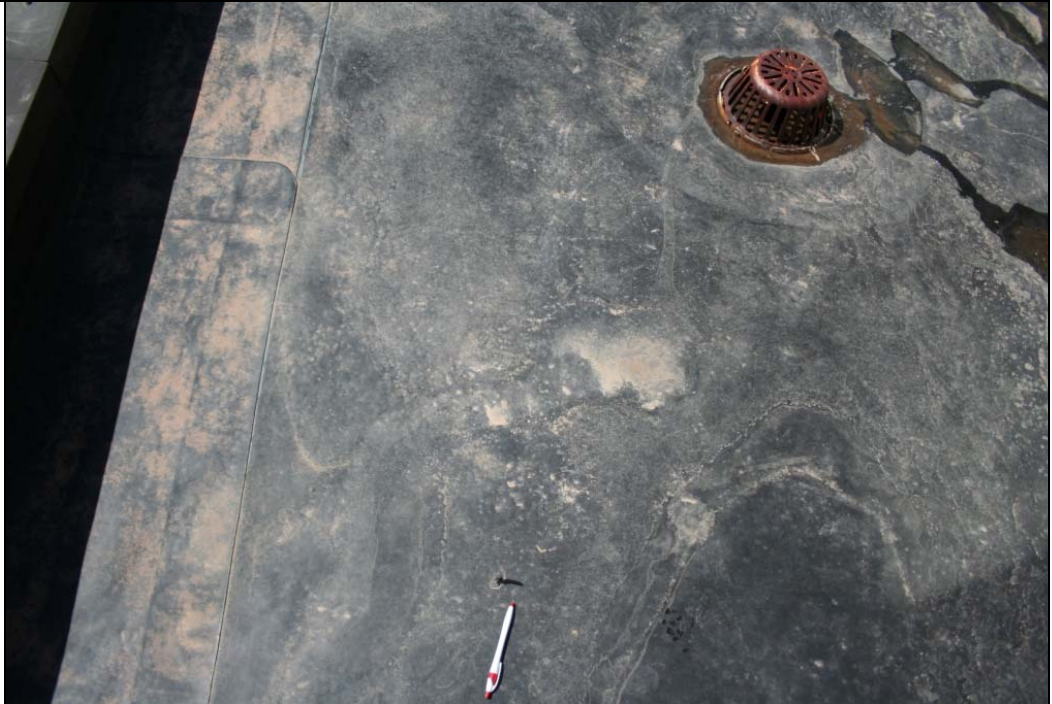
**Unit 21
Photo 3**

Notes: Hole in membrane approximately 4' southwest of roof drain.

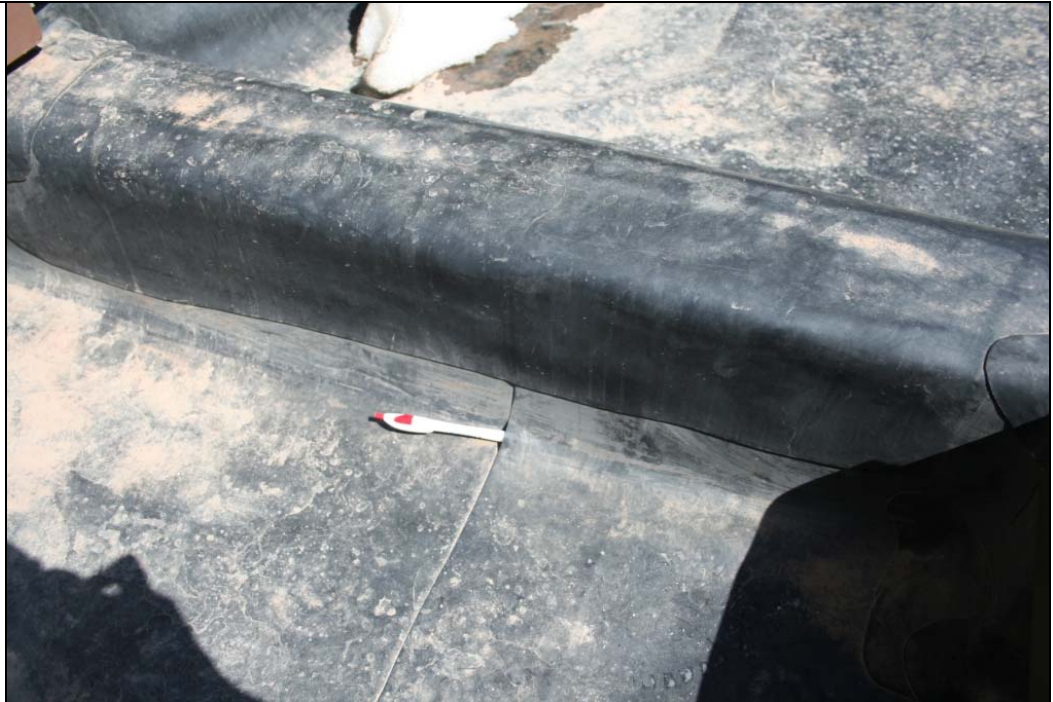
**Unit 21
Photo 10**

Notes: Seam at north side of parapet cap not fully adhered.

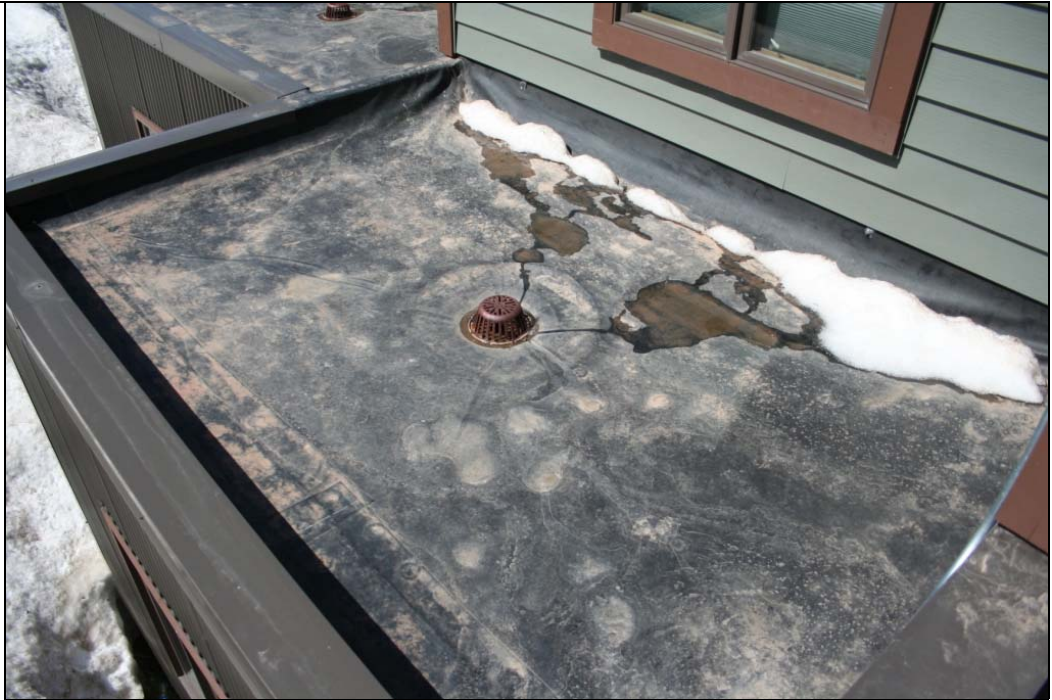
**Unit 22
Photo 1**

Notes: Roof Photo #1.

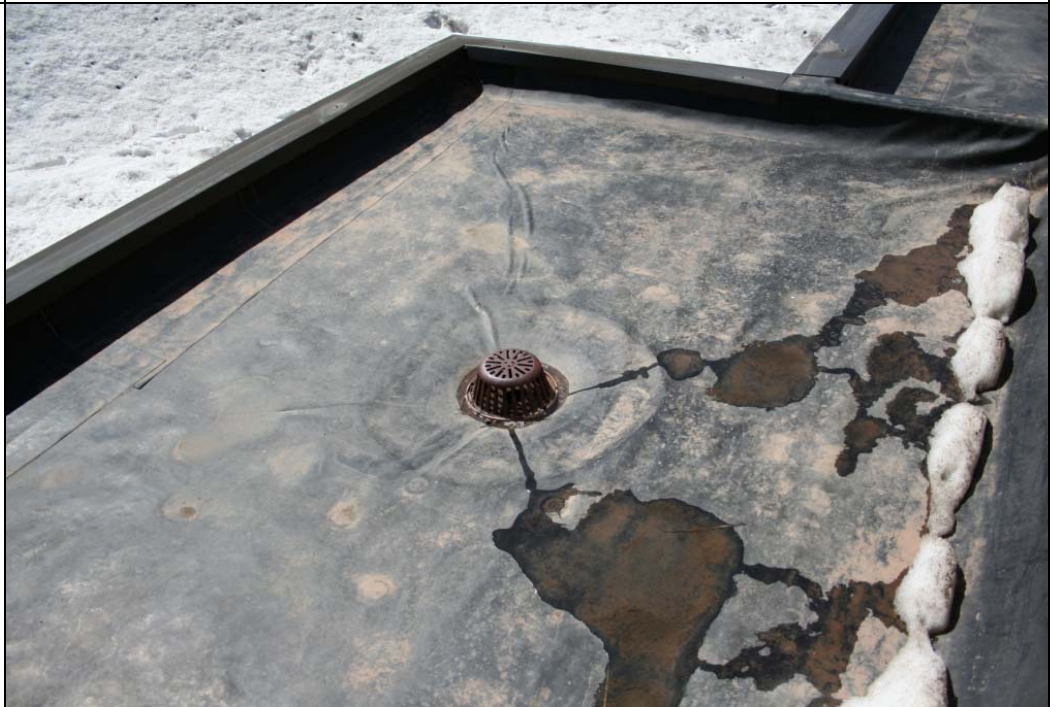
**Unit 22
Photo 2**

Notes: Roof Photo #2.

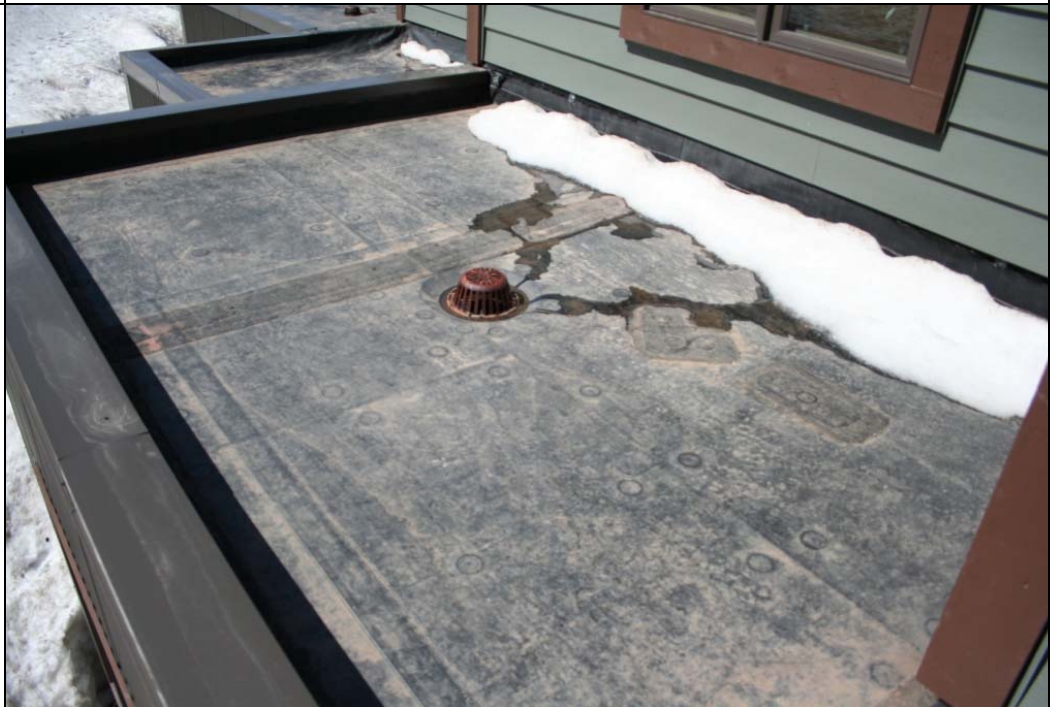
**Unit 23
Photo 1**

Notes: Roof Photo #1.

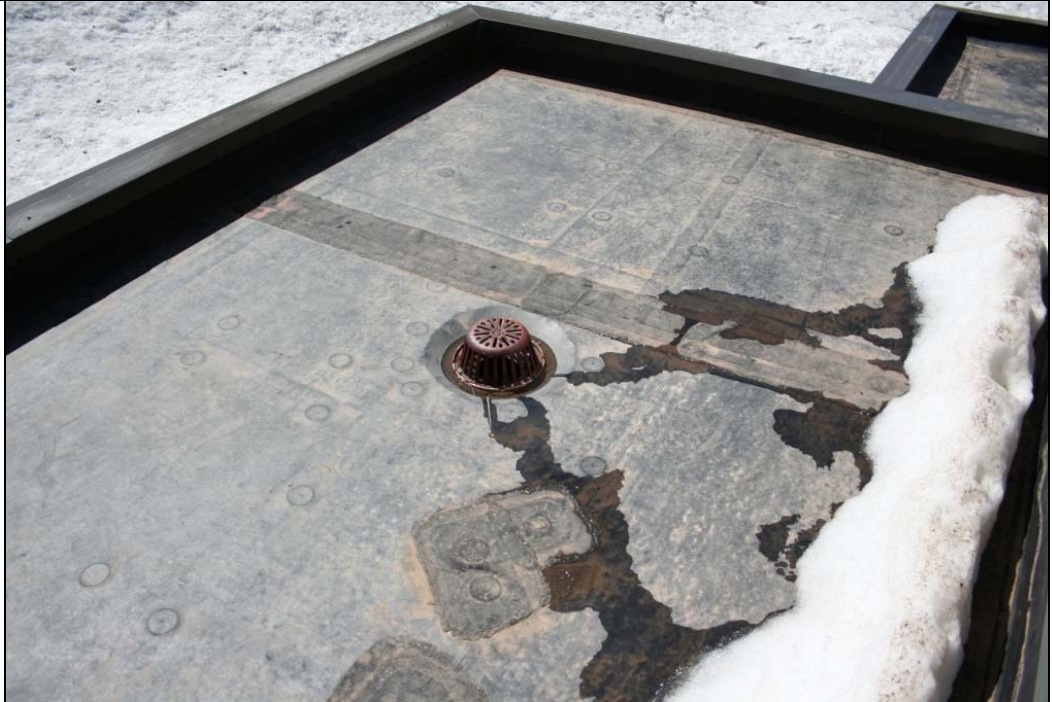
**Unit 23
Photo 2**

Notes: Roof Photo #2.

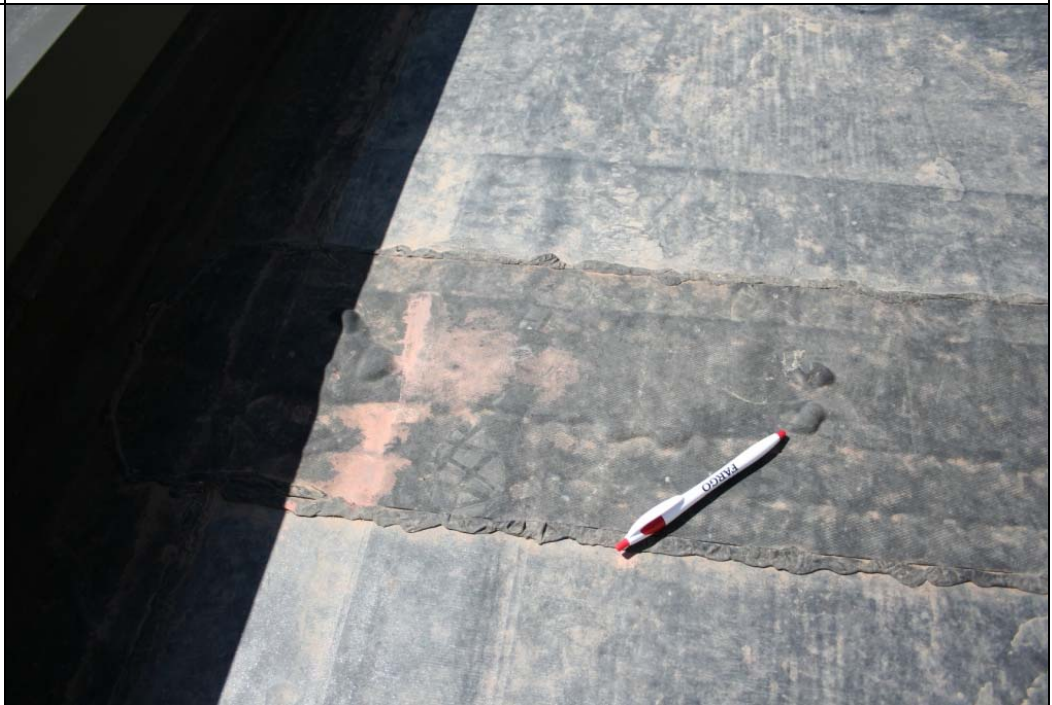
**Unit 23
Photo 3**

Notes: Bubbling in seam in multiple locations.

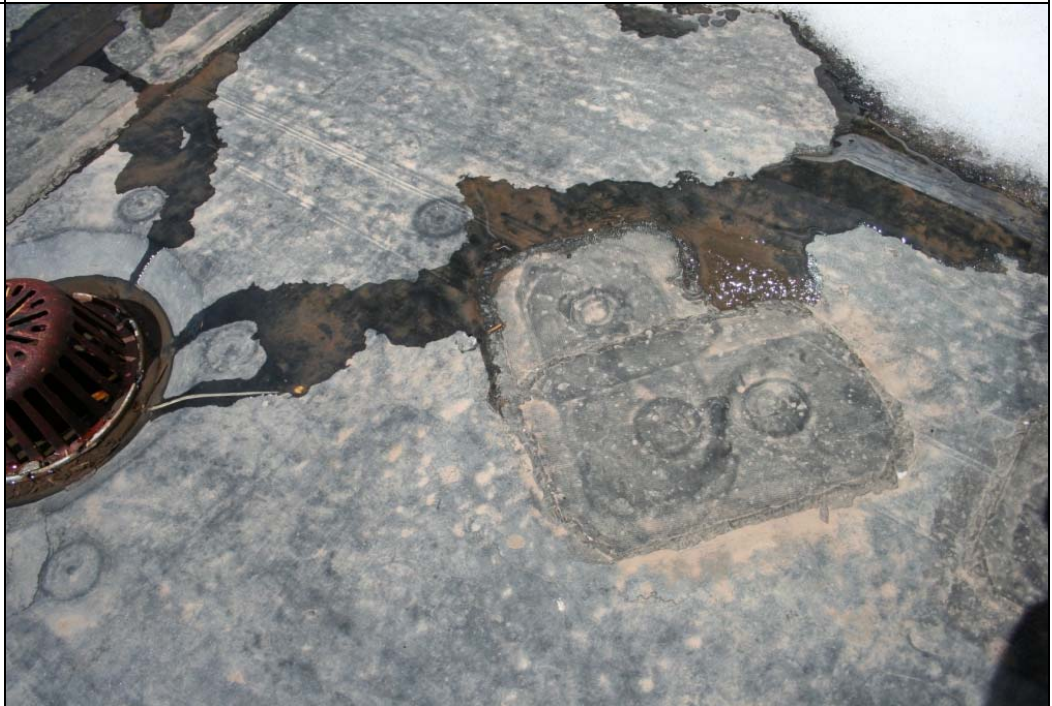
**Unit 23
Photo 5**

Notes: Patch located southeast of drain.

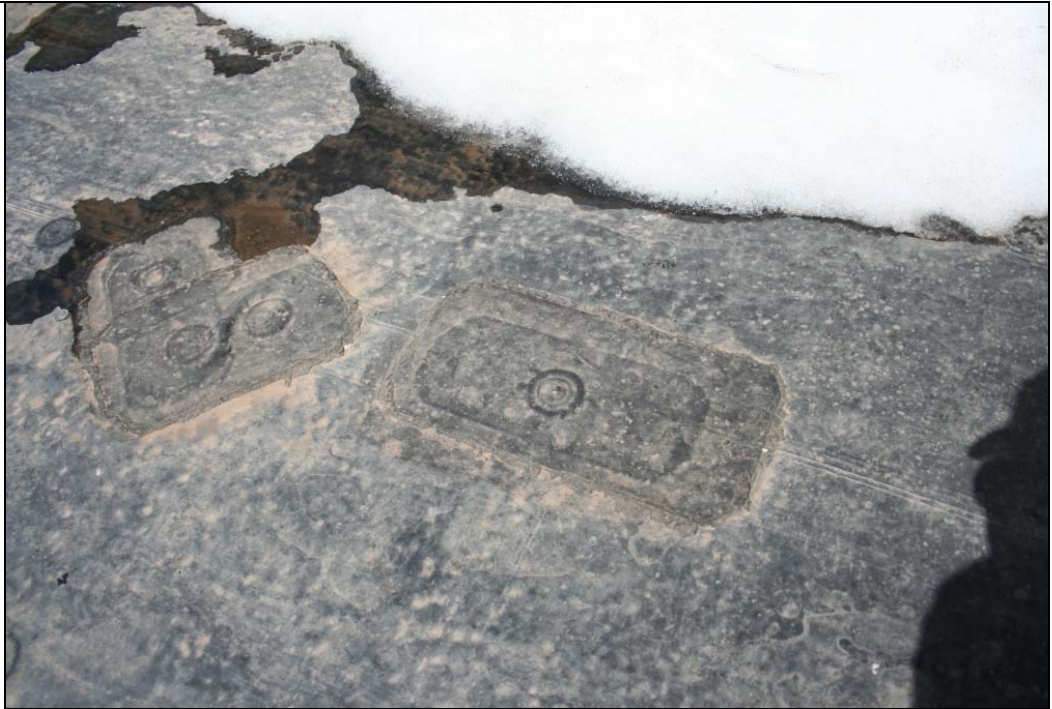
**Unit 23
Photo 6**

Notes: Patch located southeast of drain.

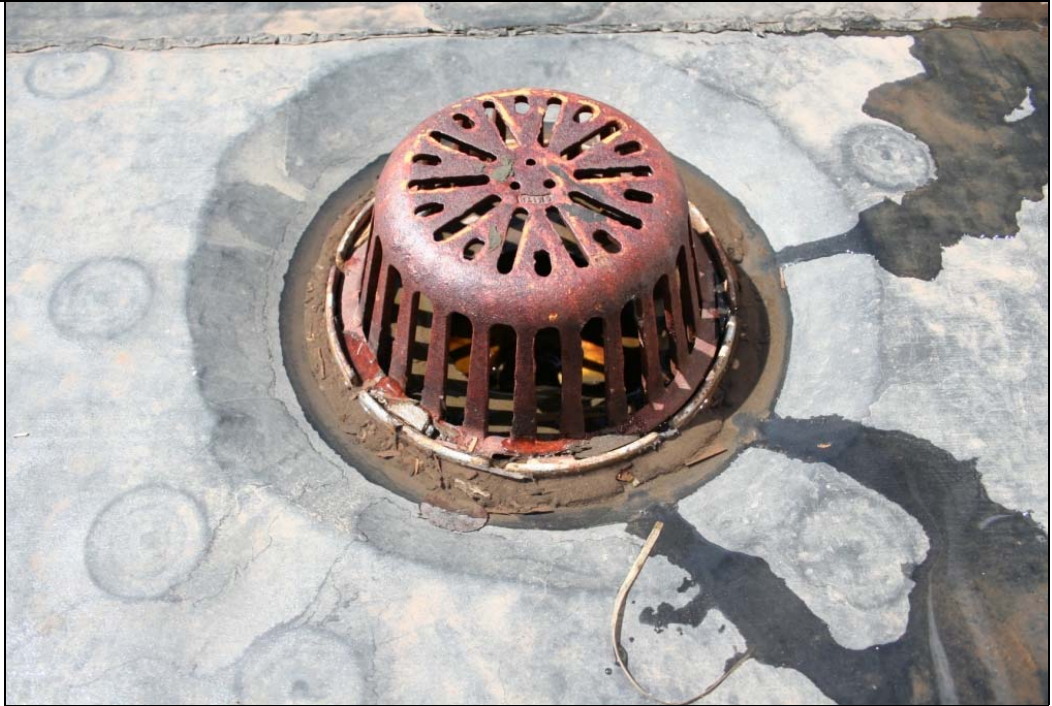
**Unit 23
Photo 8**

Notes: Debris around perimeter of roof drain.

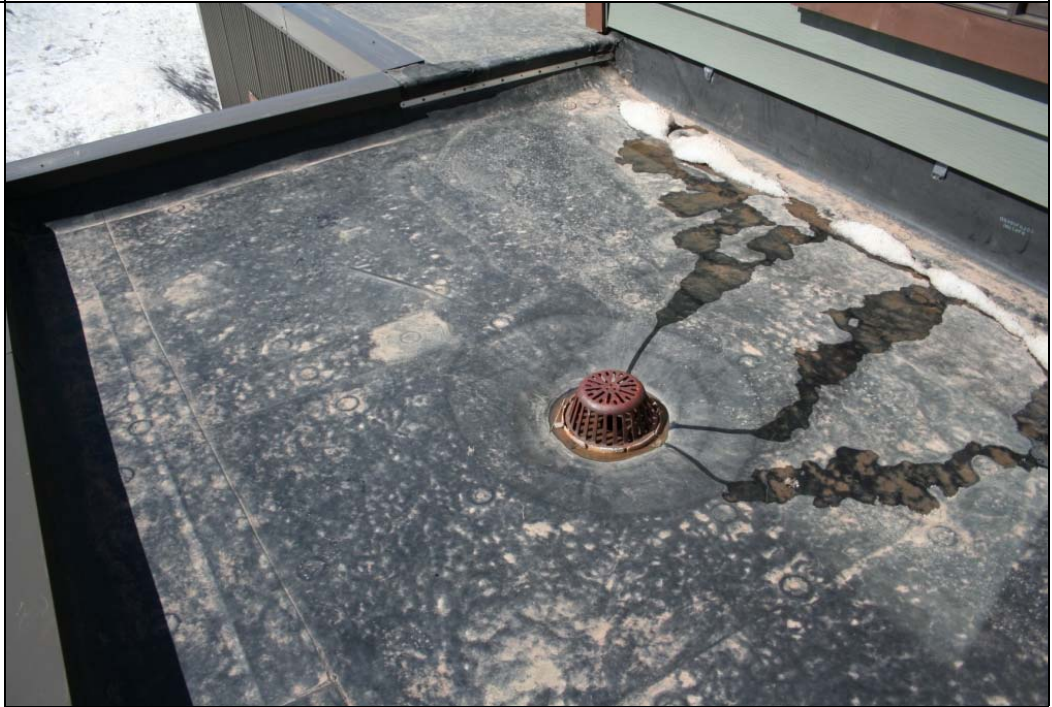
**Unit 24
Photo 1**

Notes: Roof Photo #1.

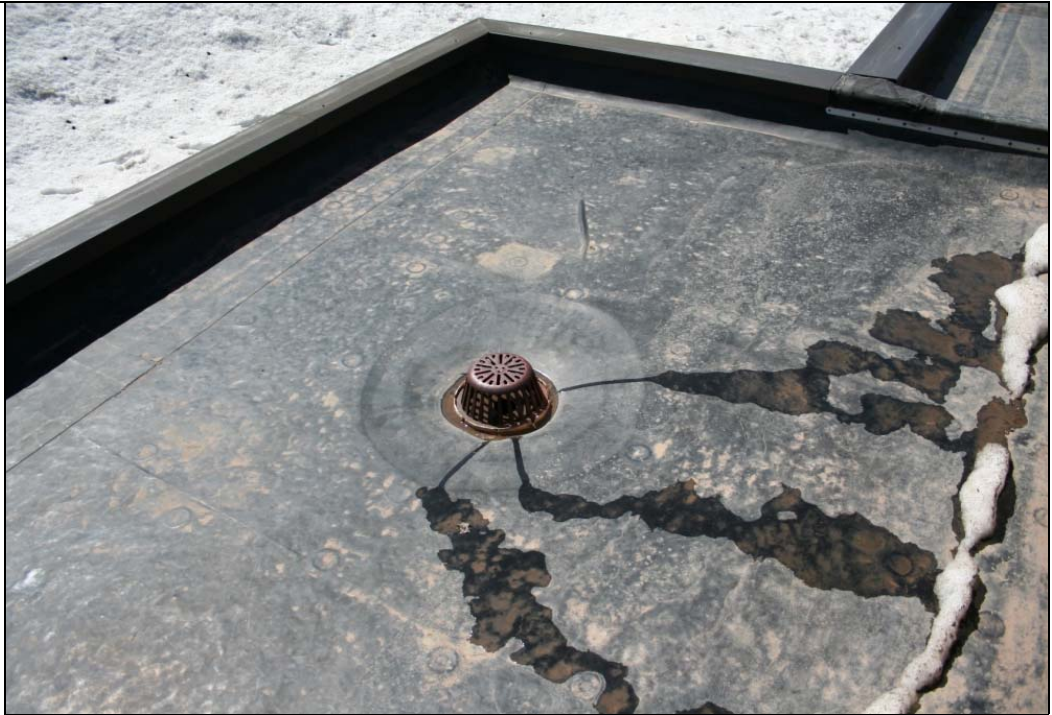
**Unit 24
Photo 2**

Notes: Roof Photo #2.

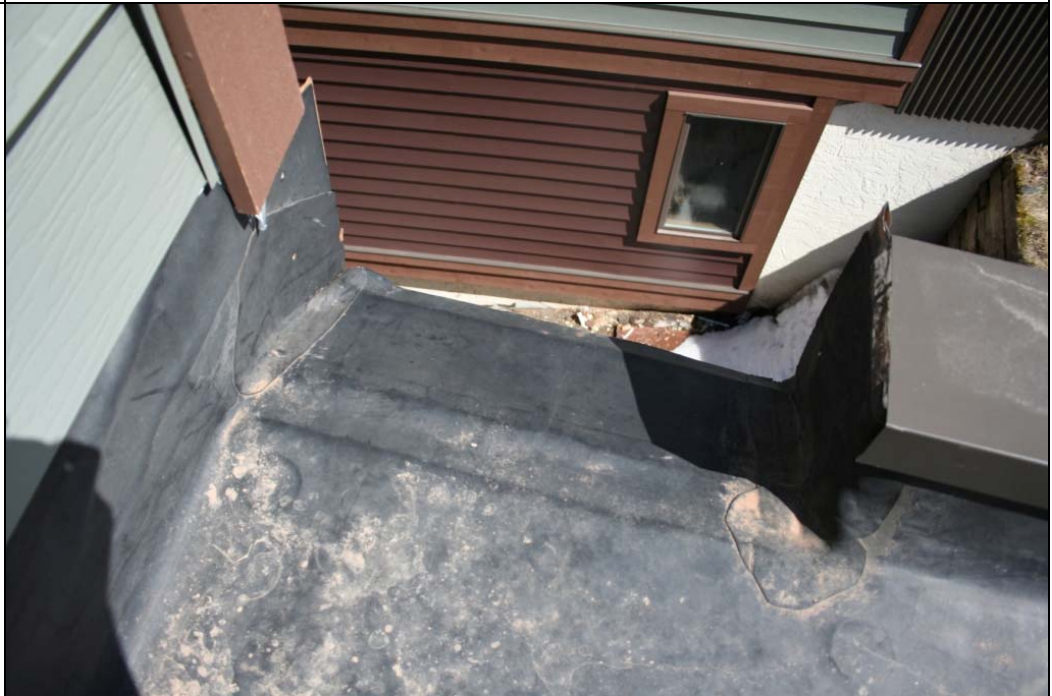
**Unit 24
Photo 3**

Notes: Detail of overflow scupper.

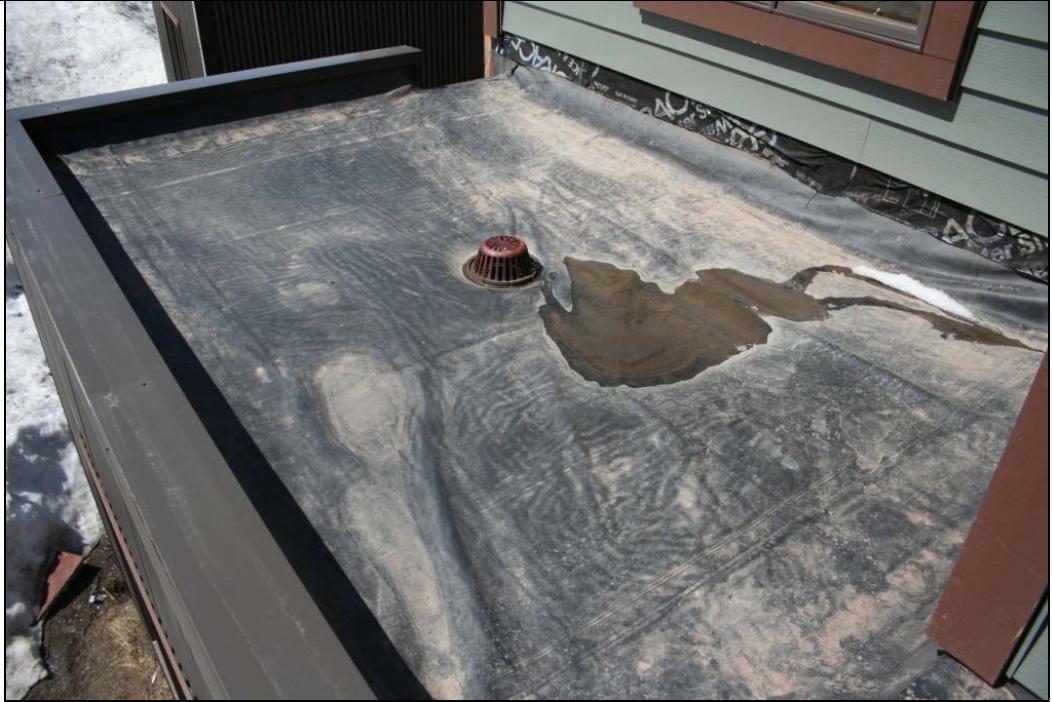
**Unit 25
Photo 1**

Notes: Roof Photo #1

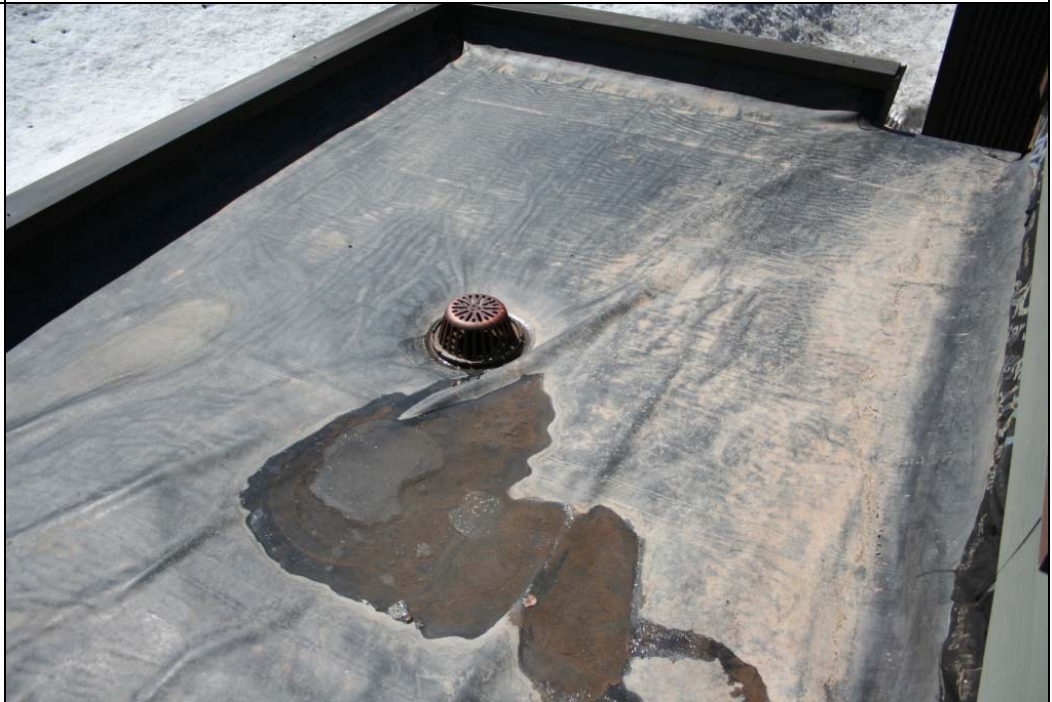
**Unit 25
Photo 2**

Notes: Roof Photo #2

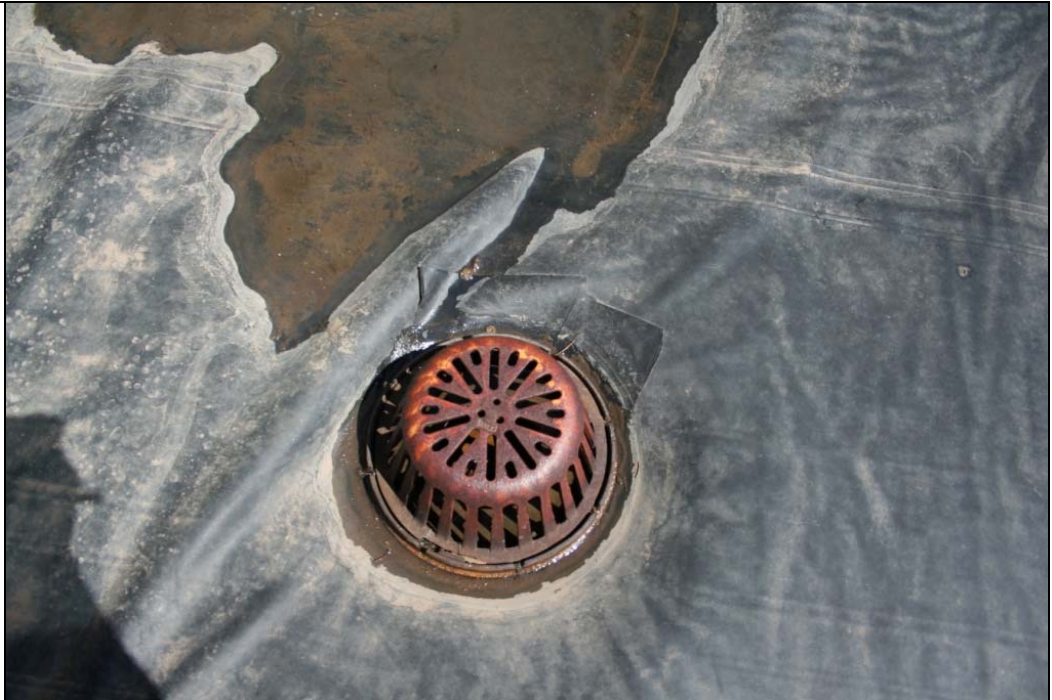
**Unit 25
Photo 3**

Notes: Patches south of roof drain.

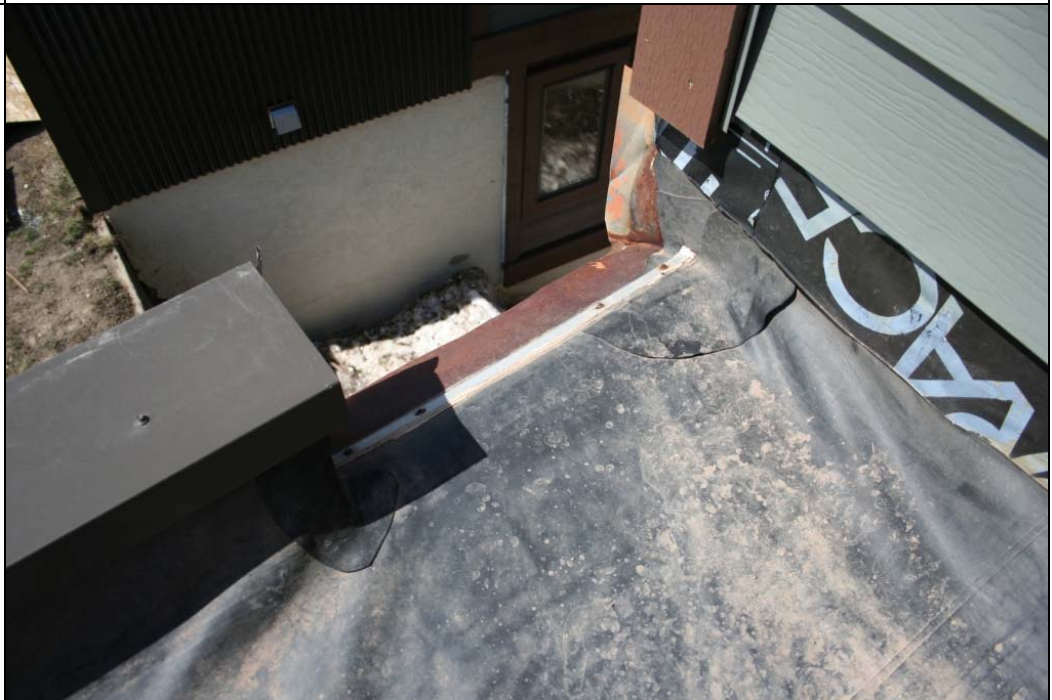
**Unit 25
Photo 4**

Notes: Detail of overflow scupper.

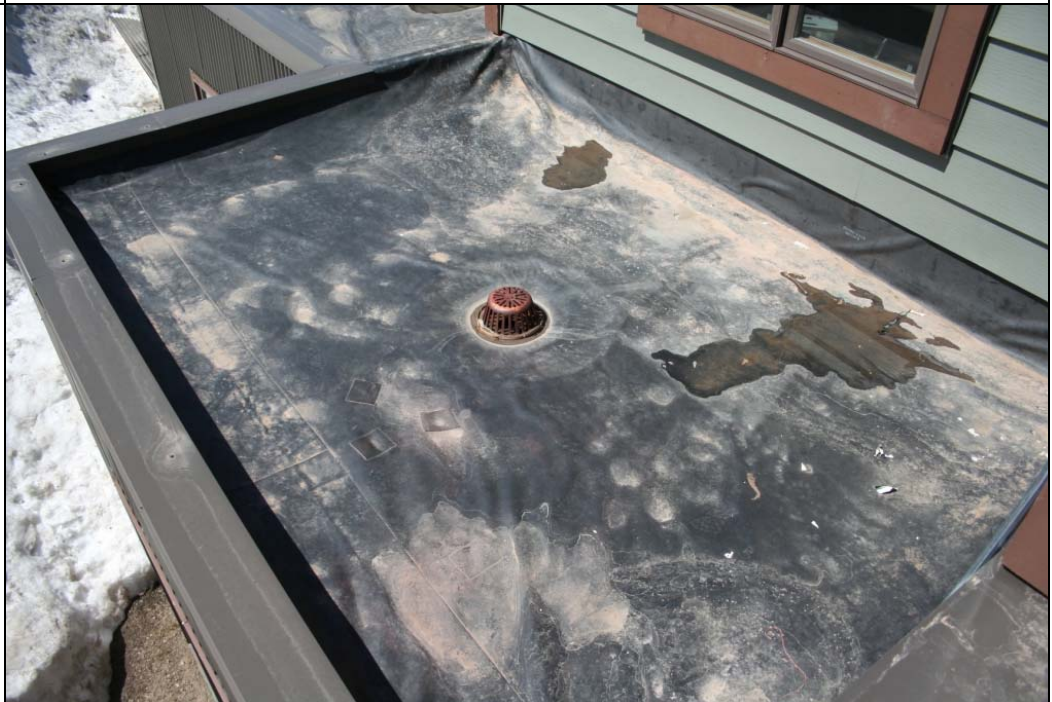
**Unit 26
Photo 1**

Notes: Roof Photo #1.

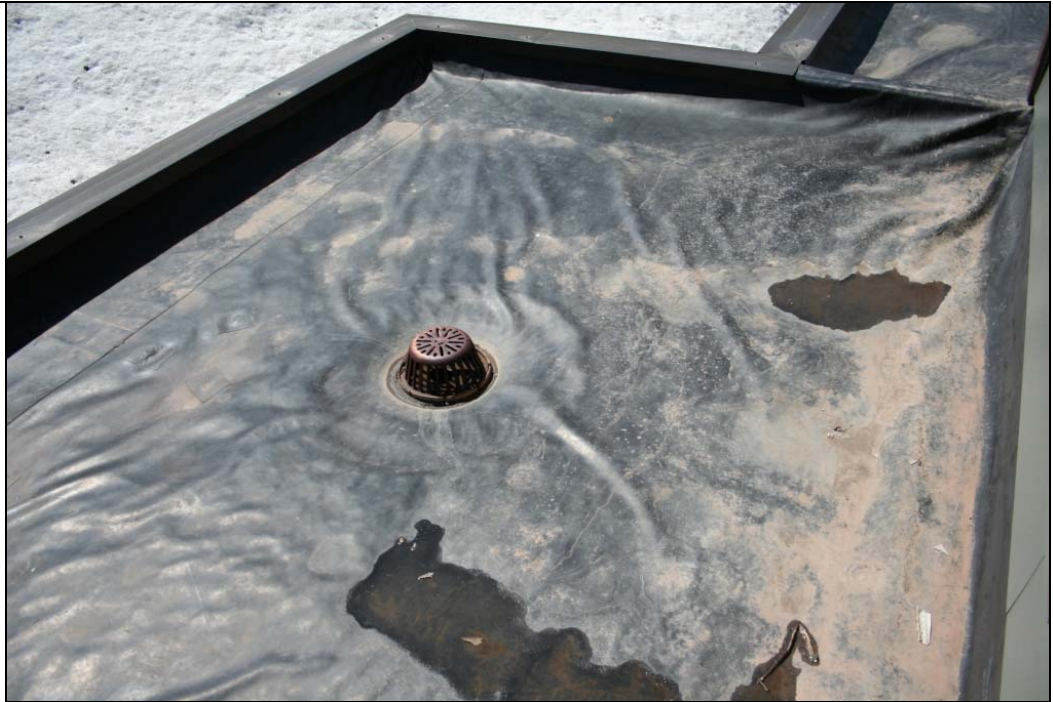
**Unit 26
Photo 2**

Notes: Roof Photo #2.

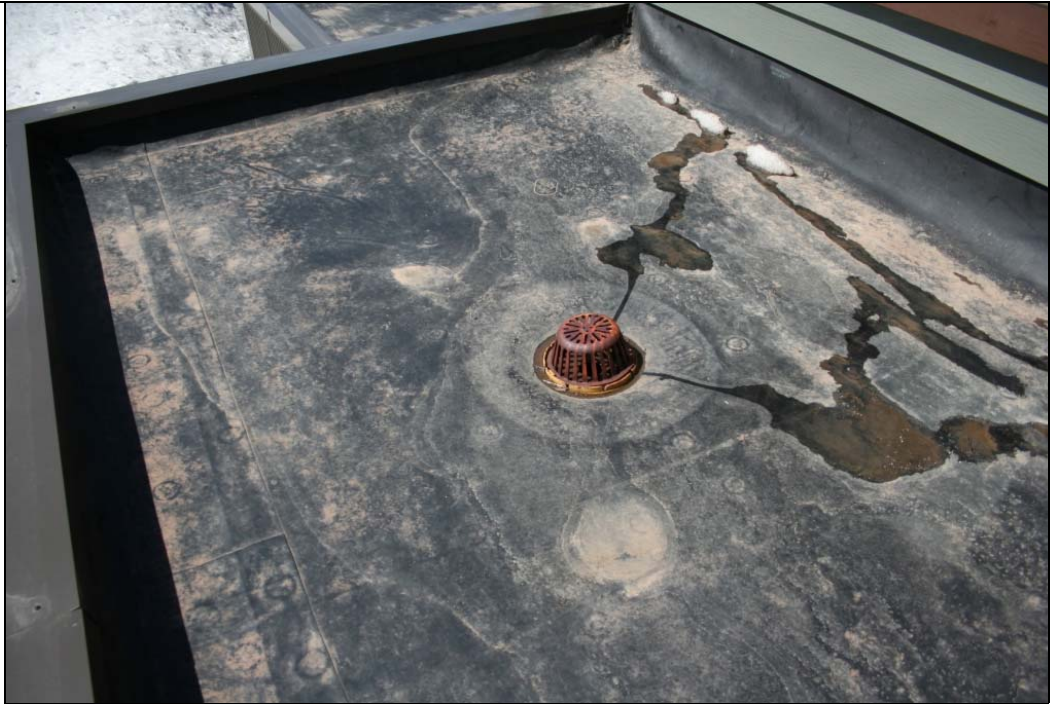
**Unit 27
Photo 1**

Notes: Roof Photo #1.

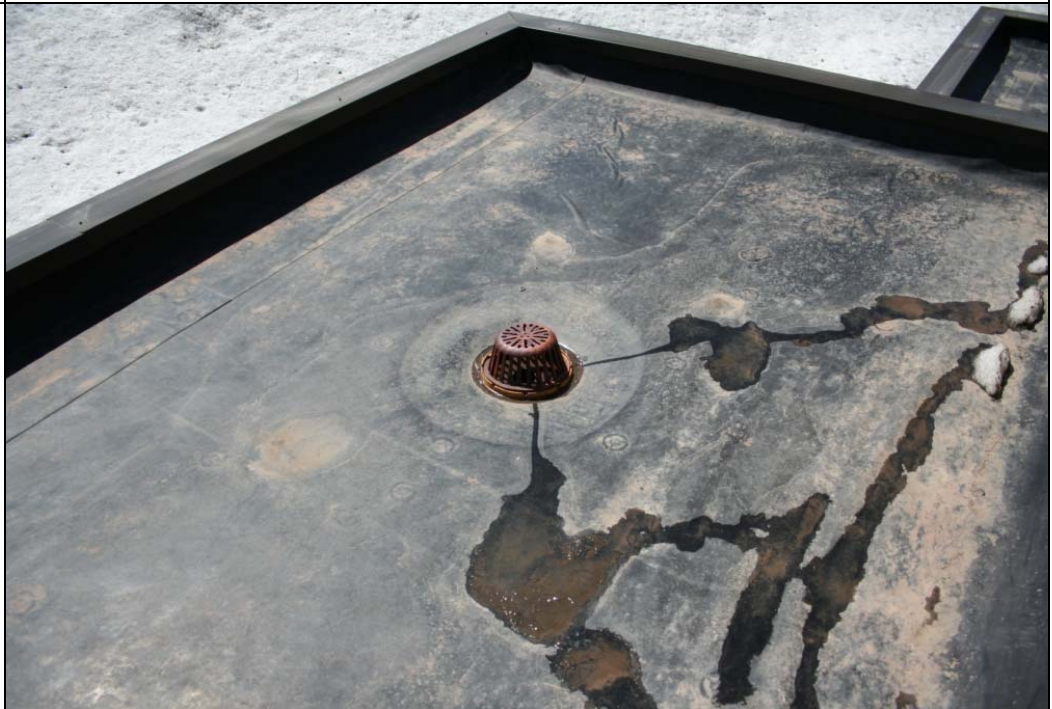
**Unit 27
Photo 2**

Notes: Roof Photo #2.

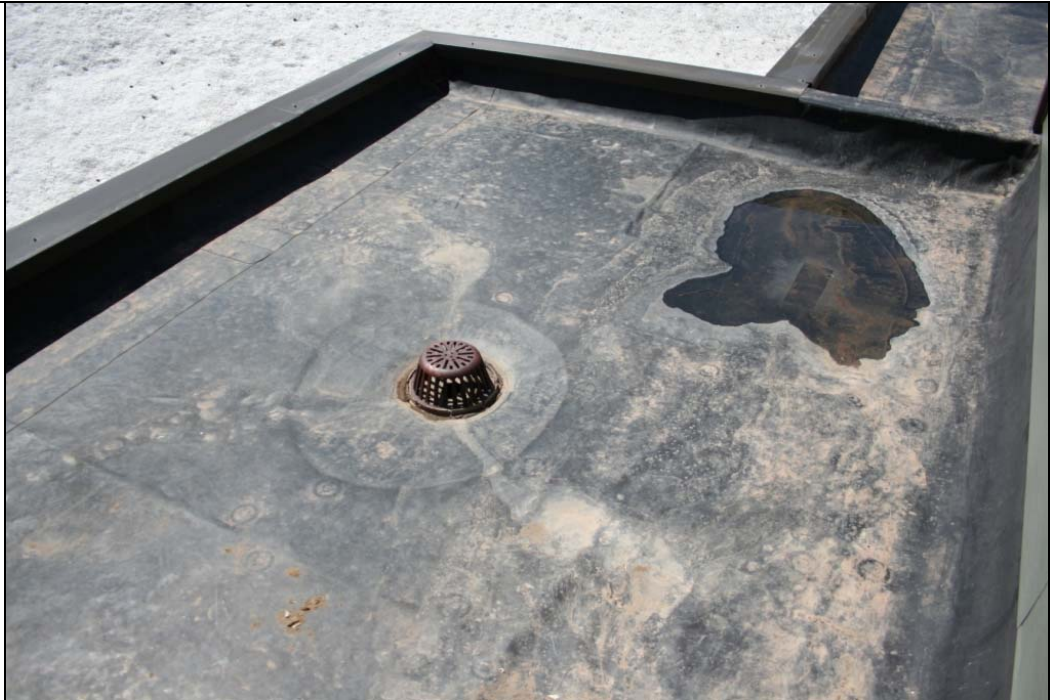
**Unit 28
Photo 2**

Notes: Roof Photo #2.
