ARCHITECT'S FIELD REPORT

PROJECT	Eagle's Nest Townhouses 11 Morning Glory Way & 31 Marcellina Lane Mt. Crested Butte, CO 81225	DATE	5/9/11
----------------	--	-------------	--------

WORK OBSERVED
Phase II – Roof Audit, Existing Conditions Units 1 through 8

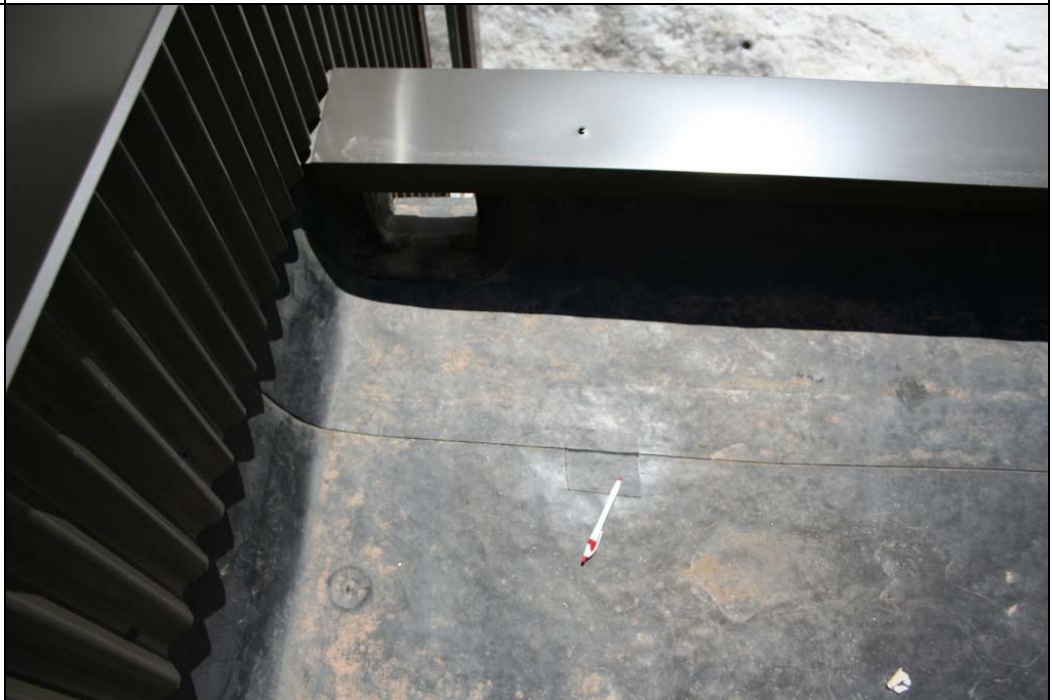
**Unit 28
Photo 3**

Notes: Patch located in southwest corner.

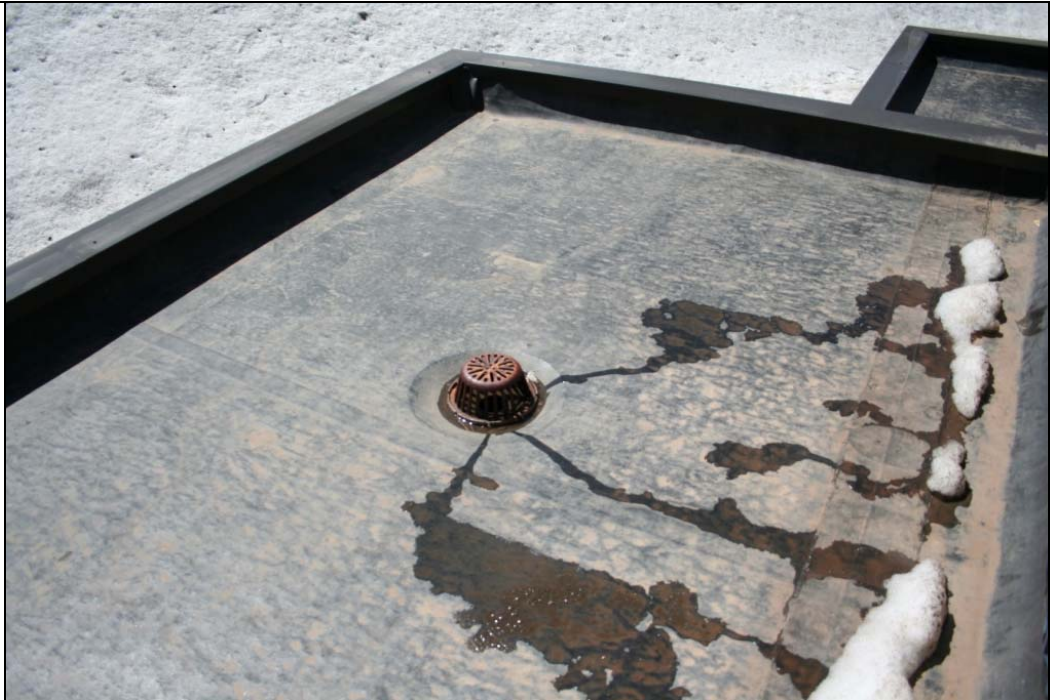
**Unit 29
Photo 2**

Notes: Roof Photo #2.

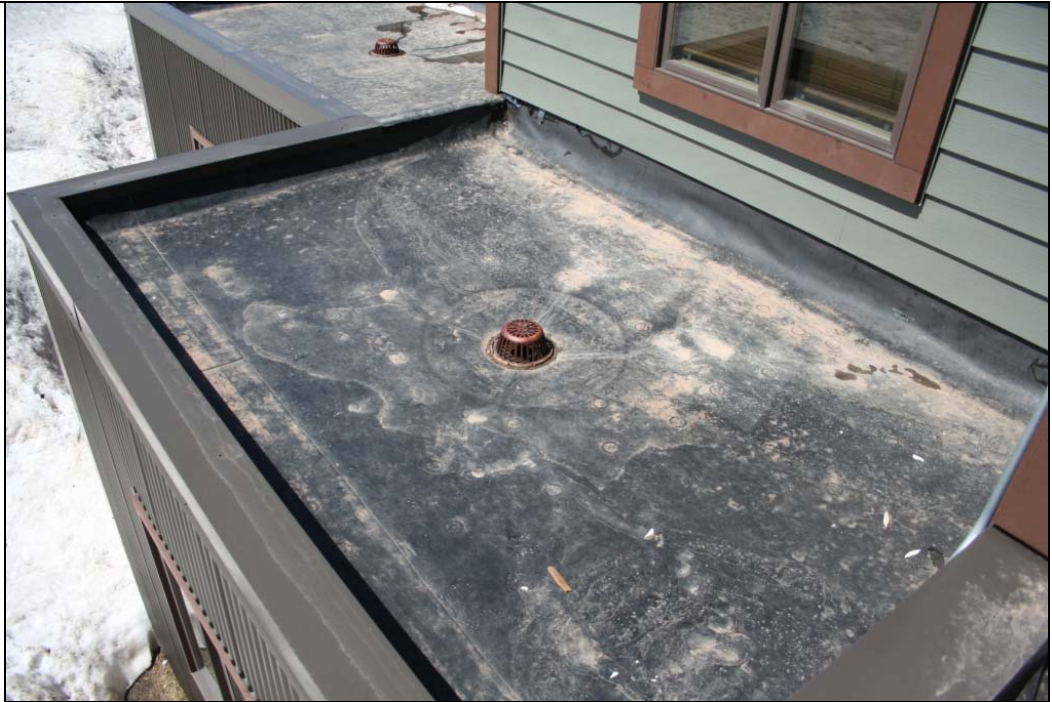
**Unit 30
Photo 1**

Notes: Roof Photo #1.

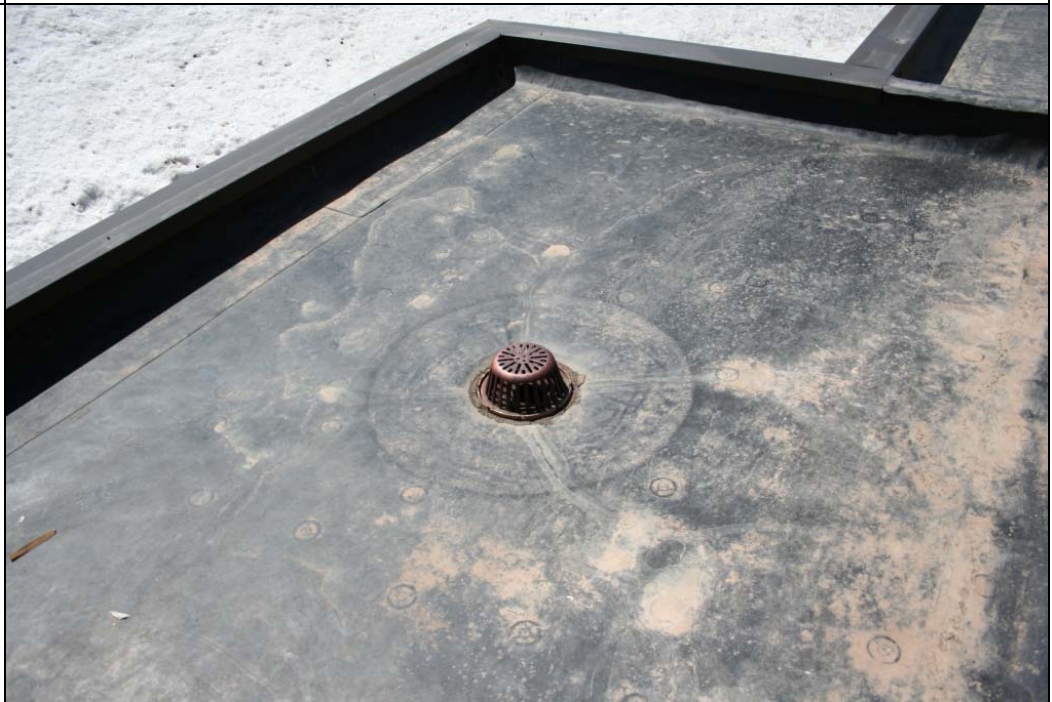
**Unit 30
Photo 2**

Notes: Roof Photo #2.

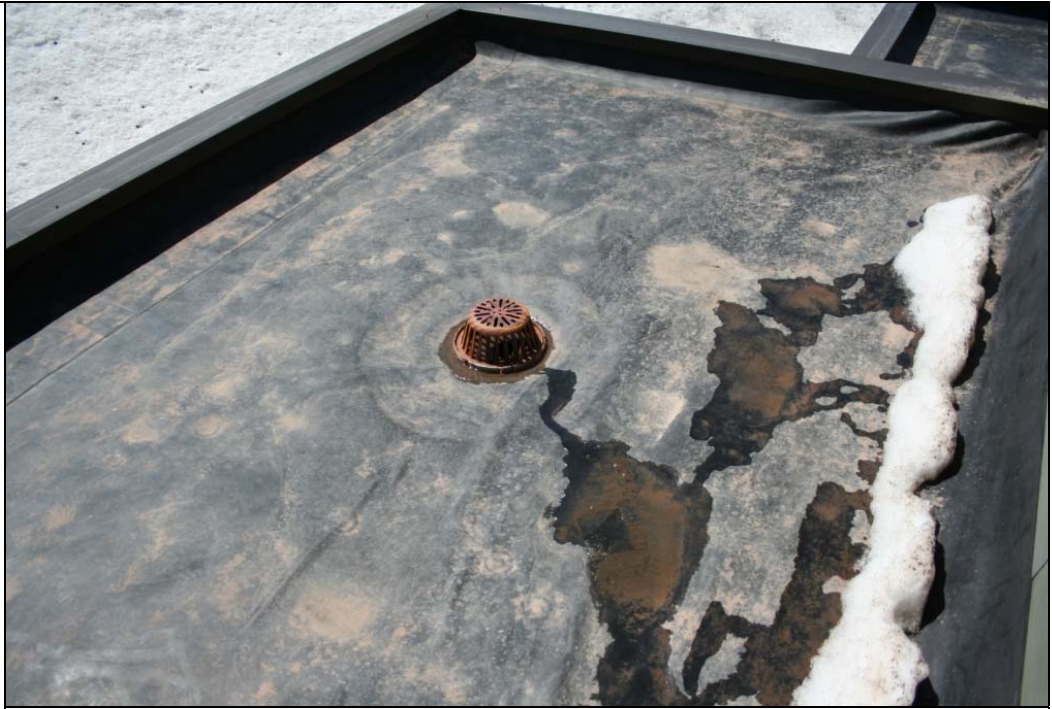
**Unit 31
Photo 2**

Notes: Roof Photo #2.

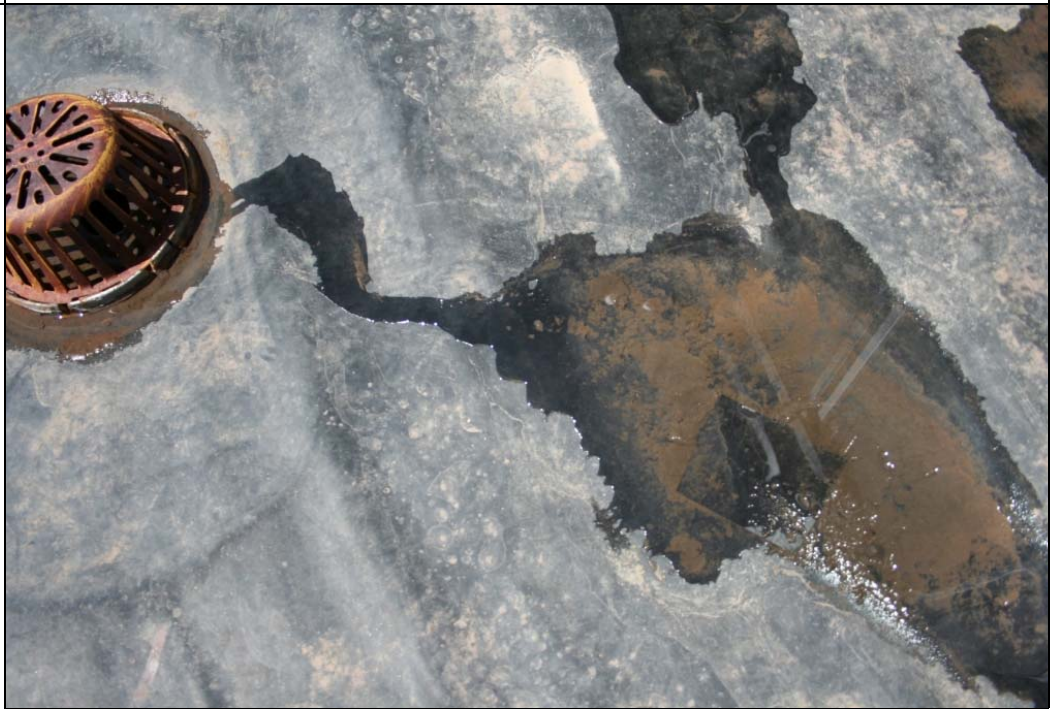
**Unit 31
Photo 3**

Notes: 1 Patch southeast of roof drain.

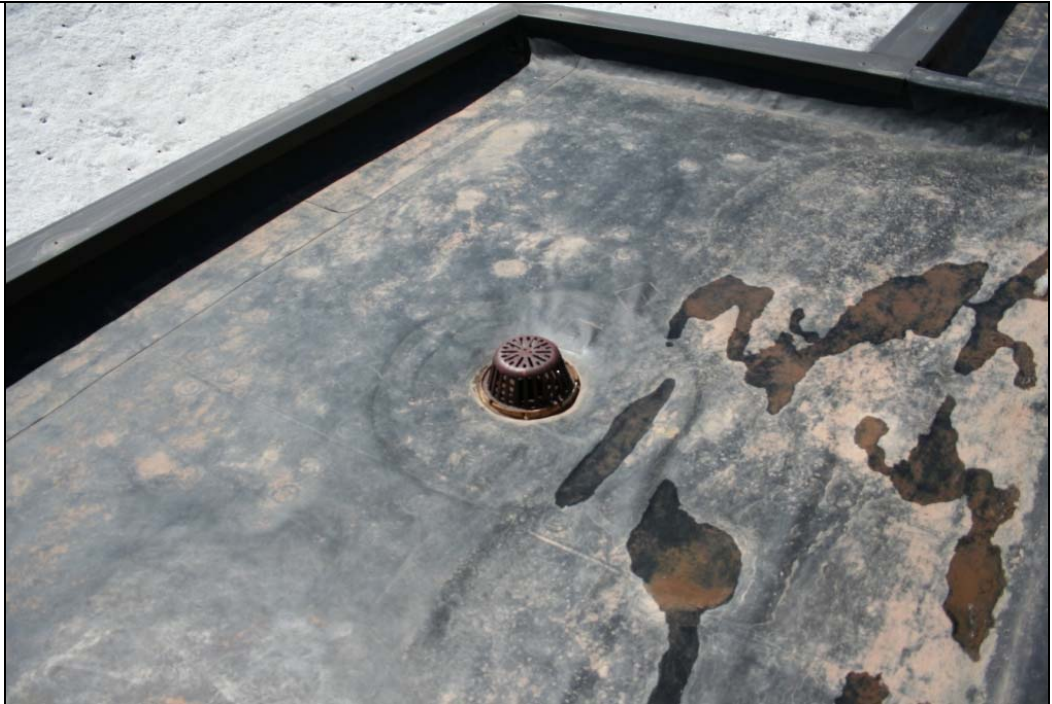
**Unit 32
Photo 1**

Notes: Roof Photo #1.

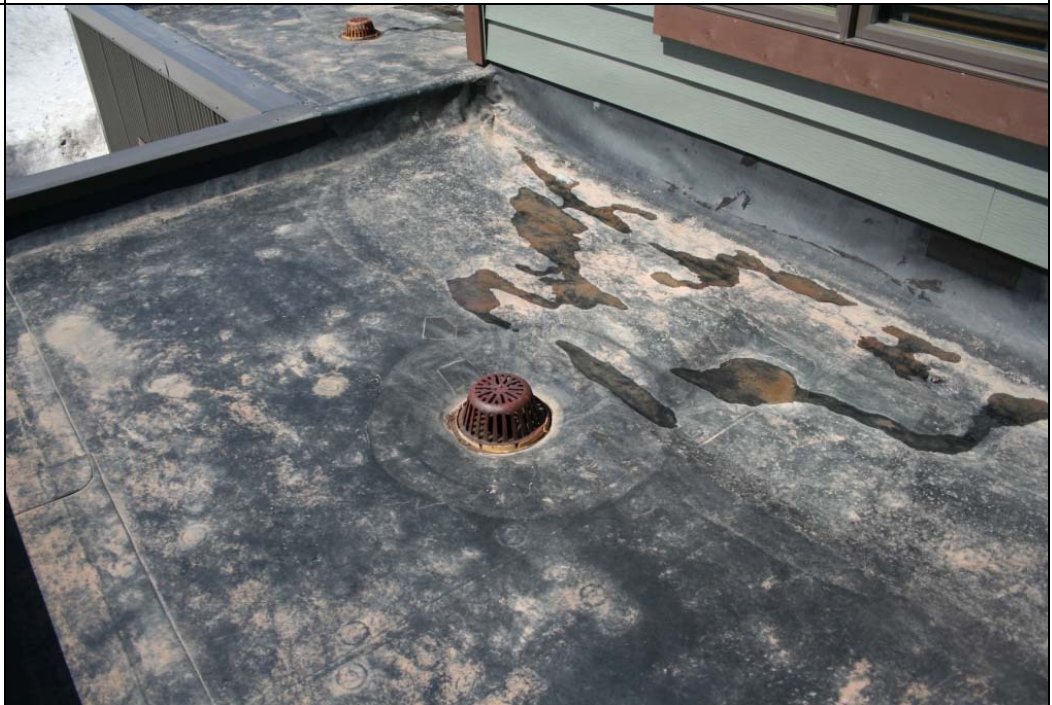
**Unit 32
Photo 2**

Notes: Roof Photo #2.

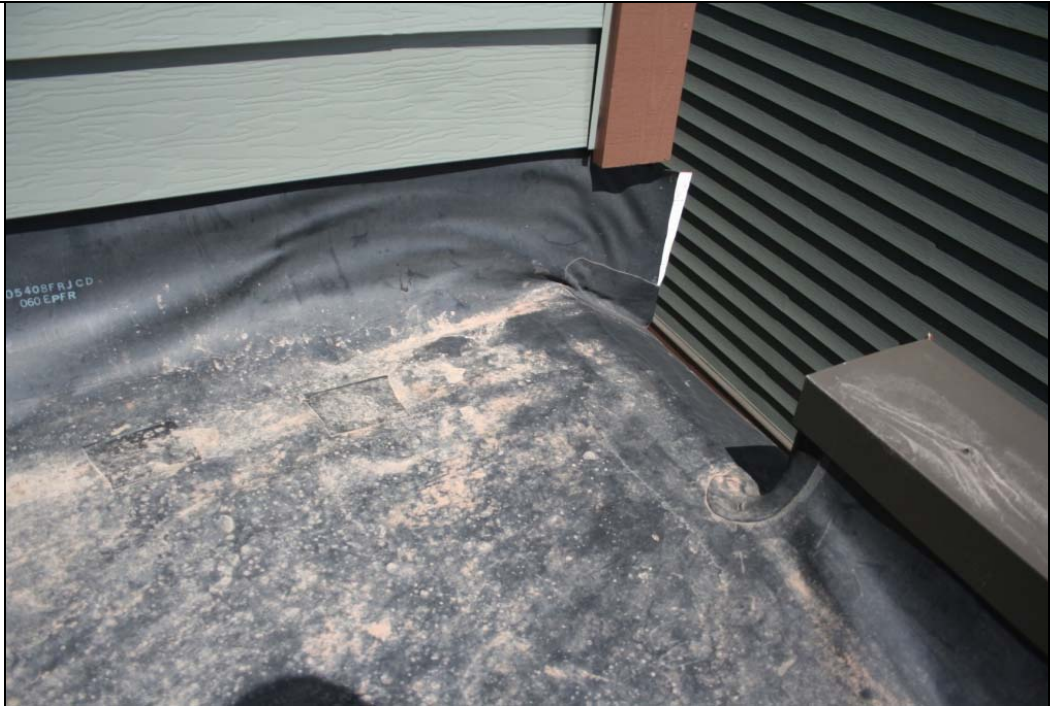
**Unit 32
Photo 3**

Notes: Detail of overflow scupper and two patches.

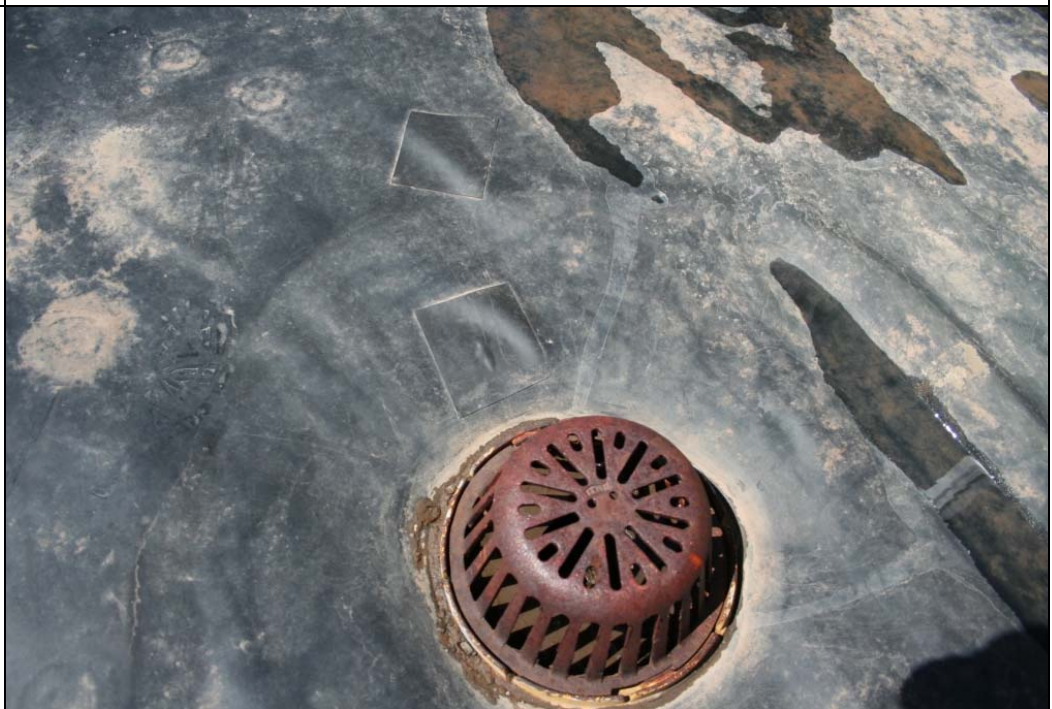
**Unit 32
Photo 4**

Notes: Two additional patches just north of the roof drain.

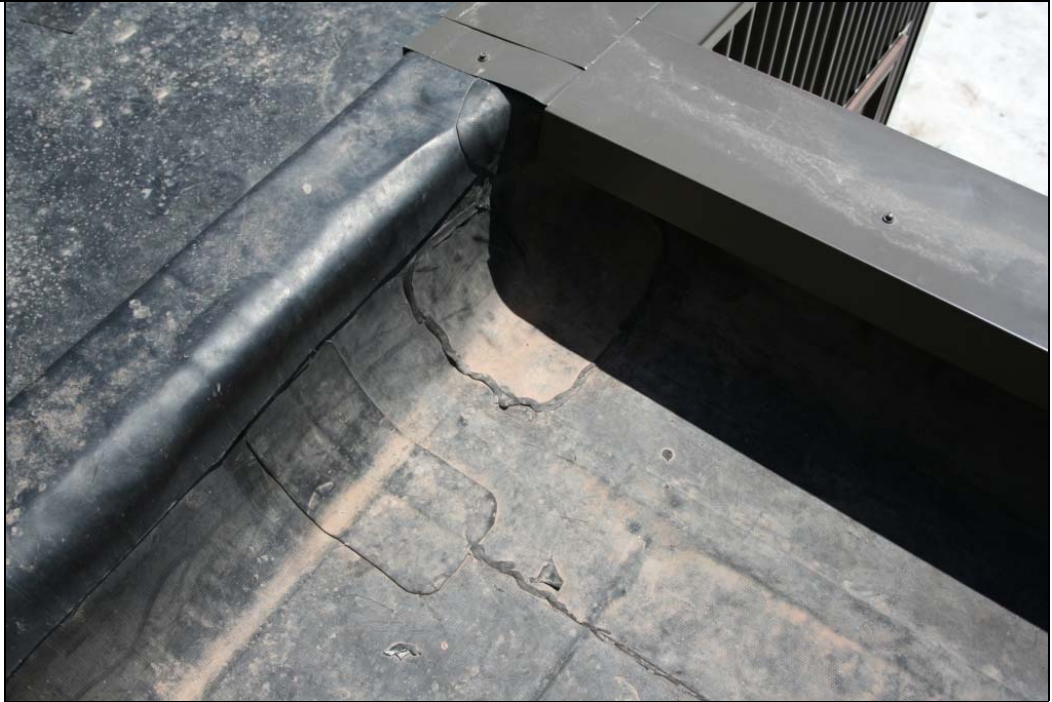
Unit 33
Photo 3

Notes: Glued patches and seams at southwest corner.

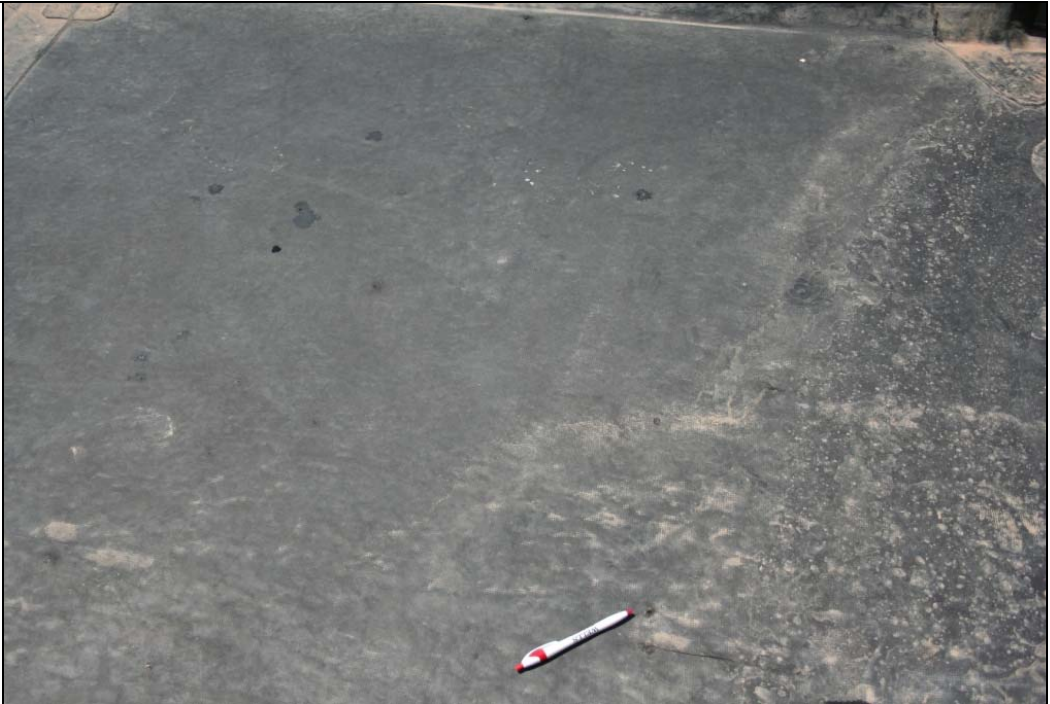
Unit 33
Photo 9

Notes: Nail heads protruding through membrane.

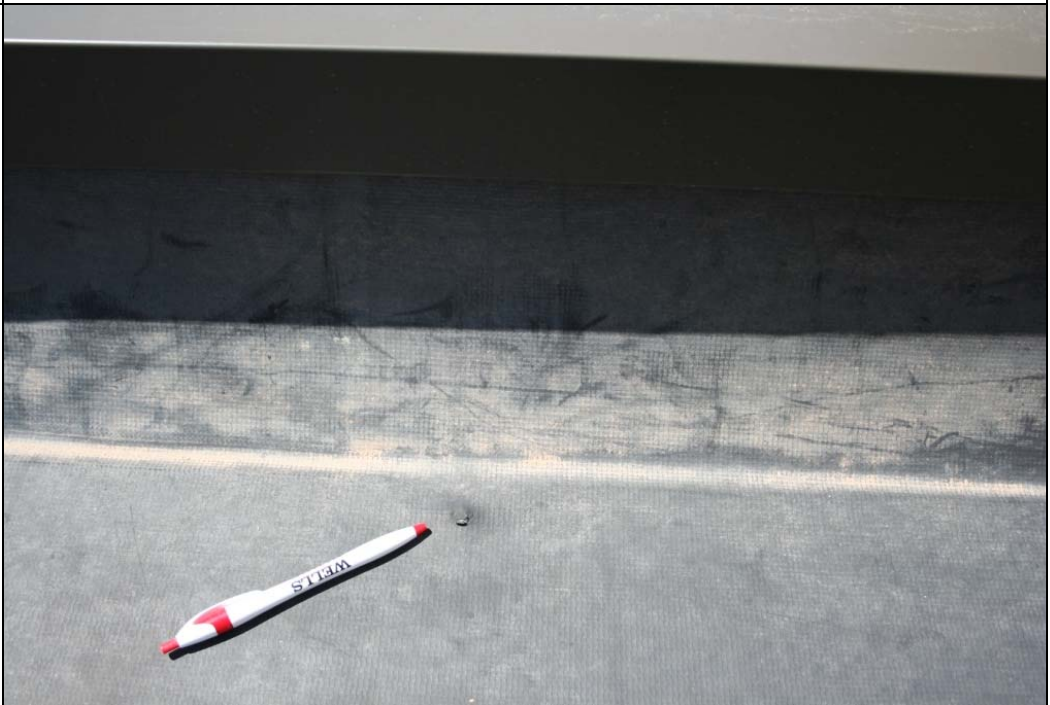
Unit 33
Photo 10

Notes: Detail of nail head protruding near overflow scupper.

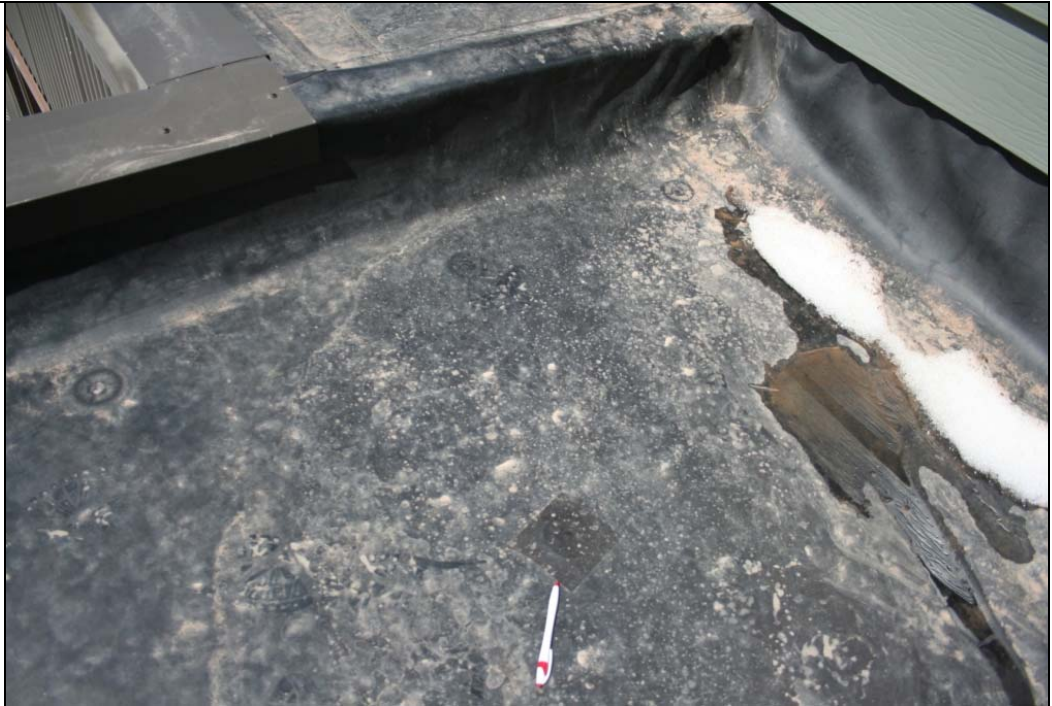
**Unit 34
Photo 4**

Notes: Existing patch in northeast corner.

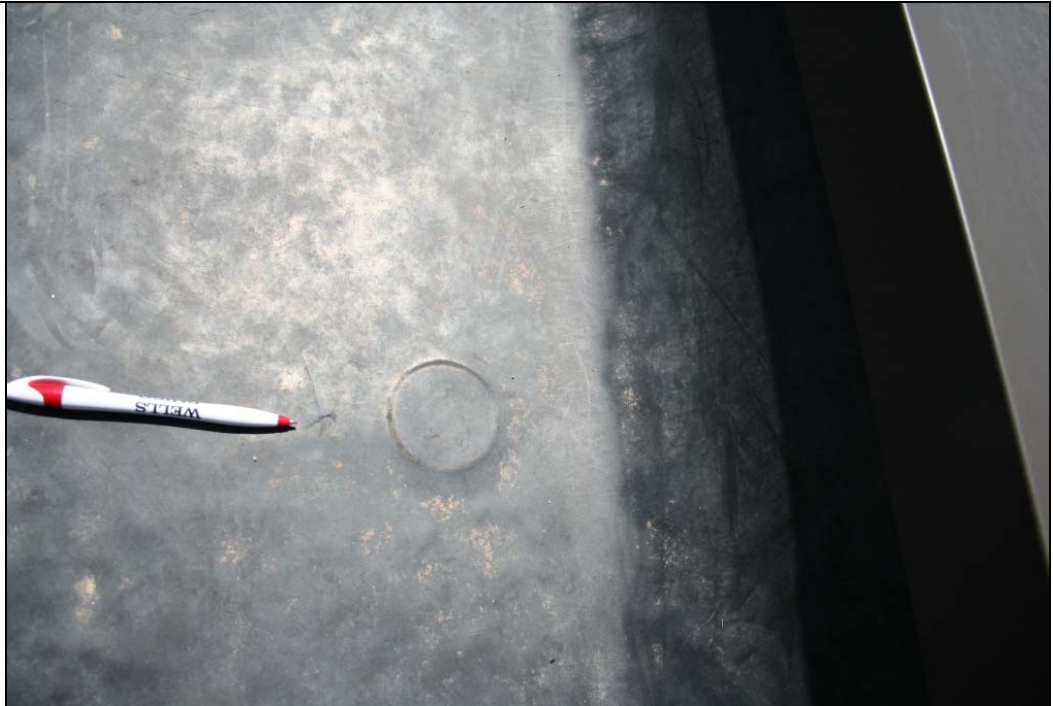
**Unit 34
Photo 6**

Notes: Hole in membrane, northwest corner.

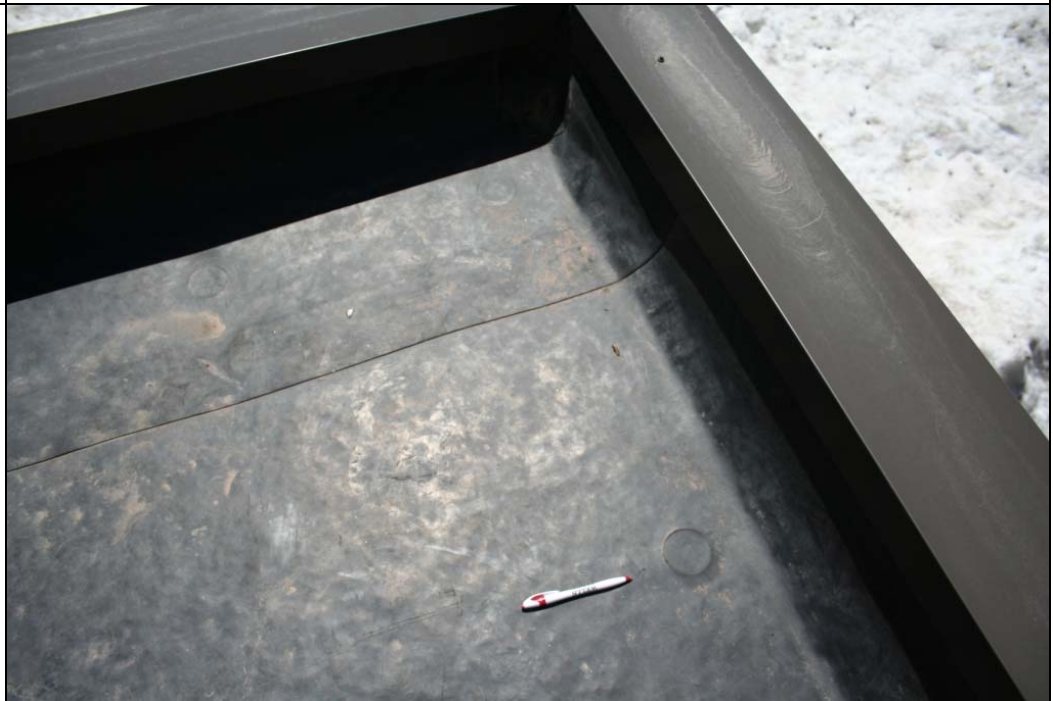
**Unit 34
Photo 7**

Notes: Location photo of hole in Photo 6.

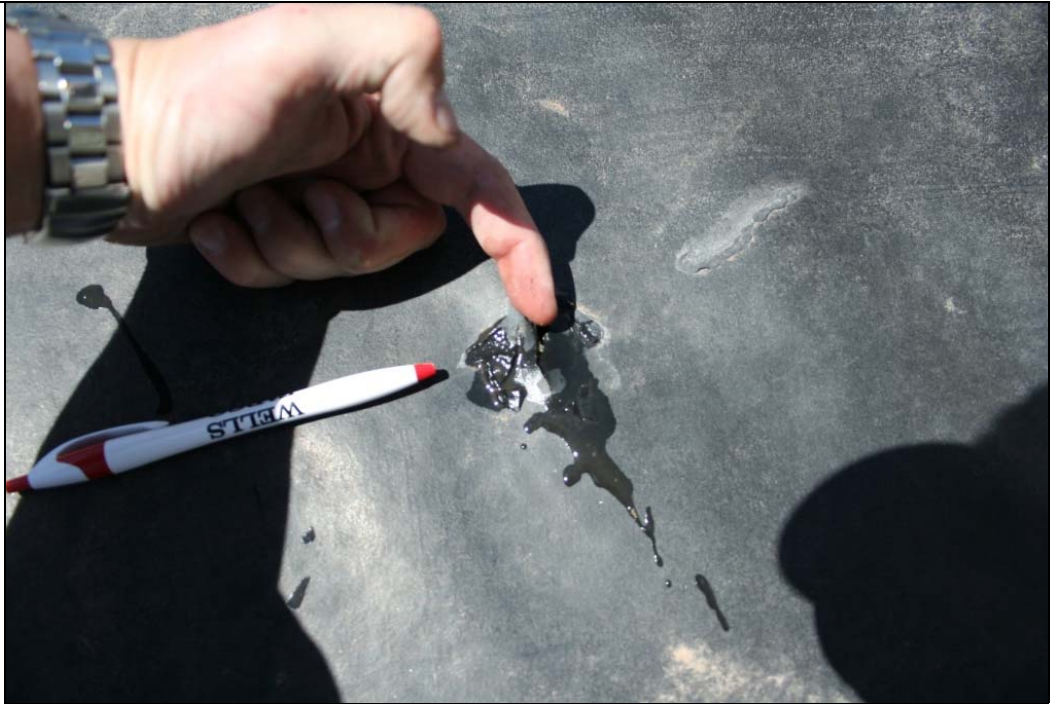
**Unit 36
Photo 5**

Notes: Detail of hole in Photo 4.

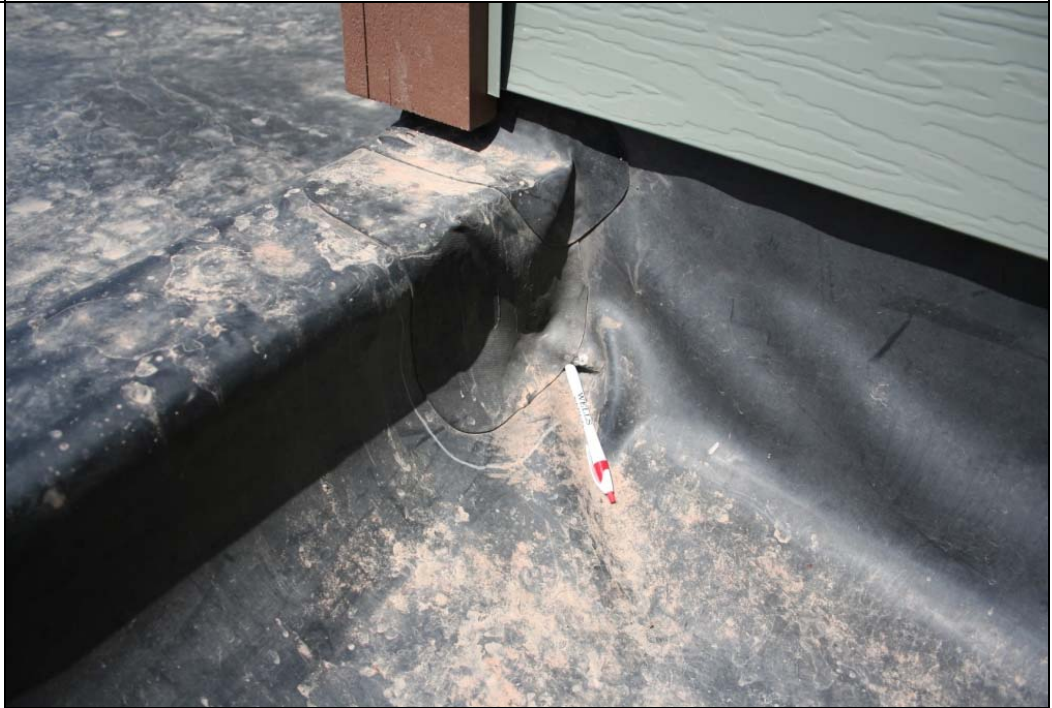
**Unit 38
Photo 4**

Notes: Corner seam not fully adhered at northeast corner.

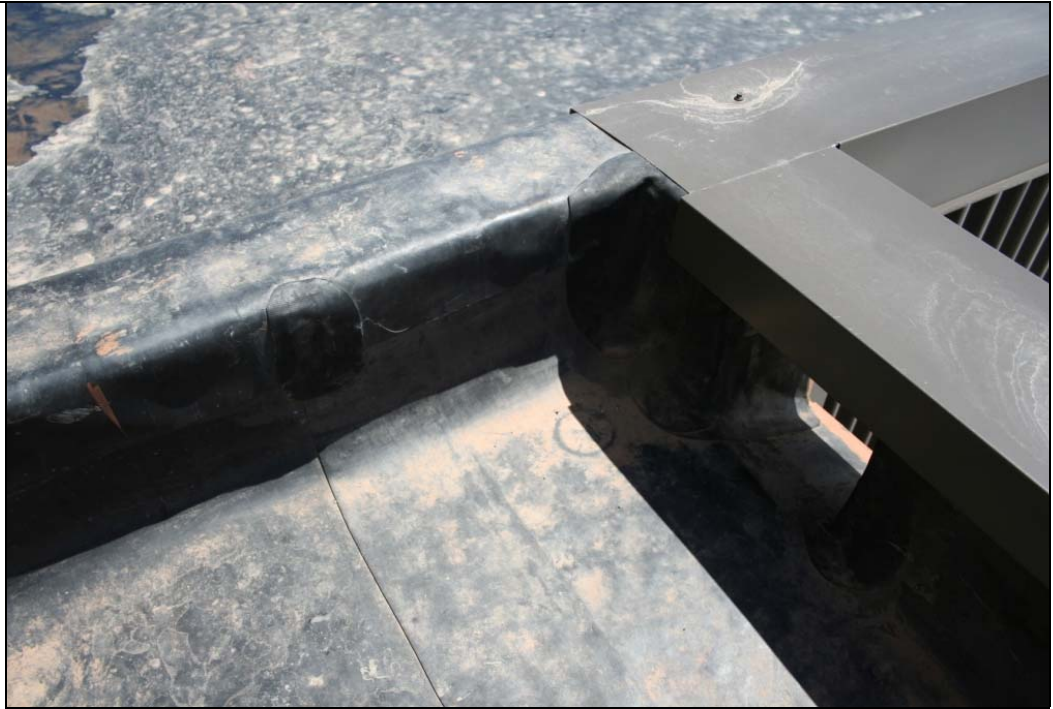
**Unit 39
Photo 4**

Notes: Patch at seam on south parapet wall near overflow scupper.

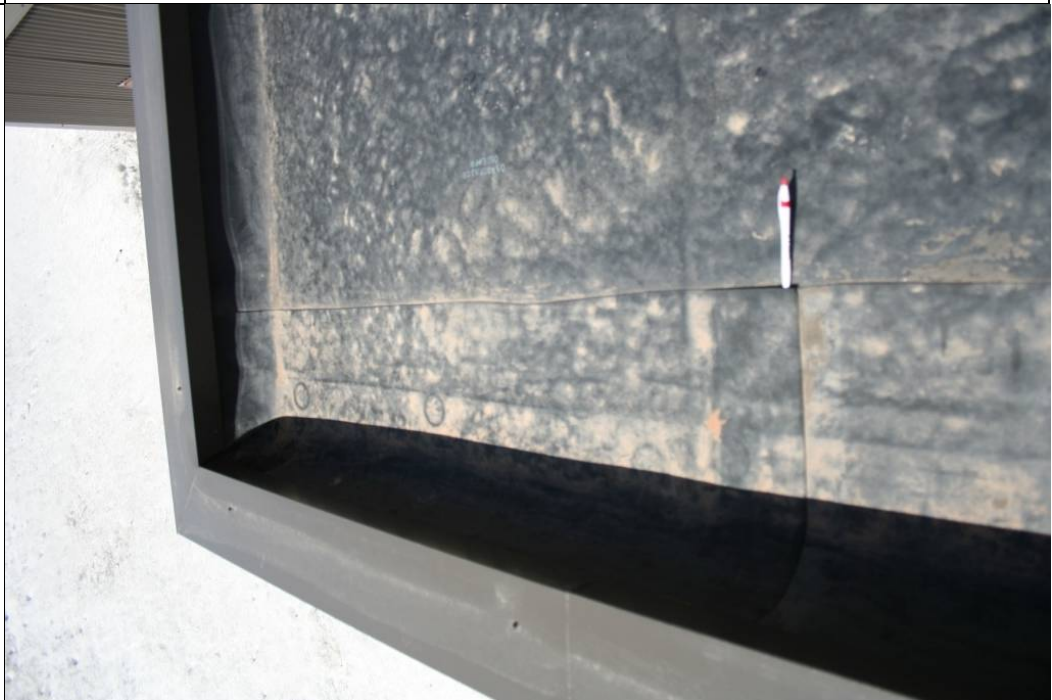
**Unit 40
Photo 4**

Notes: West seam not fully adhered.

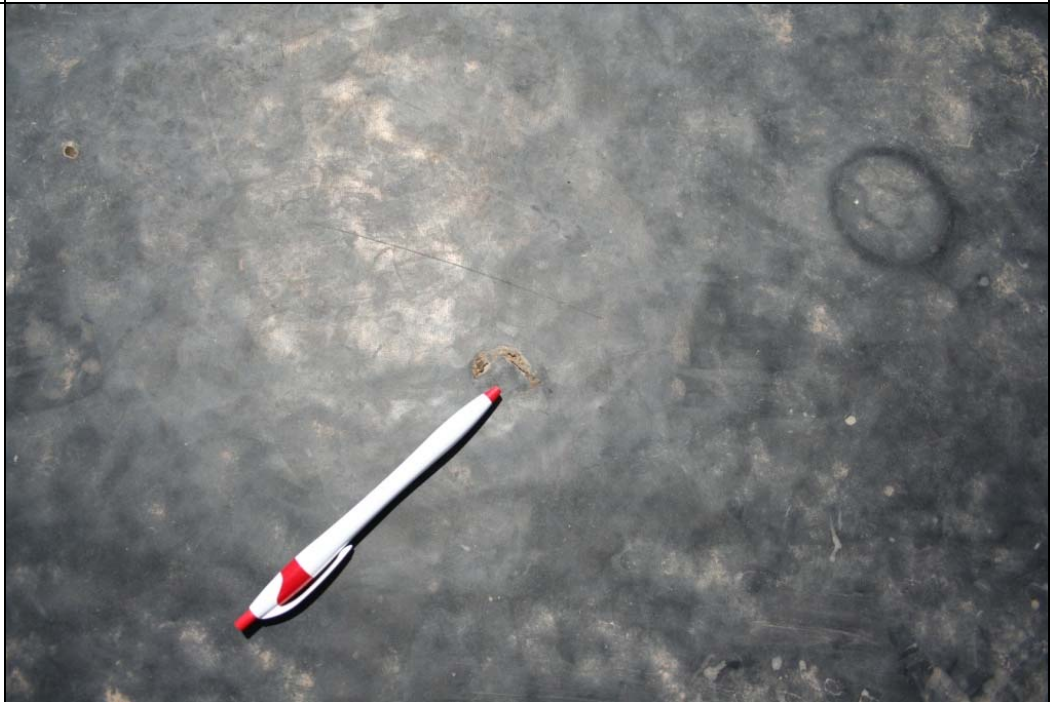
Unit 40
Photo 6

Notes: Hole 3-'6" north of drain.

Notes: Detail of Photo 5. Hole appears to have been previously fixed.
