ARCHITECT'S FIELD REPORT

PROJECT	Eagle's Nest Townhouses 11 Morning Glory Way & 31 Marcellina Lane Mt. Crested Butte, CO 81225	DATE	5/9/11
----------------	--	-------------	--------

WORK OBSERVED
Phase II – Roof Audit, Existing Conditions Units 1 through 8

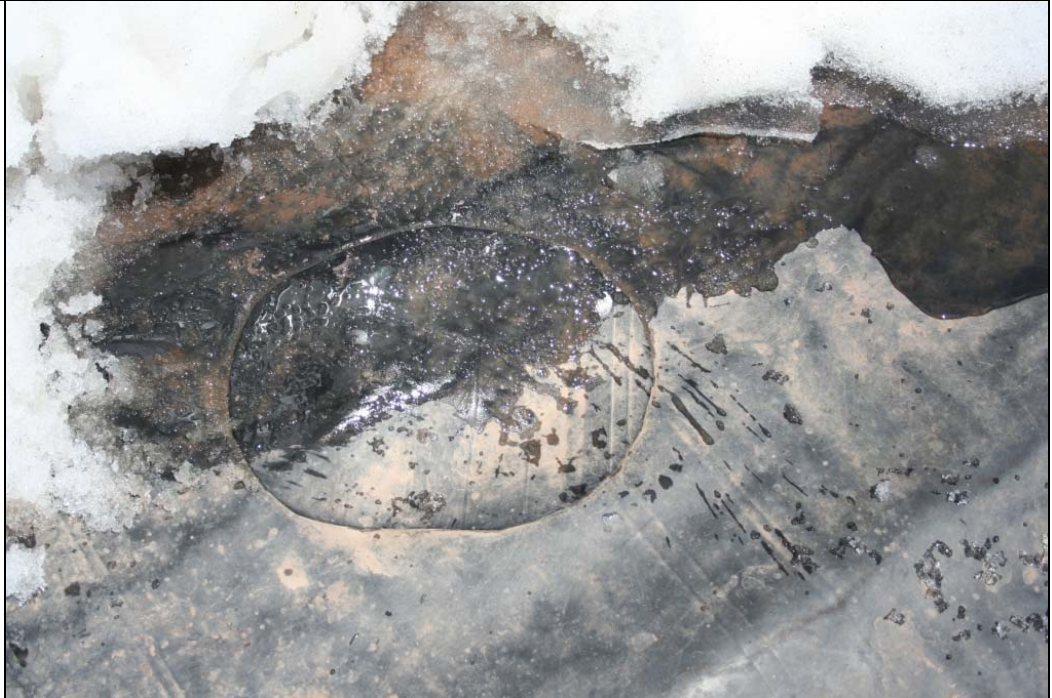
**Unit 1
Photo 5**

Notes: Detail of large patch northeast of drain.

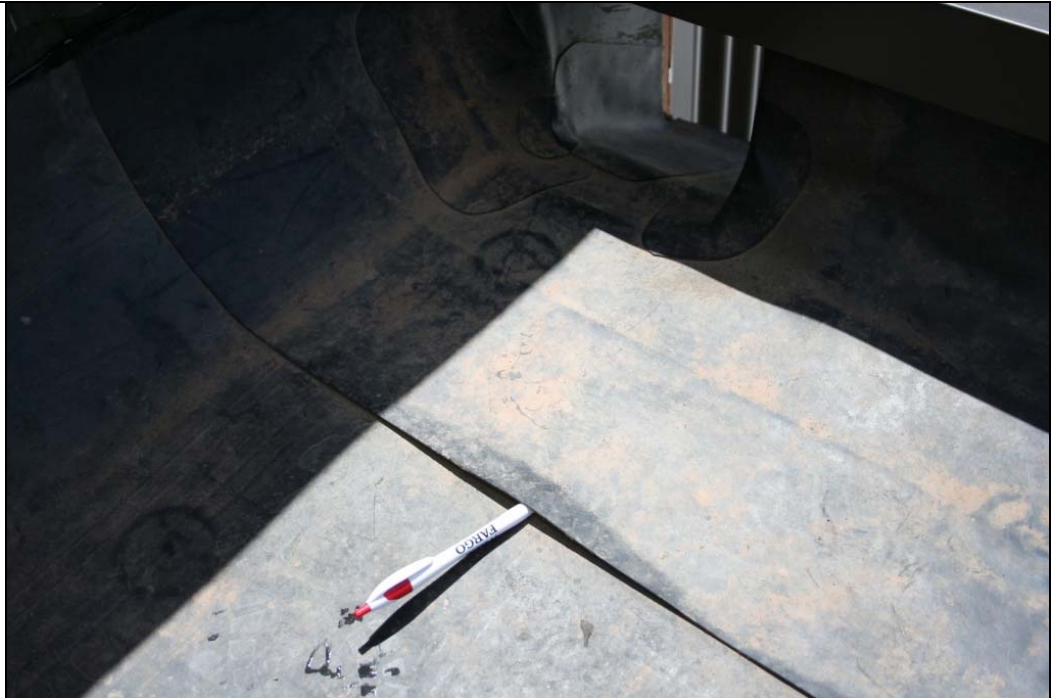
**Unit 3
Photo 3**

Notes: Seam near overflow scupper not fully adhered.

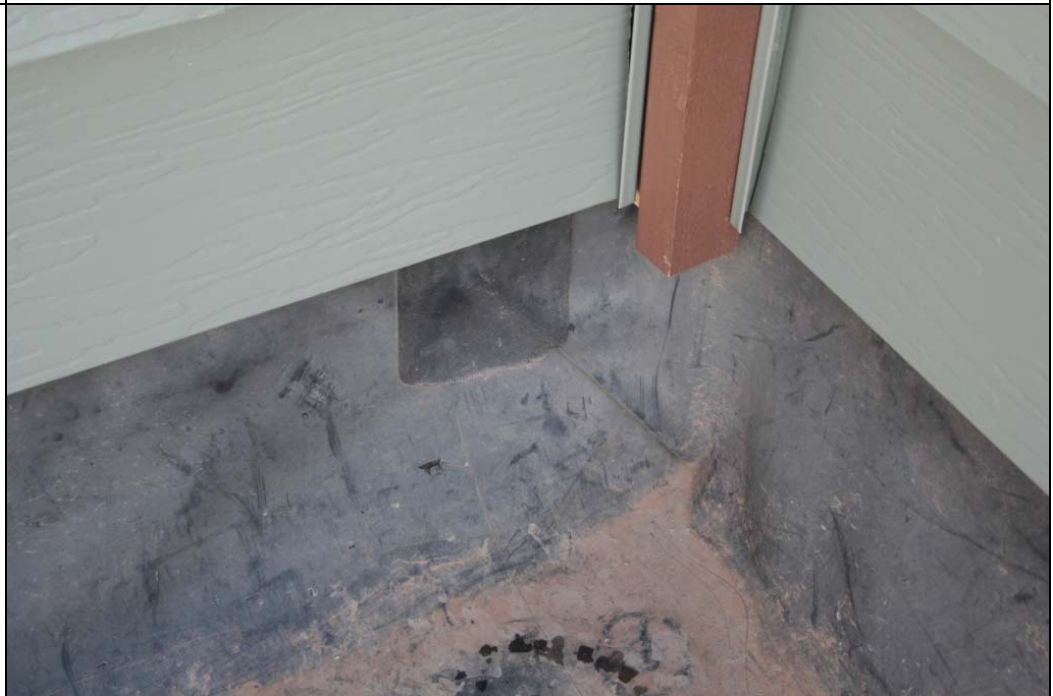
**Unit 5
Photo 4**

Notes: Patch in southeast corner.

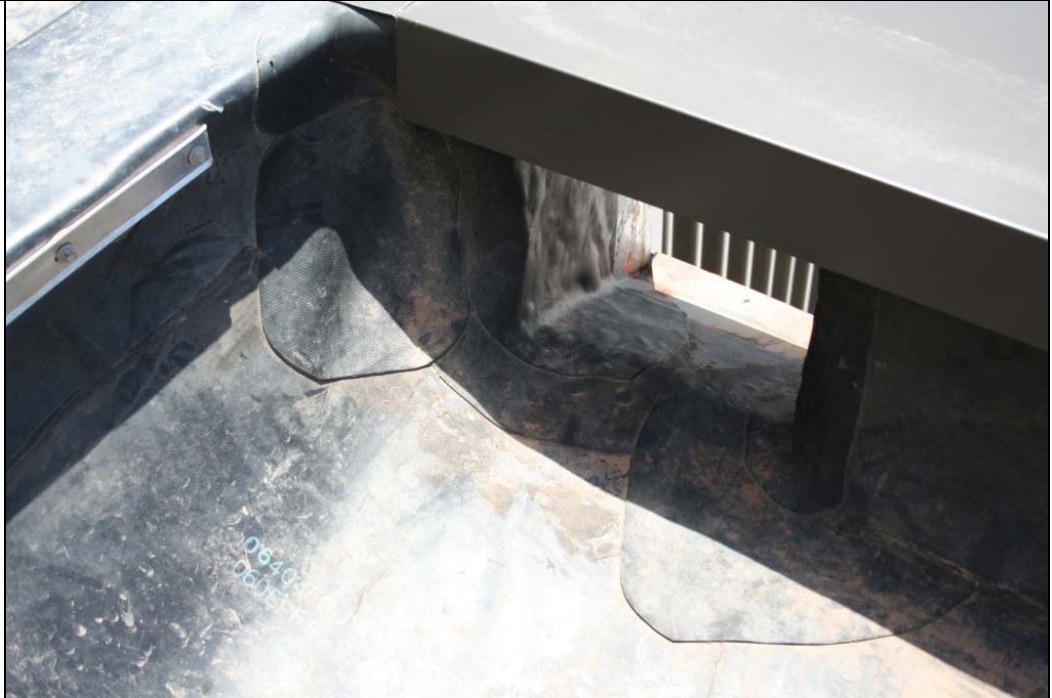
**Unit 6
Photo 3**

Notes: Construction patches at overflow scupper.

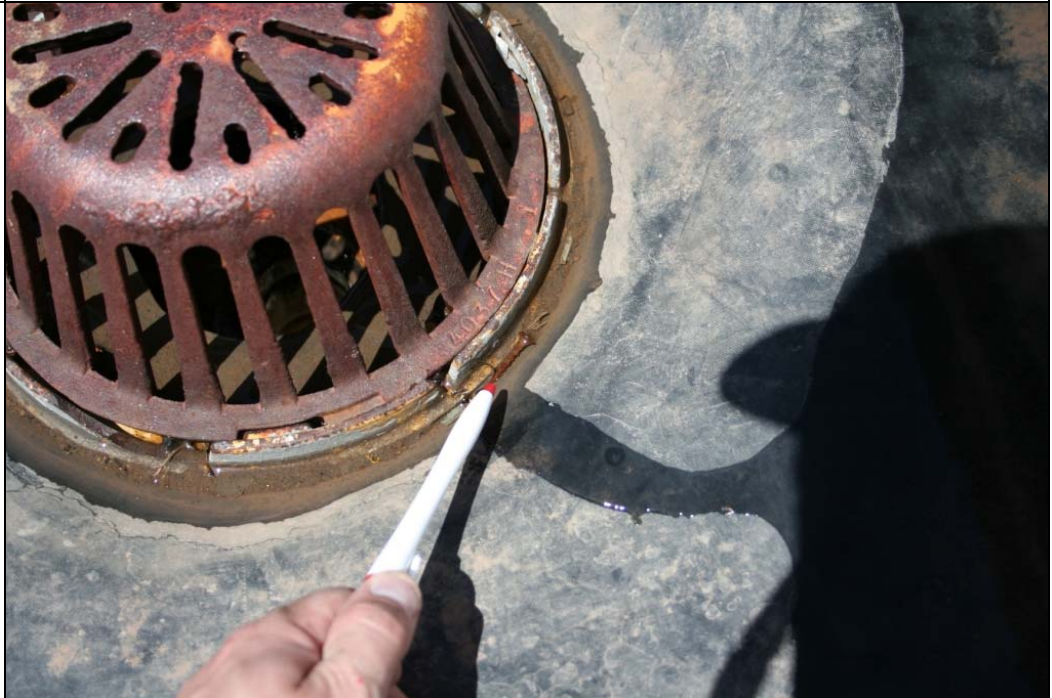
**Unit 6
Photo 4**

Notes: 1 screw located adjacent to drain. Removed.

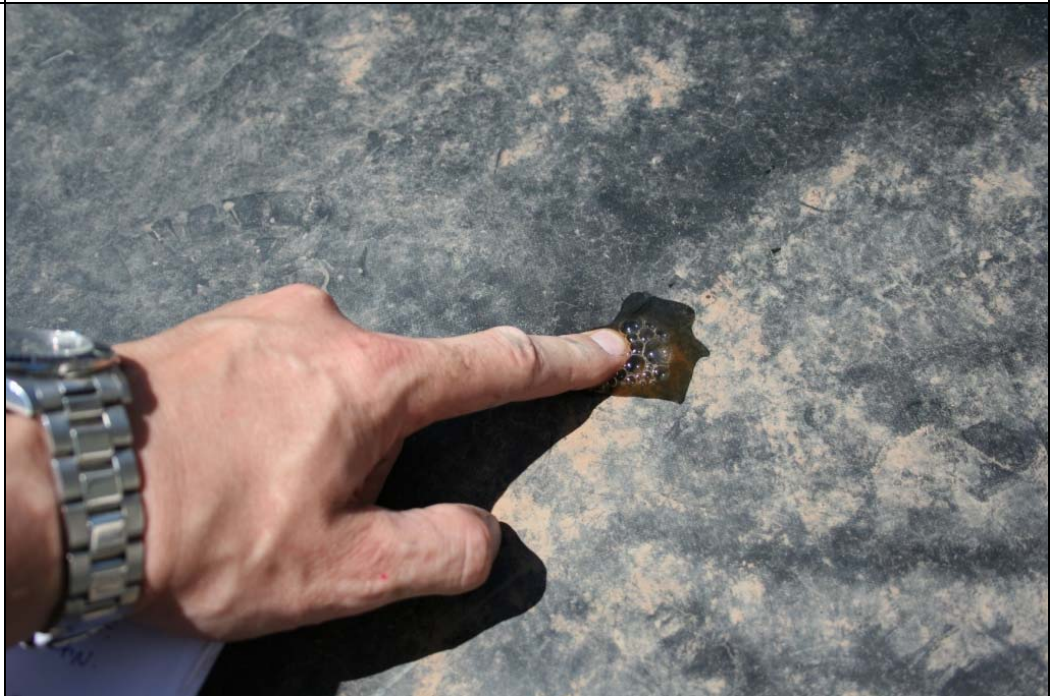
**Unit 7
Photo 3**

Notes: Hole #1 located north of drain.

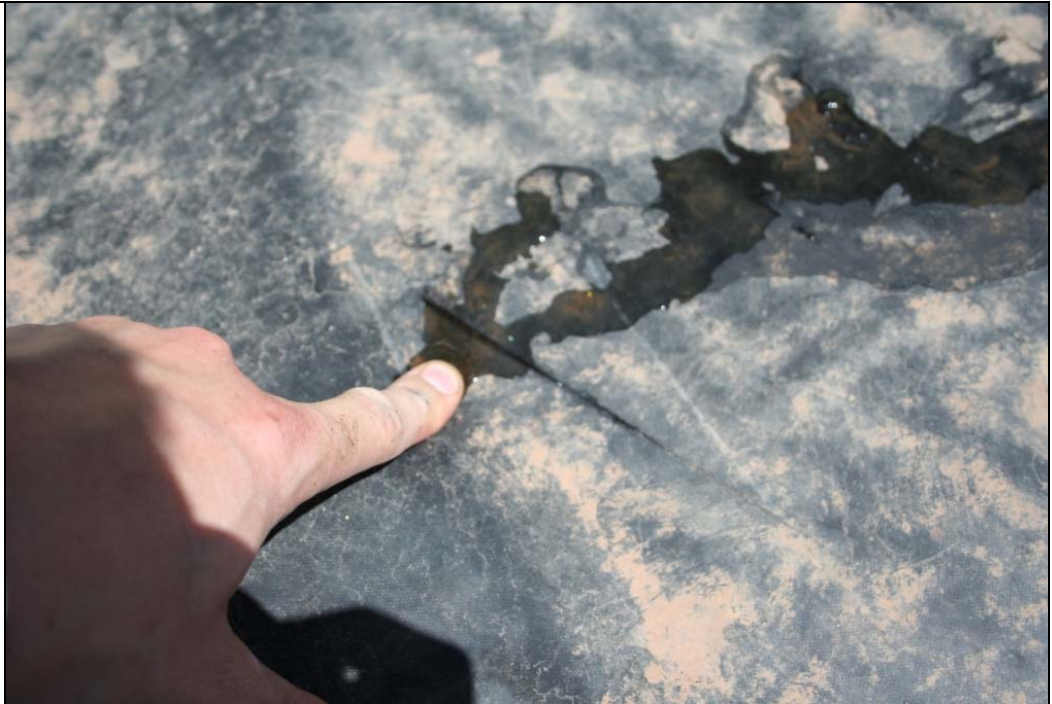
**Unit 7
Photo 1**

Notes: Gash located west of drain.

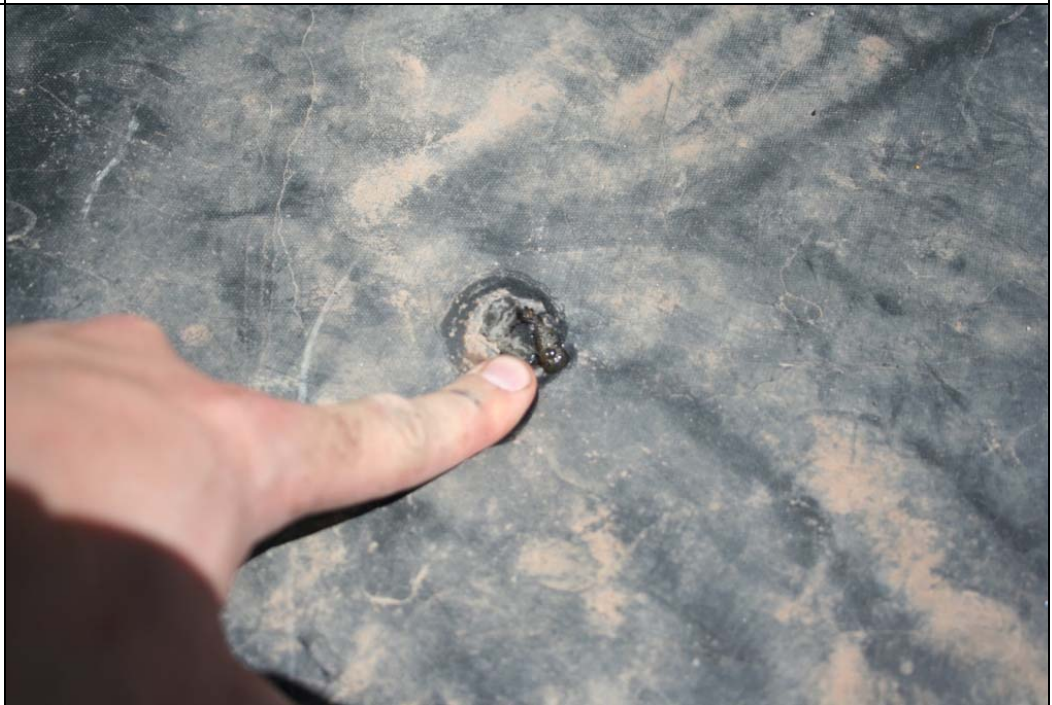
**Unit 7
Photo 2**

Notes: Hole #2 located northeast of drain. Hole was previously sealed.

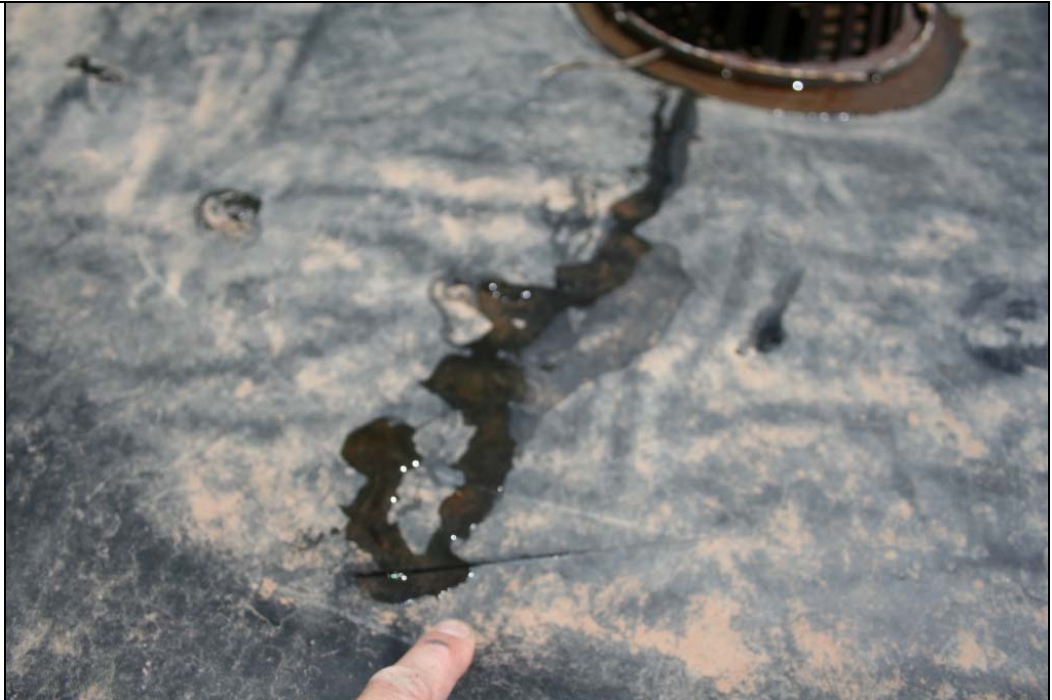
**Unit 7
Photo 5**

Notes: Detail of gash. Substrate is saturated – pressure applied near penetration discharges water.

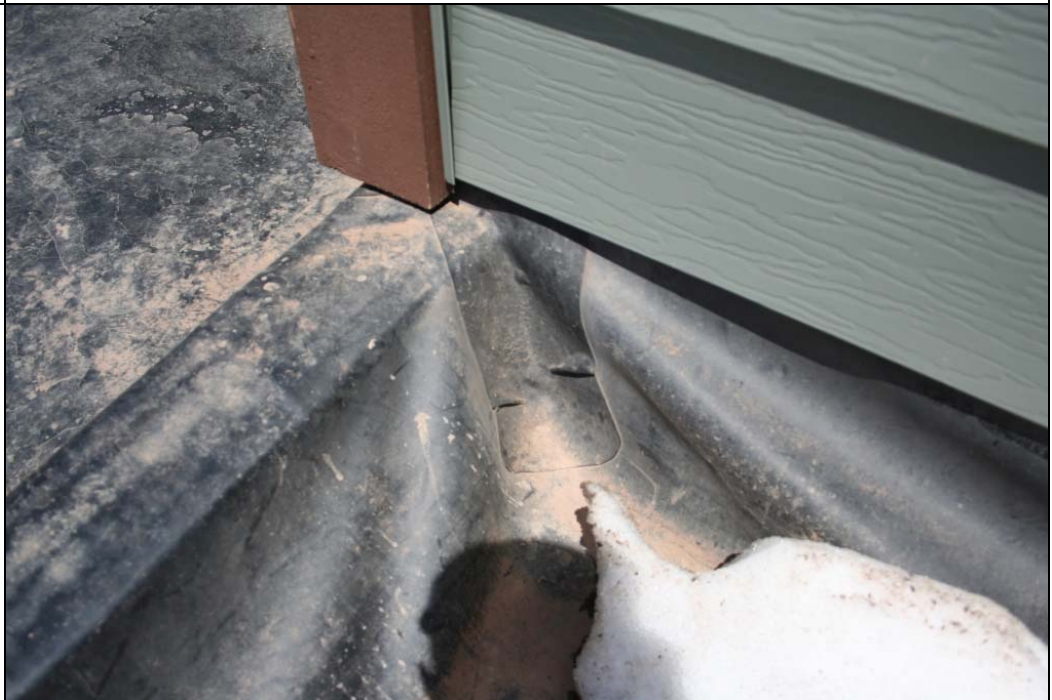
**Unit 7
Photo 6**

Notes: Construction seam in northeast corner.

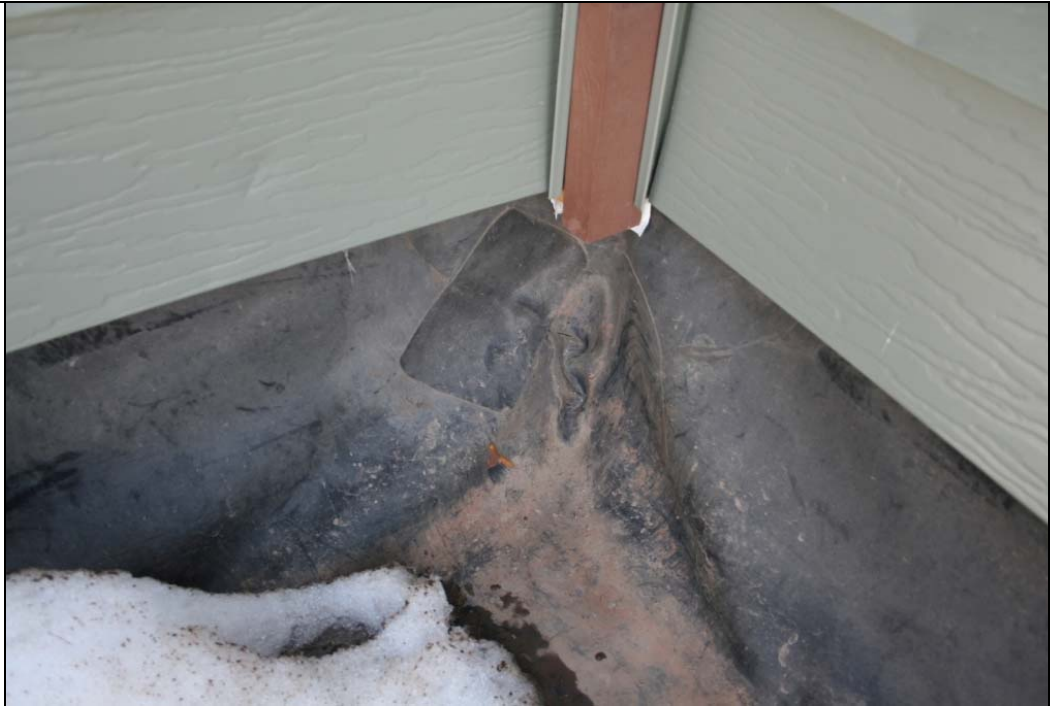
**Unit 7
Photo 7**

Notes: Construction seam in southeast corner.

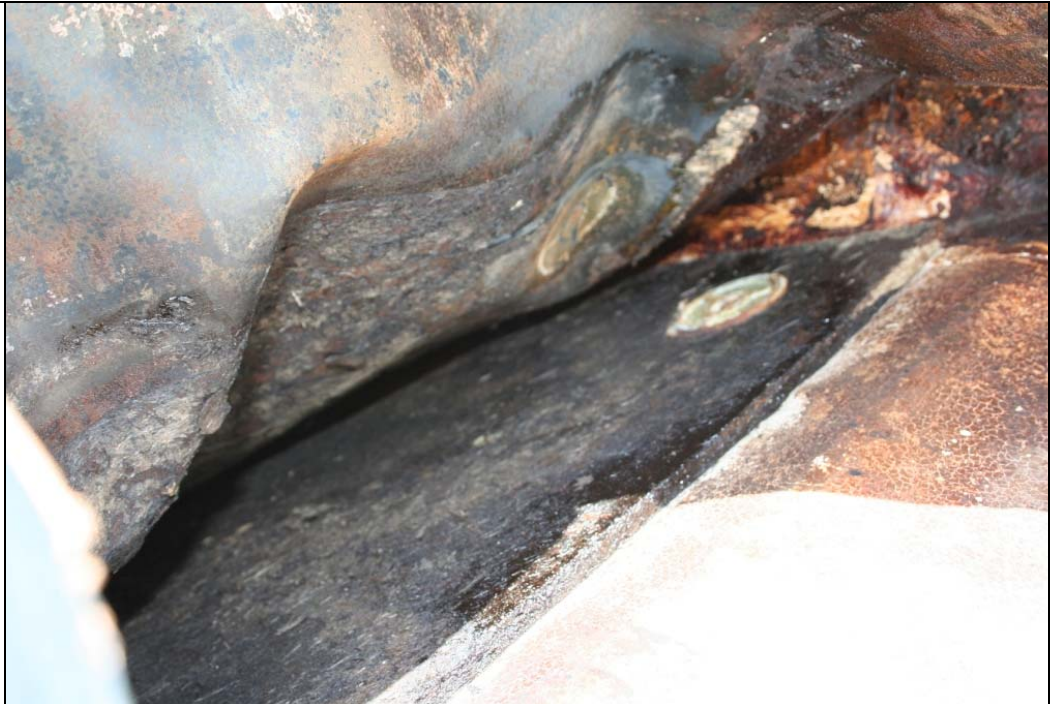
**Unit 9
Photo 3**

Notes: Membrane is detached at the overflow scupper. Note membrane is no longer adhered to the substrate.

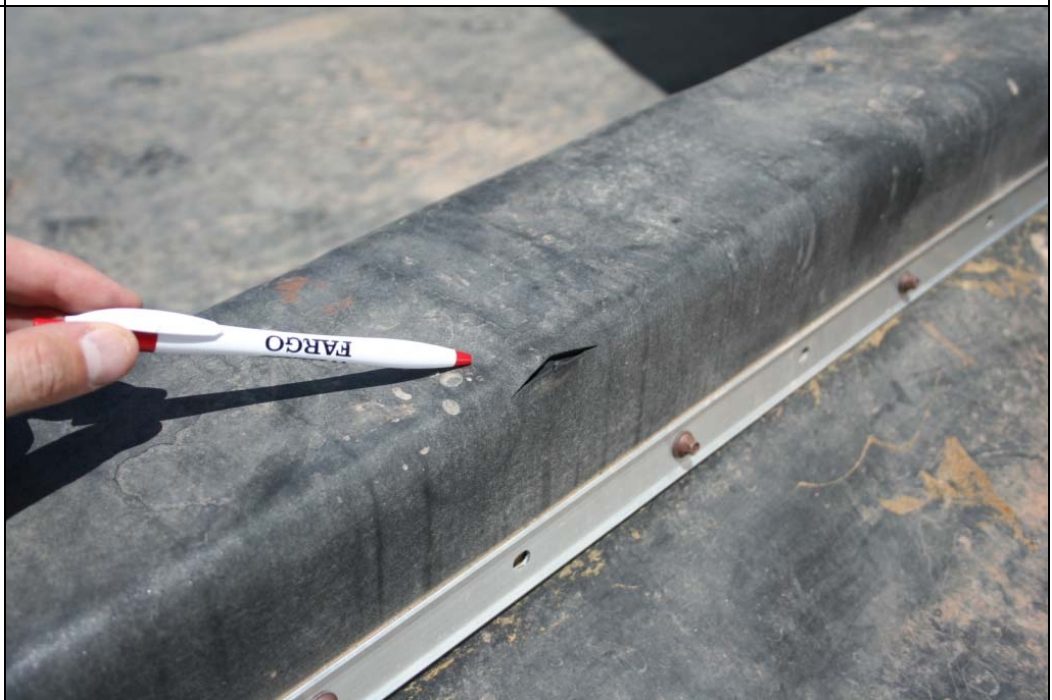
**Unit 9
Photo 4**

Notes: Gash in north parapet wall.

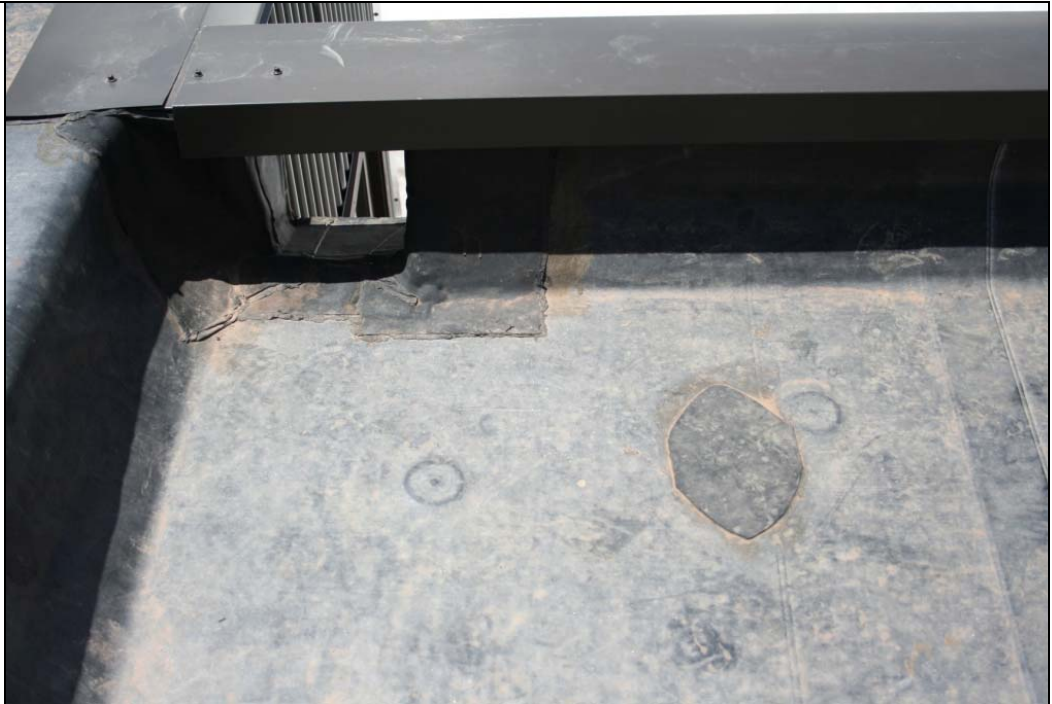
**Unit 10
Photo 3**

Notes: 2 patches located near overflow scupper.

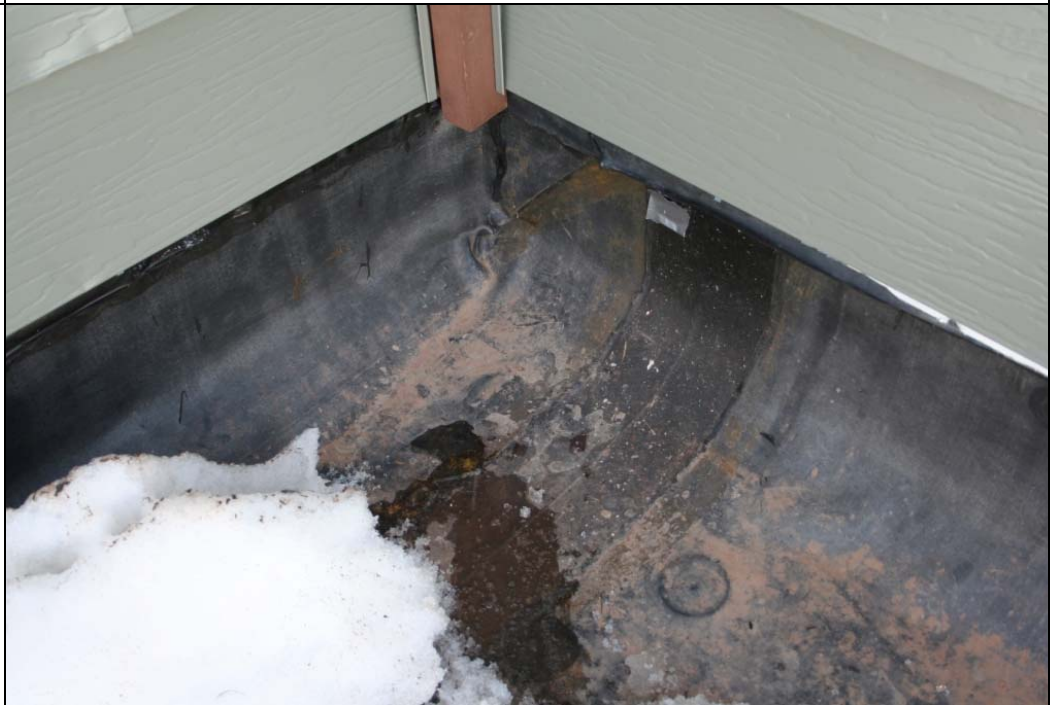
**Unit 10
Photo 4**

Notes: Unknown seam construction along east portion of roof.

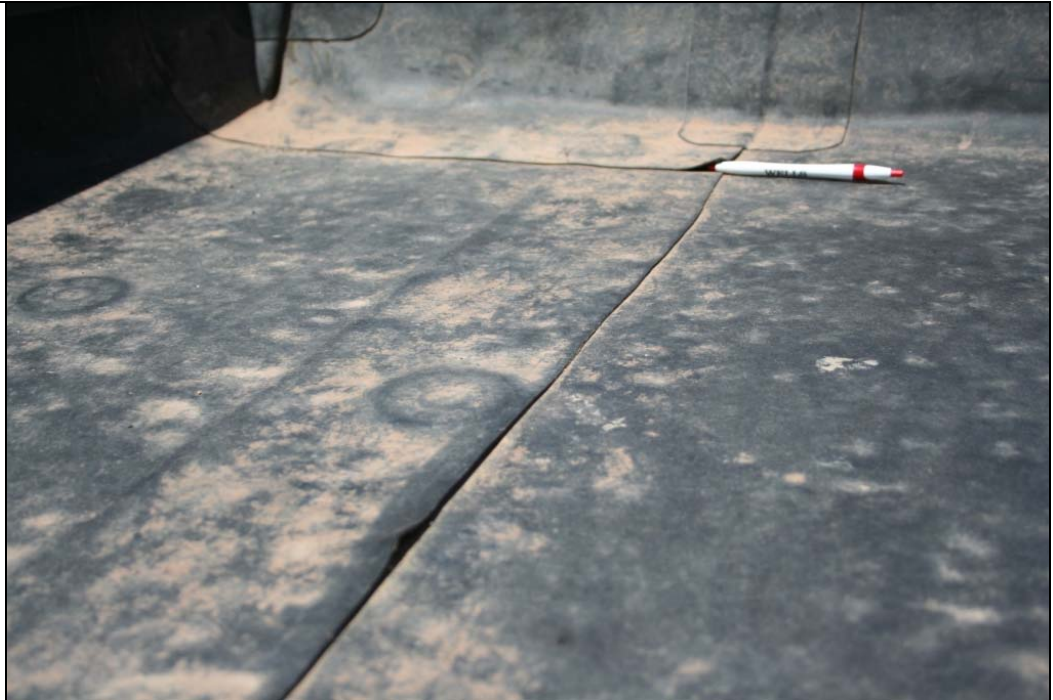
**Unit 11
Photo 5**

Notes: Seams not fully adhered.

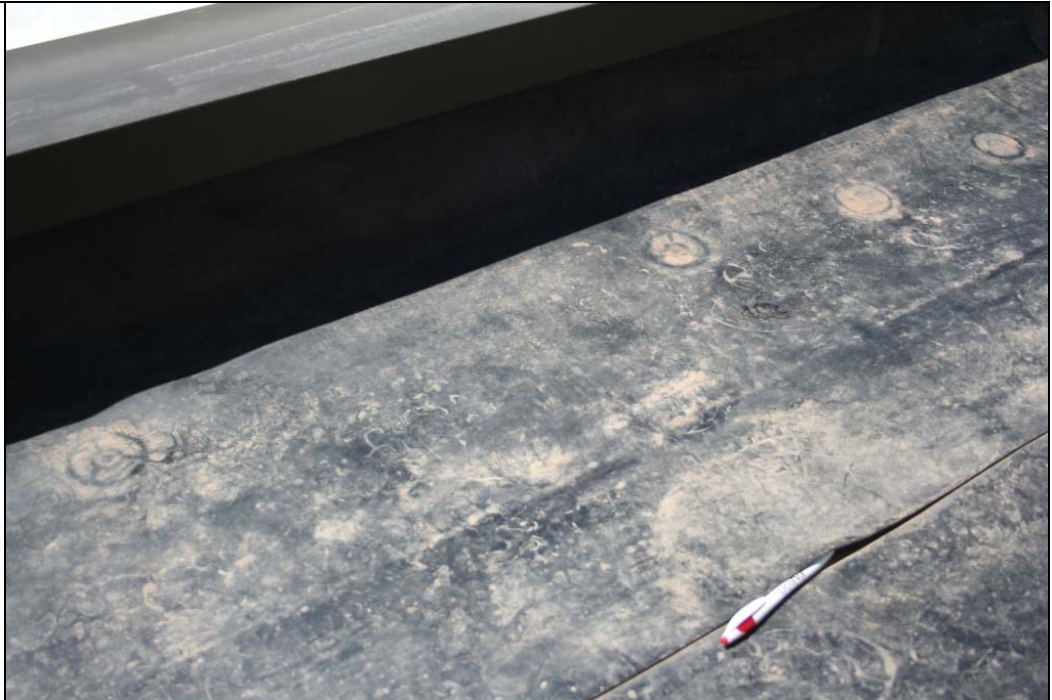
**Unit 16
Photo 4**

Notes: Seam not fully adhered.

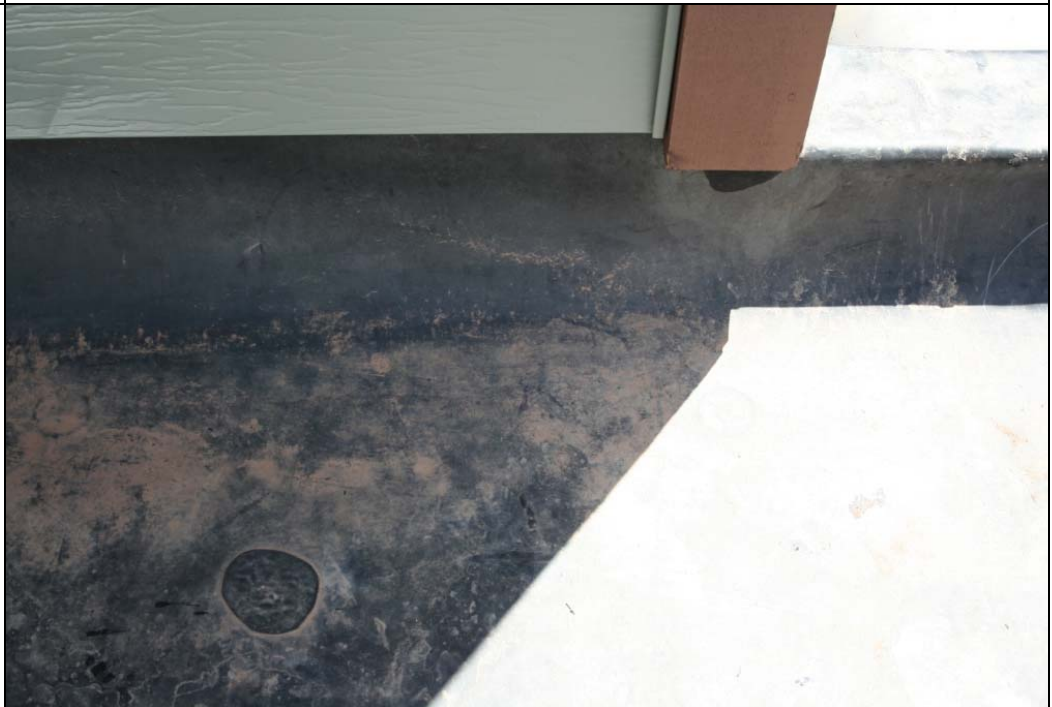
**Unit 16
Photo 5**

Notes: Patch located along south wall.

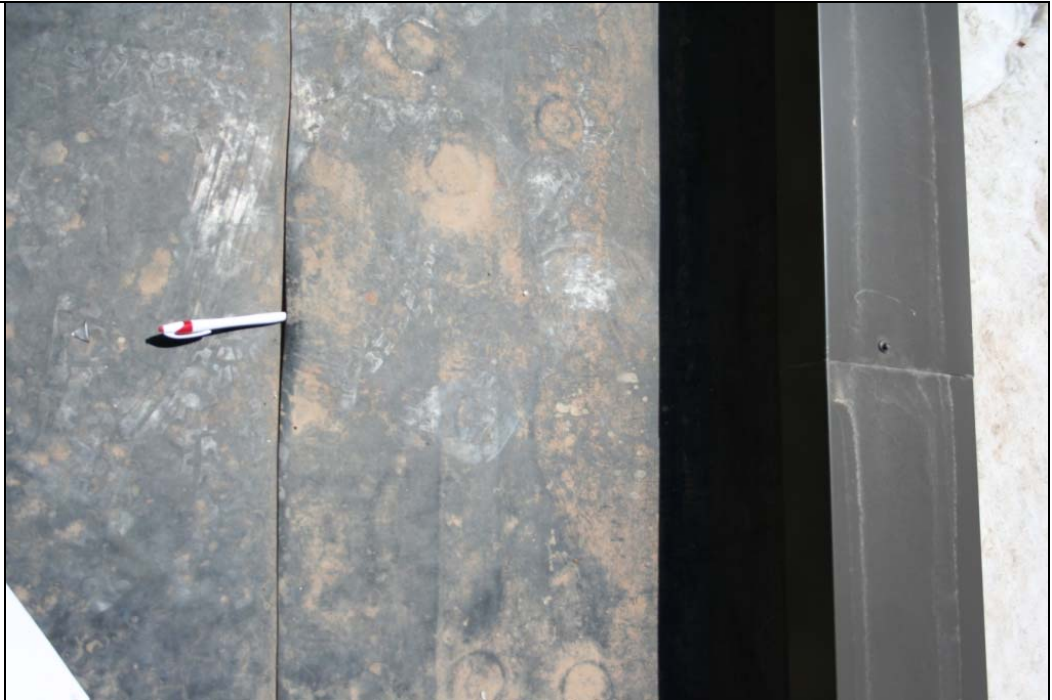
**Unit 16
Photo 6**

Notes: Seam not fully adhered.

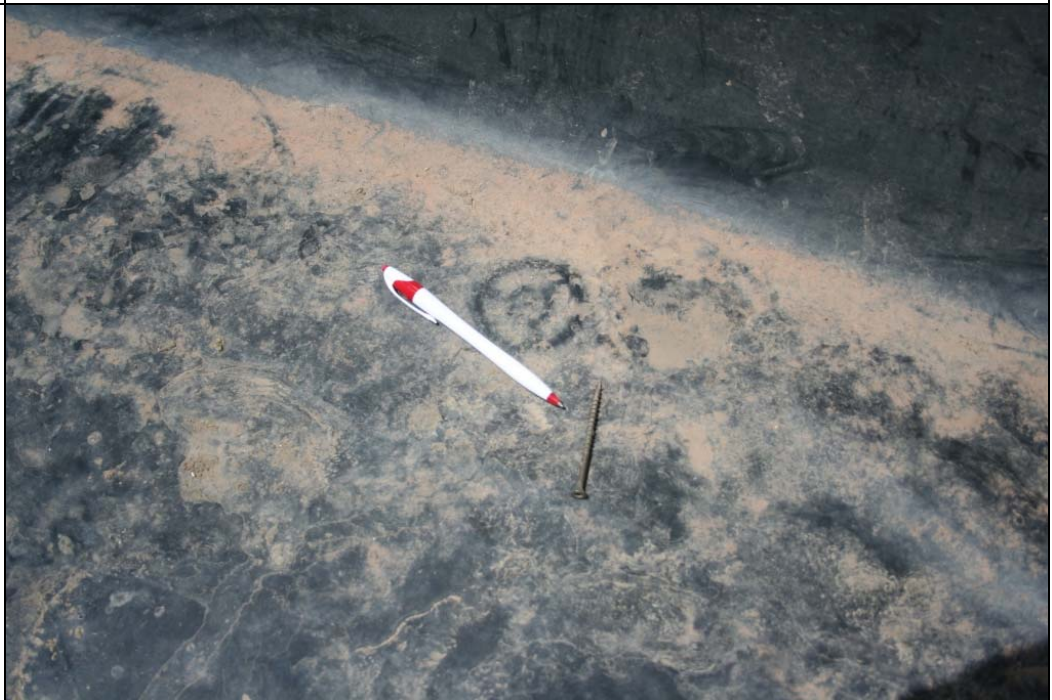
**Unit 16
Photo 7**

Notes: Screw located on roof. Removed.

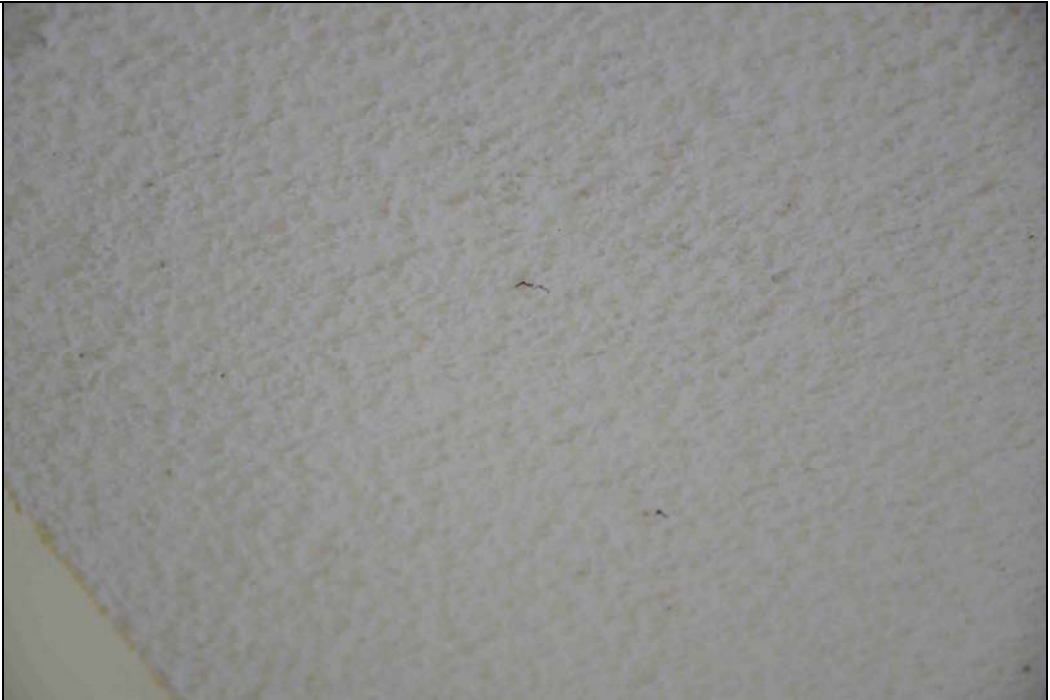
Unit 16
Photo 8

Notes: CBL Interior photo of nail heads protruding through drywall ceiling.

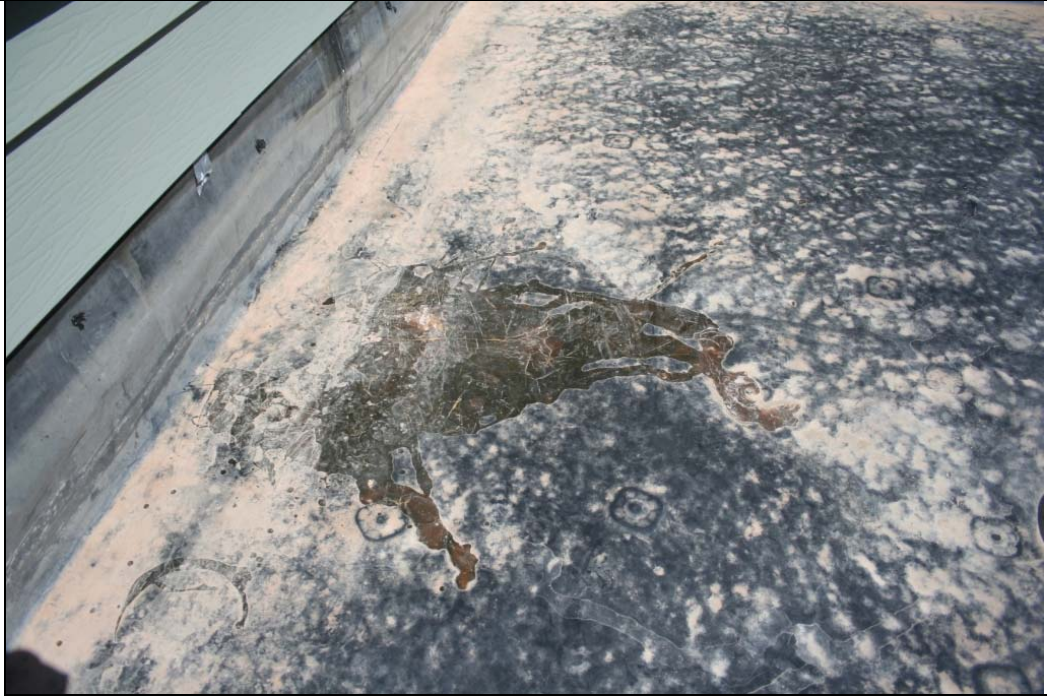
**Unit 17
Photo 3**

Notes: Unidentified spill. Dry.

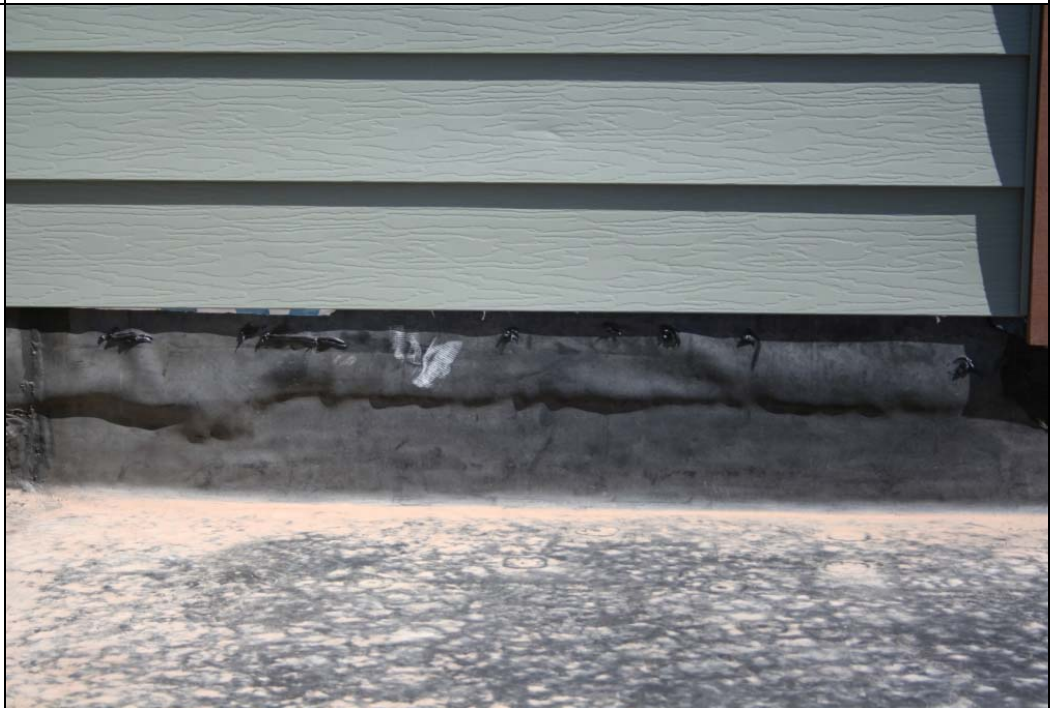
**Unit 17
Photo 6**

Notes: Nail holes/penetrations have been sealed along the perimeter.

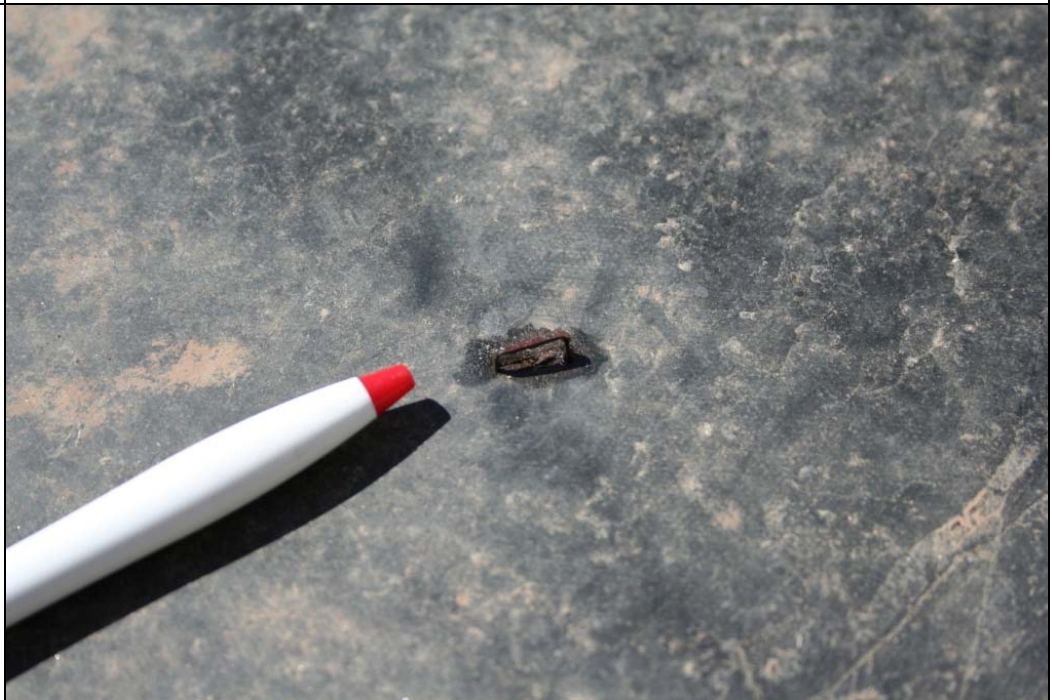
Unit 19
Photo 4

Notes: Detail of staple from Photo 3.

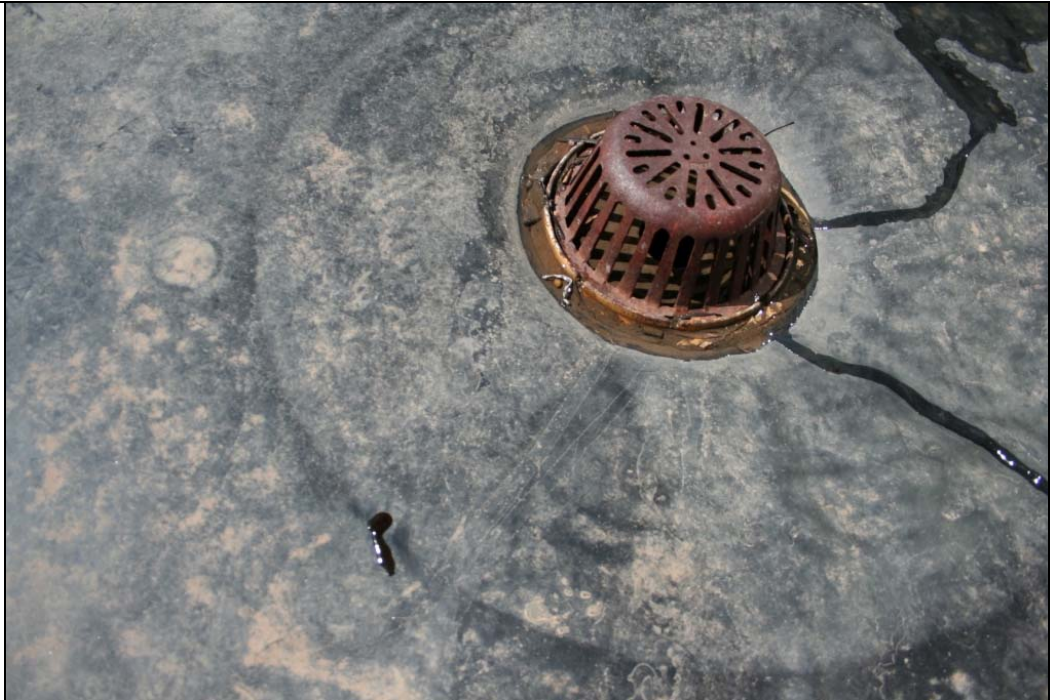
**Unit 19
Photo 5**

Notes: Staple was removed. Saturated substrate discharges water when pressure was applied adjacent to the hole.

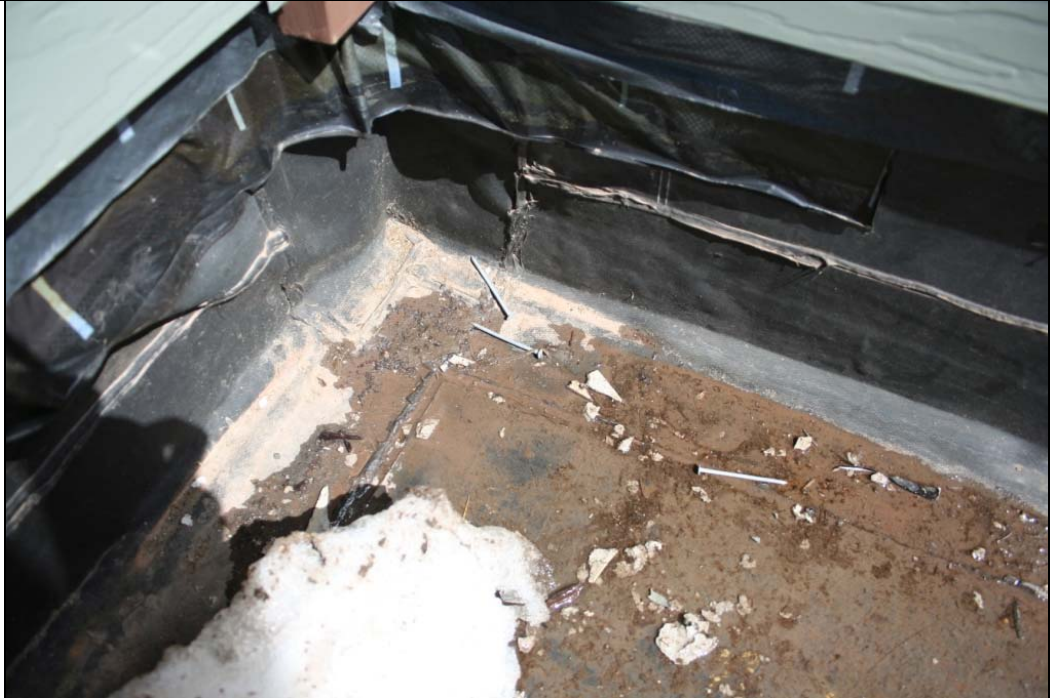
**Unit 20
Photo 3**

Notes: Debris located in southeast corner. Three nails were removed.

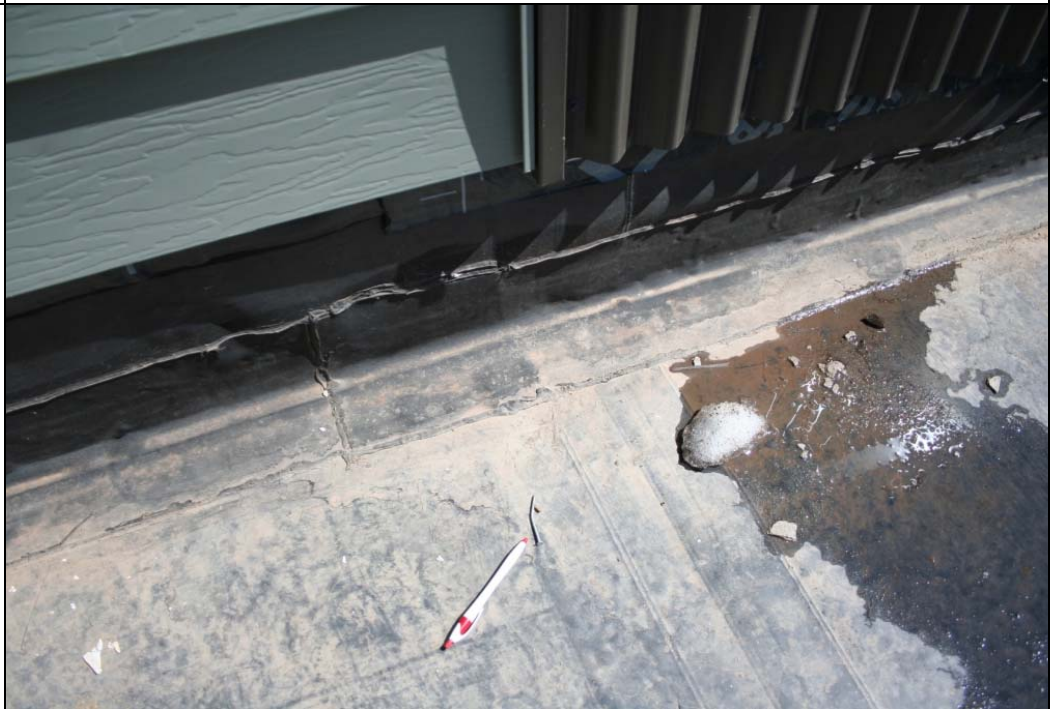
**Unit 20
Photo 4**

Notes: Additional nail located along the south wall. Removed.

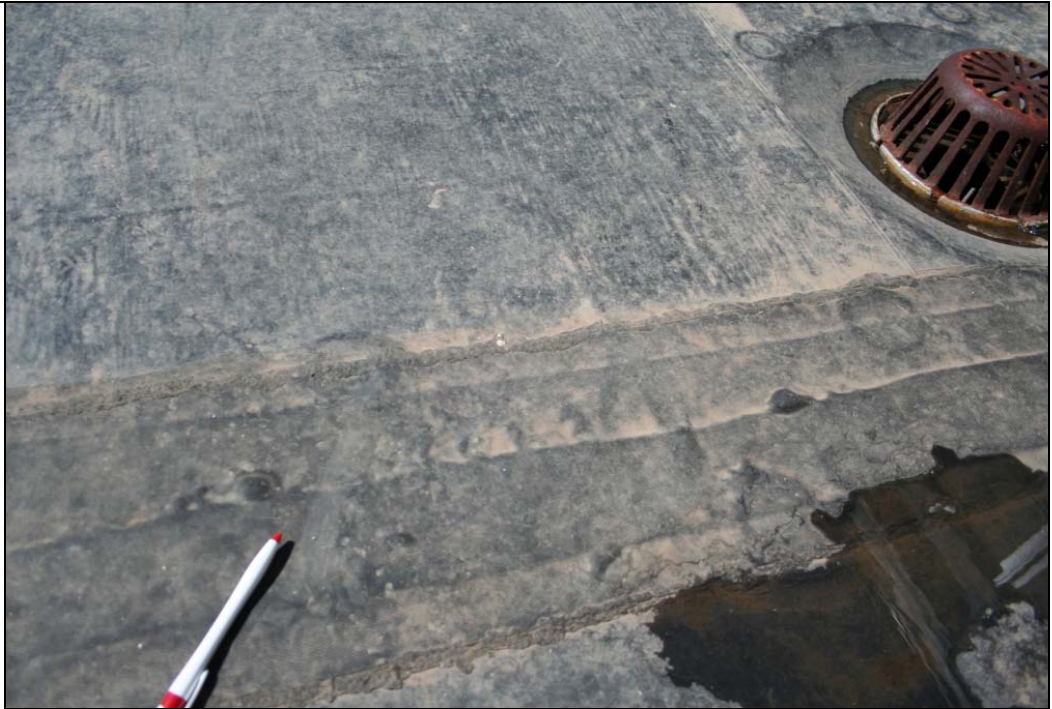
**Unit 20
Photo 7**

Notes: Bubbling in seam. Multiple locations.

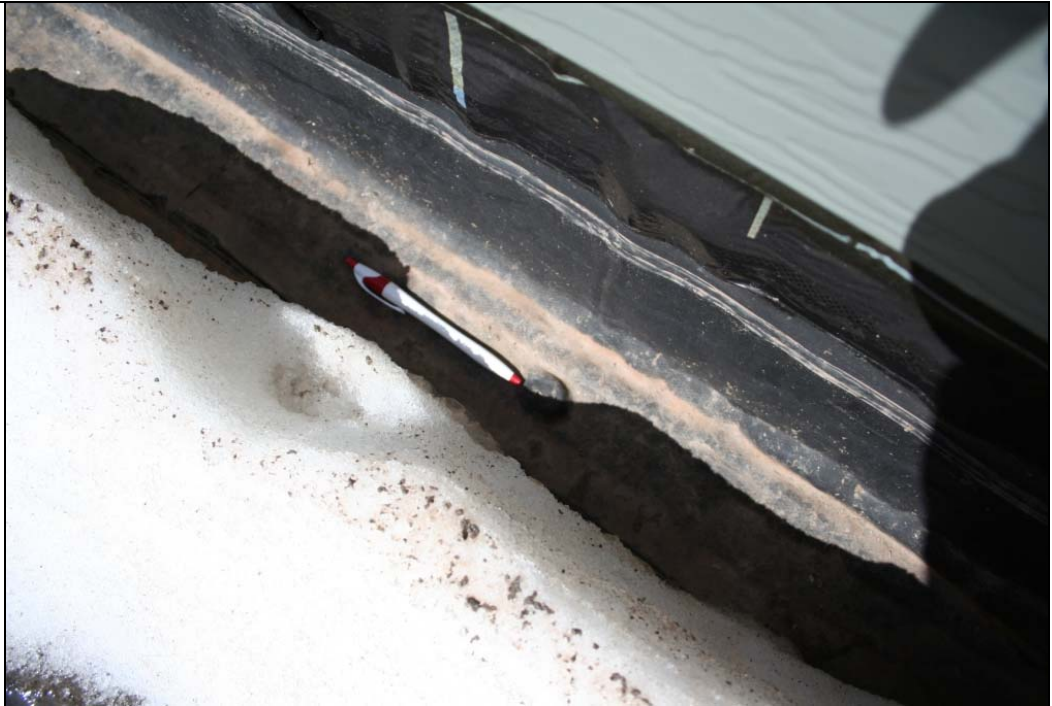
**Unit 20
Photo 9**

Notes: Bubble in seam visible against wall under window.

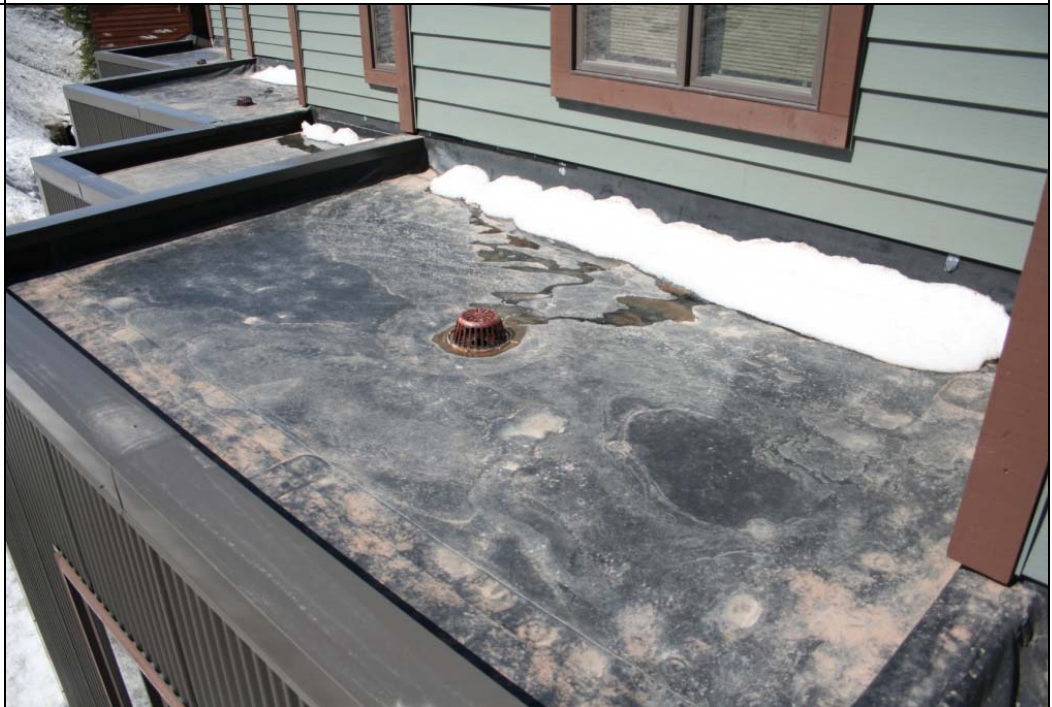
**Unit 21
Photo 1**

Notes: Roof Photo #1.
