ARCHITECT'S FIELD REPORT

PROJECT	Eagle's Nest Townhouses 11 Morning Glory Way & 31 Marcellina Lane Mt. Crested Butte, CO 81225	DATE	5/9/11
----------------	--	-------------	--------

WORK OBSERVED
Phase II – Roof Audit, Existing Conditions Units 1 through 8

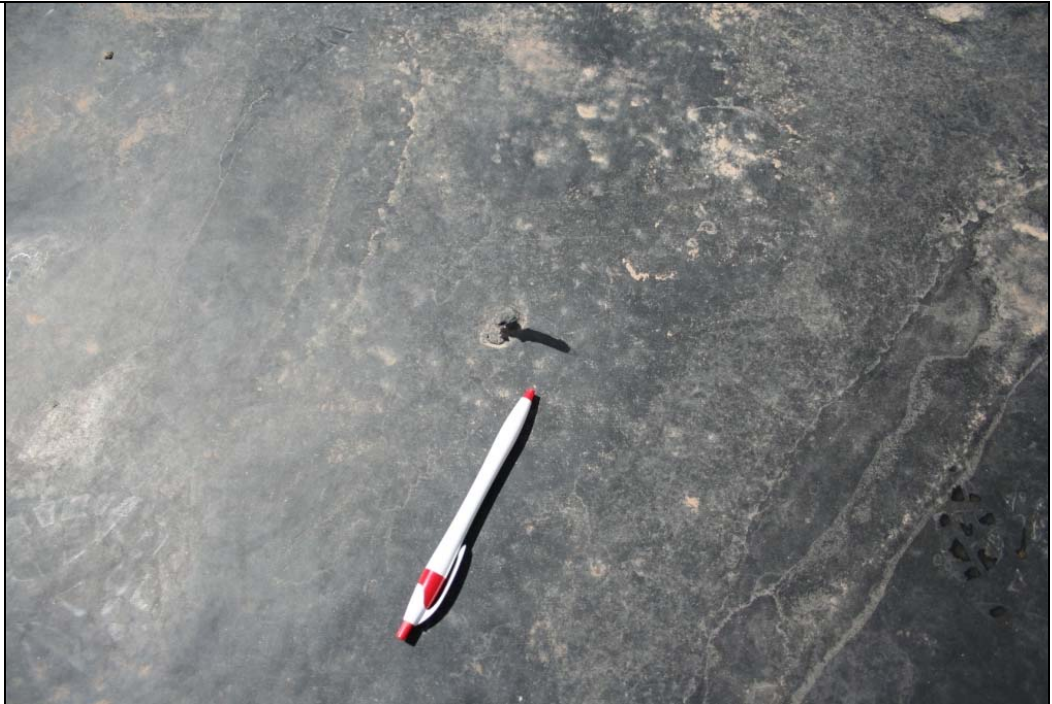
**Unit 21
Photo 4**

Notes: Detail of hole in Photo 4. This hole appears to have been previously sealed. Water discharge from saturated substrate.

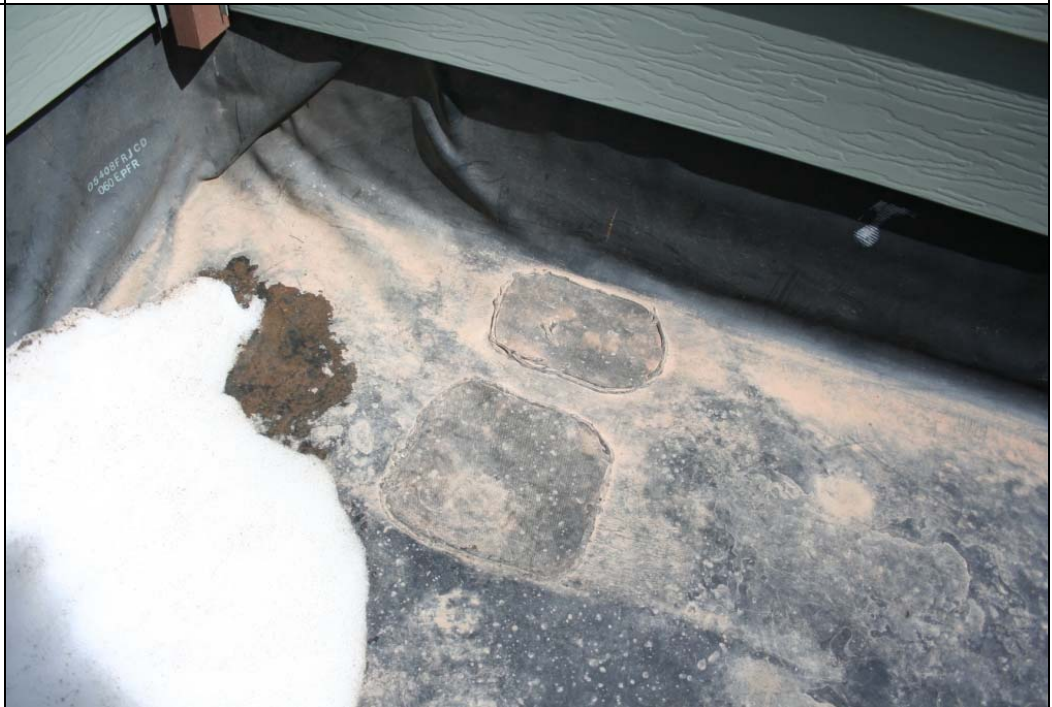
**Unit 21
Photo 5**

Notes: 2 patches located in the southeast corner.

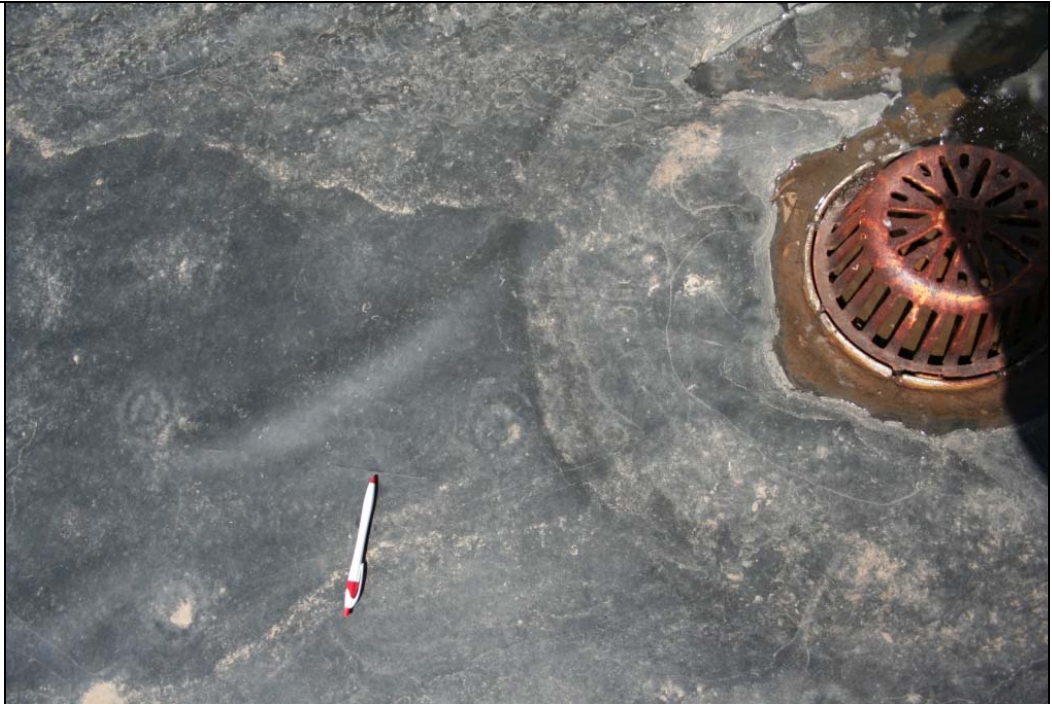
**Unit 21
Photo 6**

Notes: Surface cut 1' north of roof drain. Cut does not penetrate the full depth of the membrane.

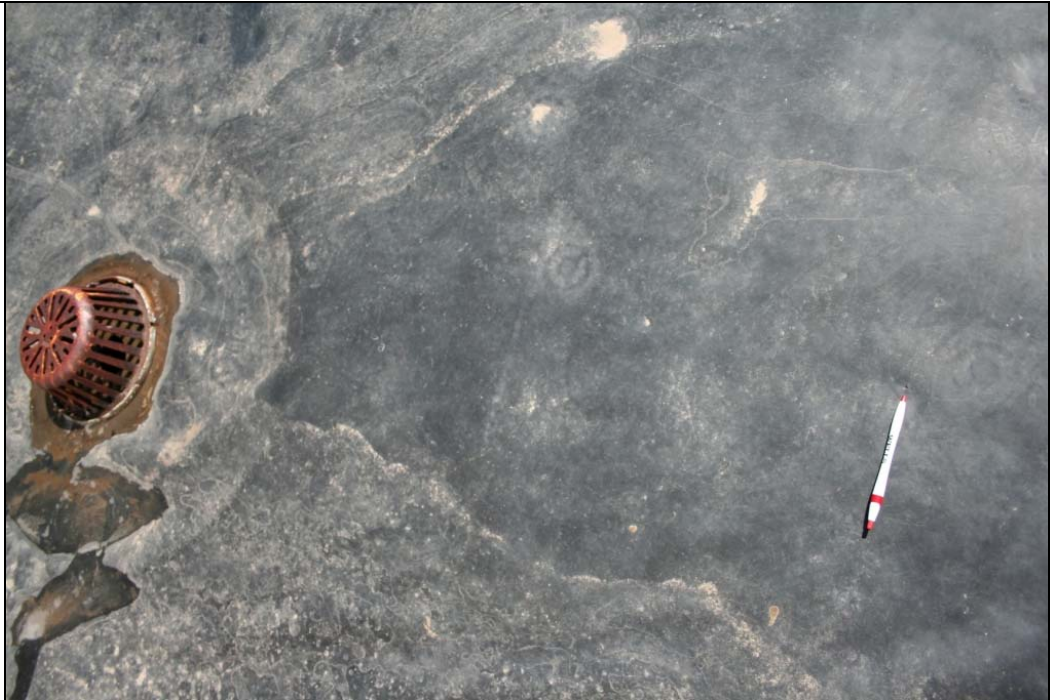
**Unit 21
Photo 8**

Notes: Pin hole in membrane approximately 4' north of roof drain.

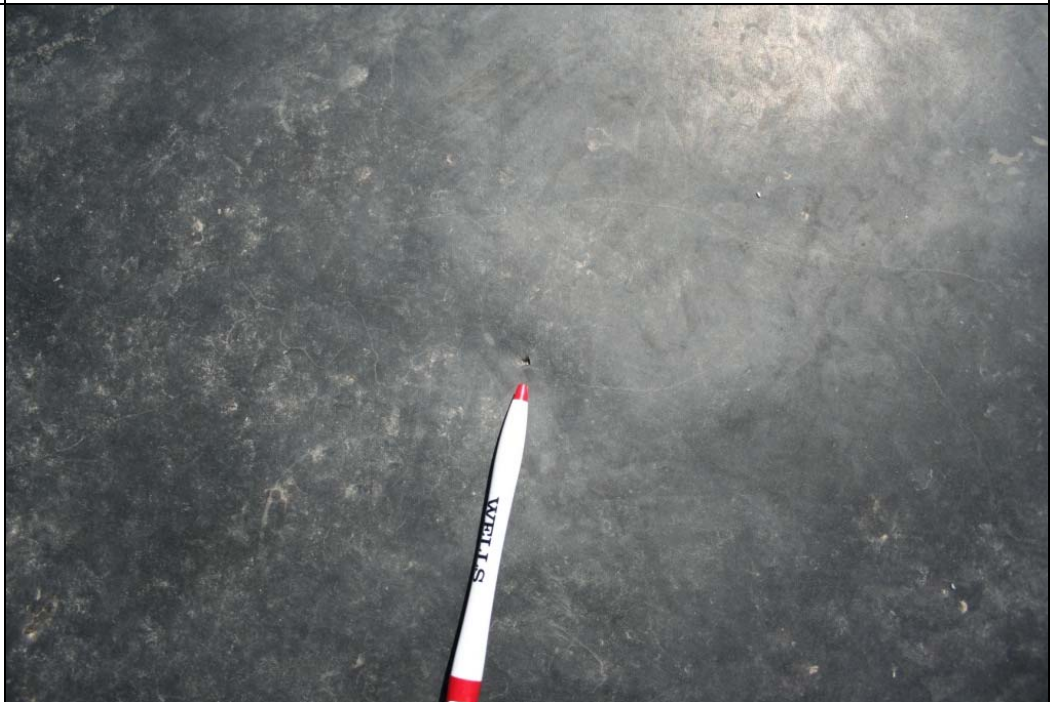
**Unit 21
Photo 9**

Notes: Detail of pin hole in Photo 8.

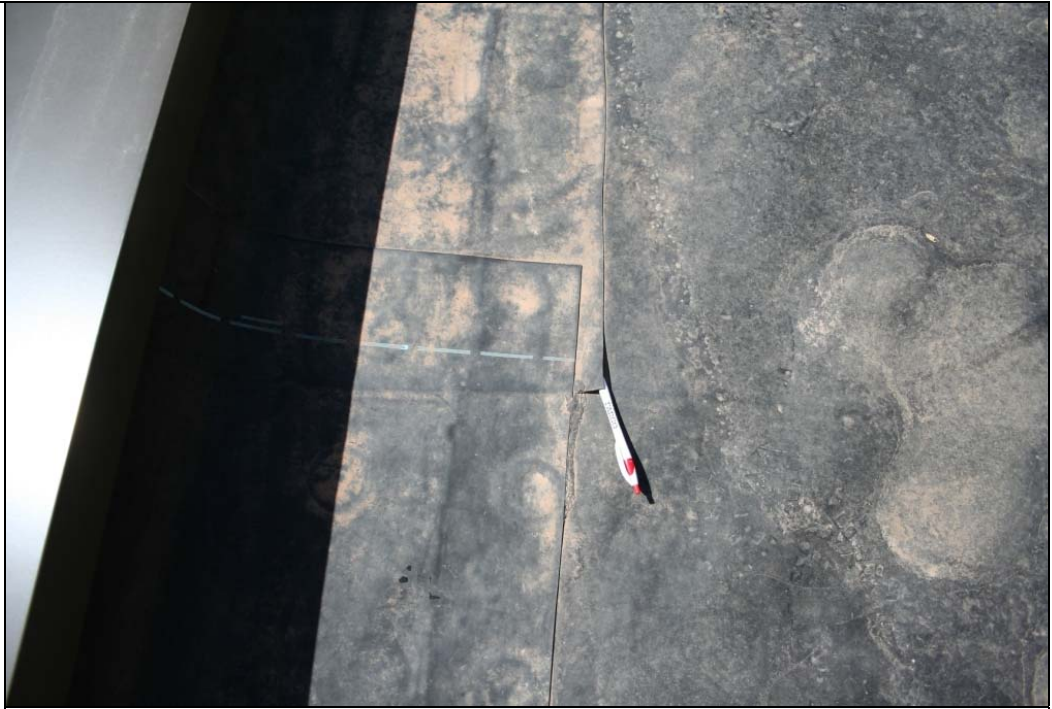
**Unit 22
Photo 3**

Notes: West seam at centerline not fully adhered.

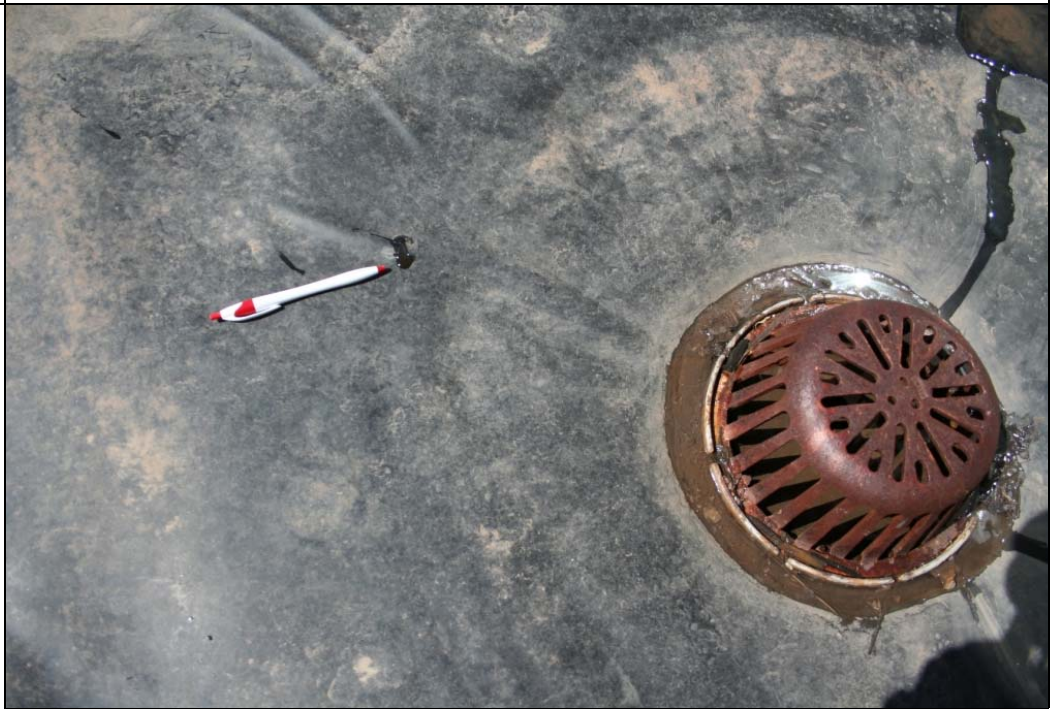
**Unit 22
Photo 4**

Notes: Hole in membrane 1' northwest of drain. Water discharge is from saturated substrate.

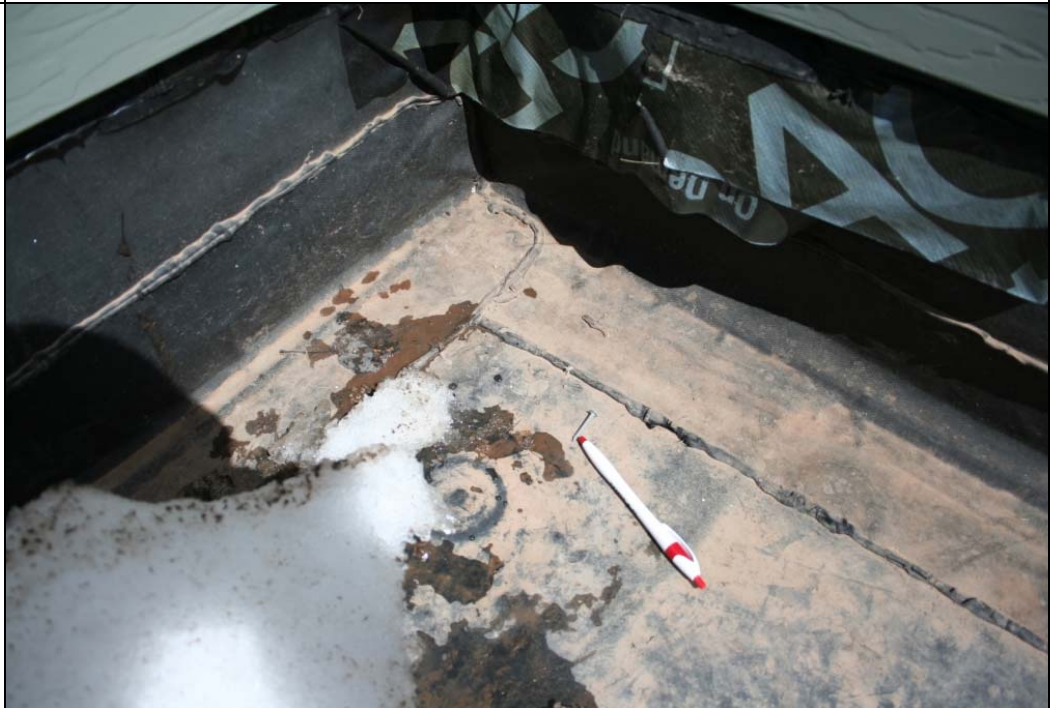
**Unit 23
Photo 7**

Notes: Nail located in southeast corner. Removed.

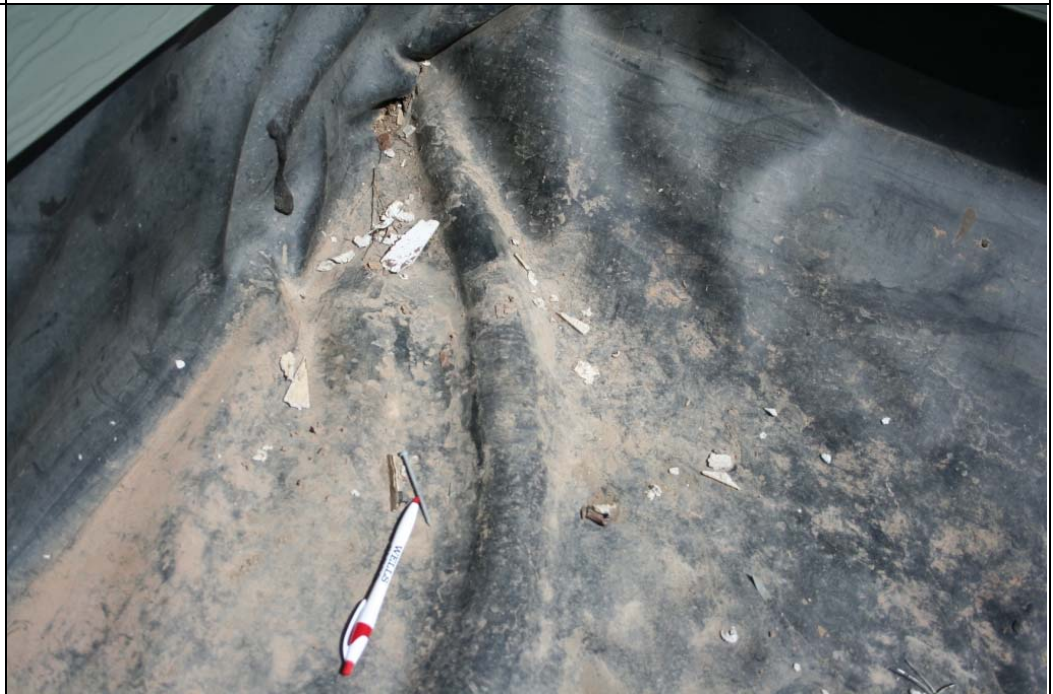
**Unit 6
Photo 3**

Notes: Debris located in southeast corner. 1 nail was removed.

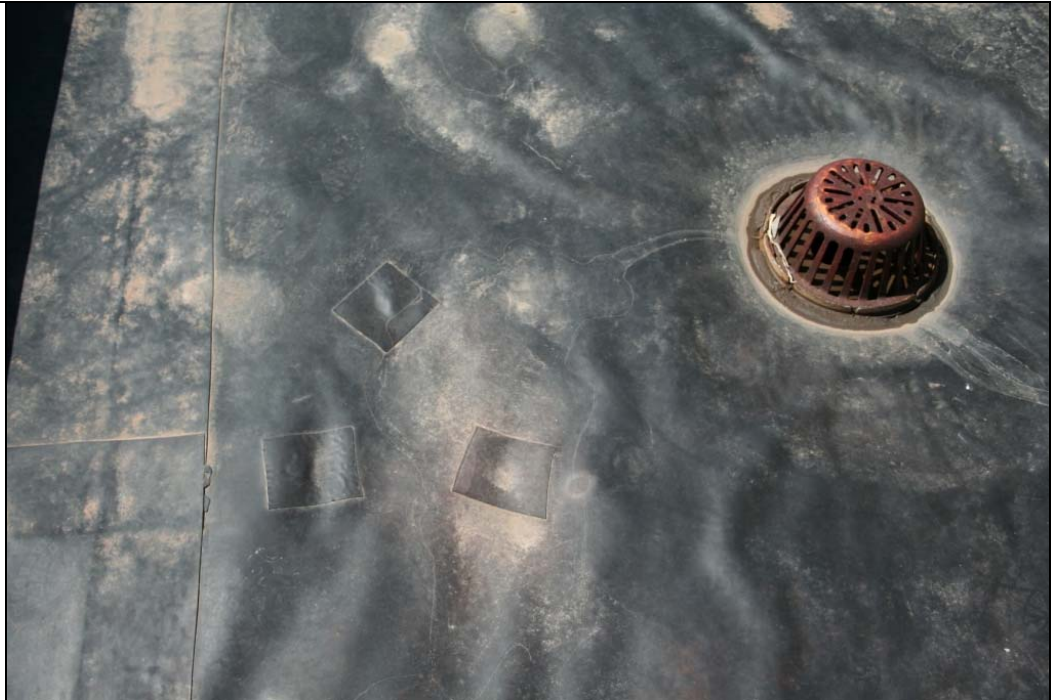
**Unit 26
Photo 4**

Notes: 3 Patches located west of roof drain.

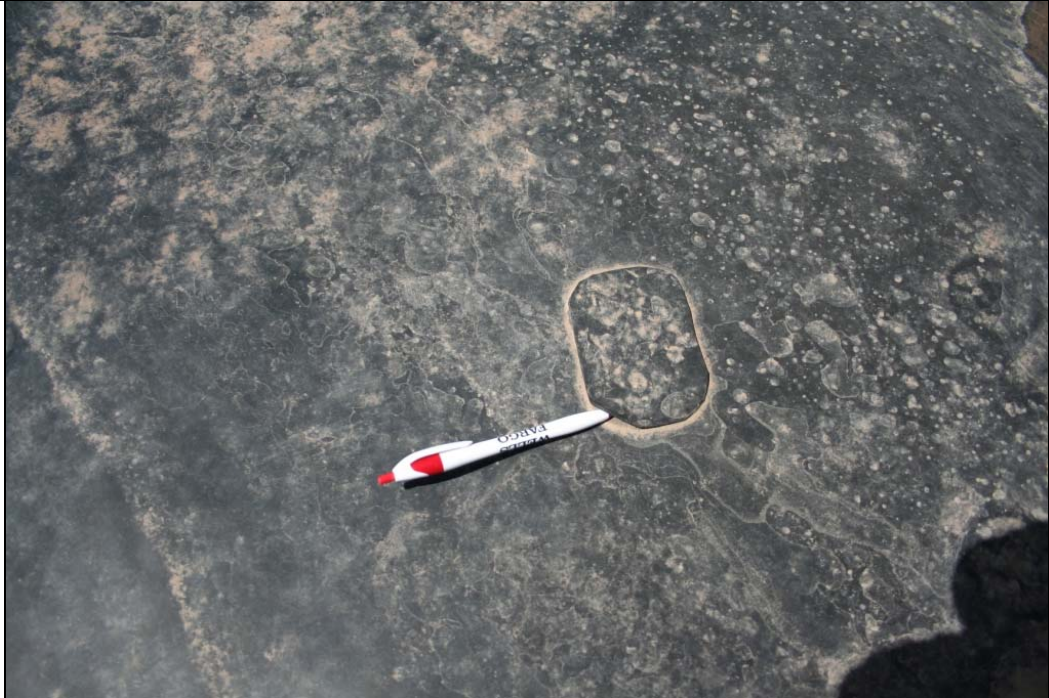
Unit 27
Photo 3

Notes: Patch located 2'-6" north of roof drain. Edge of patch is not fully adhered.

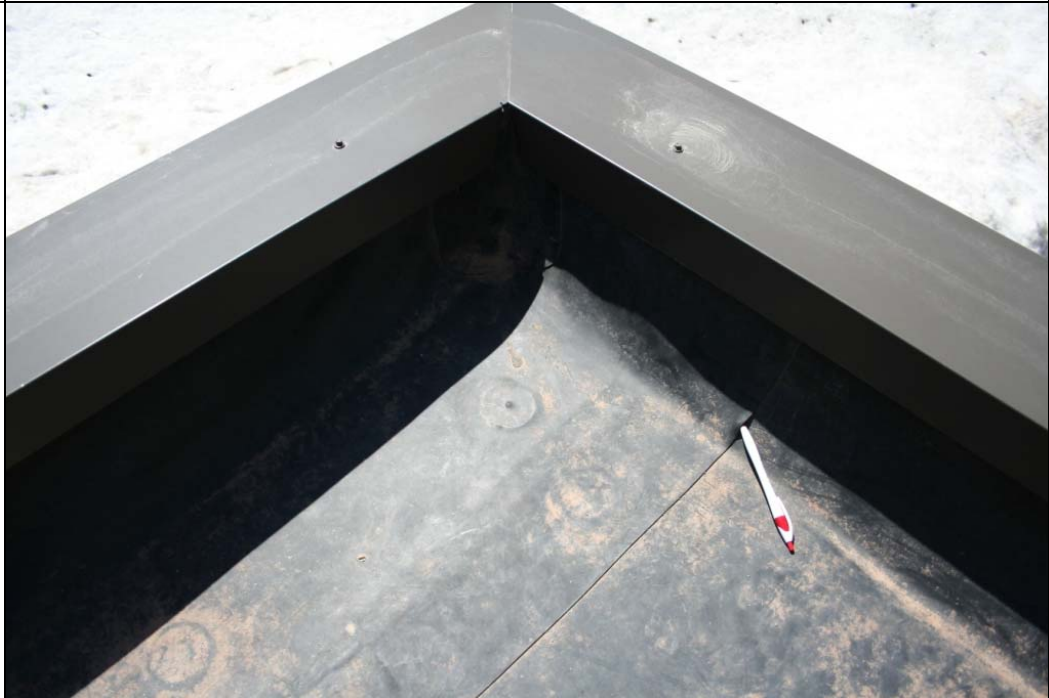
Unit 27
Photo 4

Notes: Seam is not fully adhered in northwest corner.

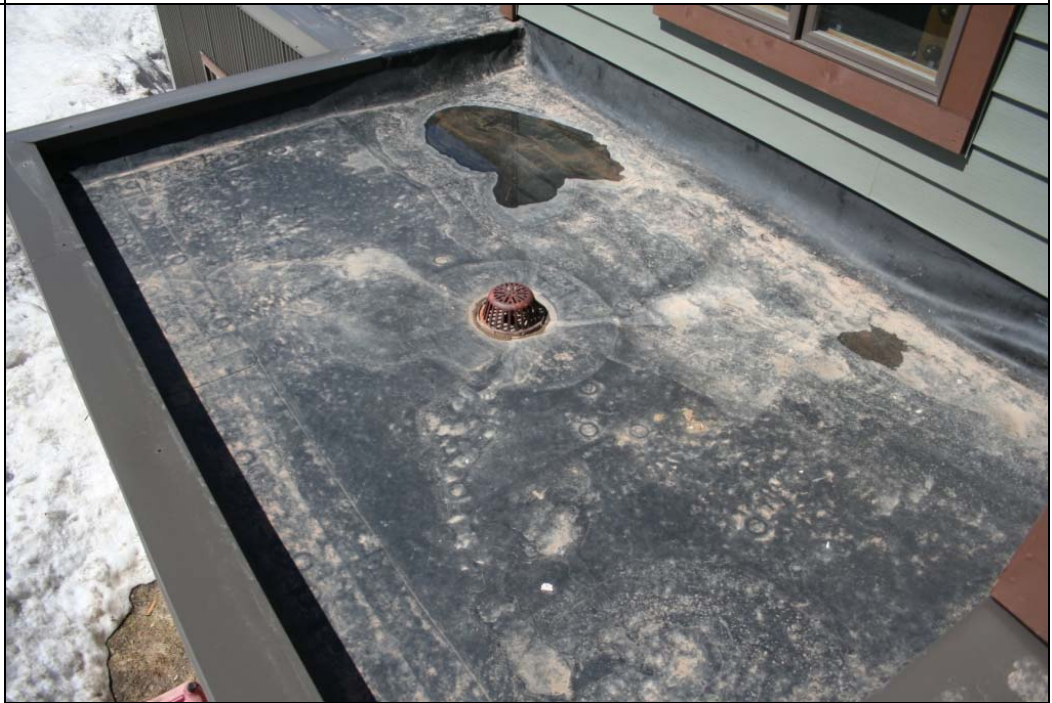
**Unit 28
Photo 1**

Notes: Roof Photo #1.

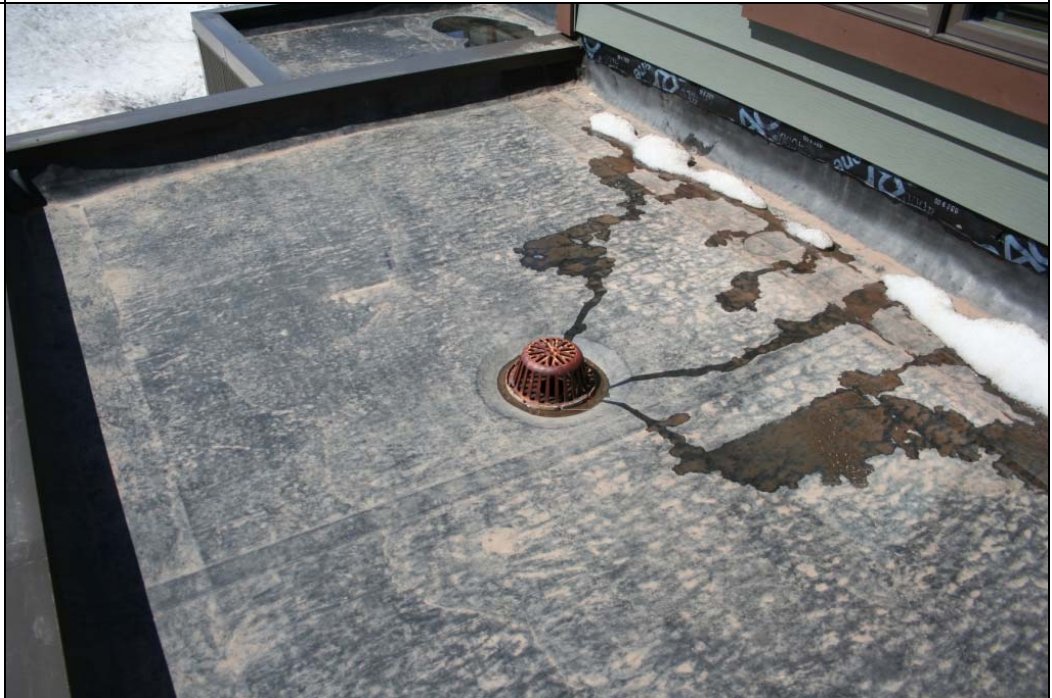
**Unit 29
Photo 1**

Notes: Roof Photo #1.

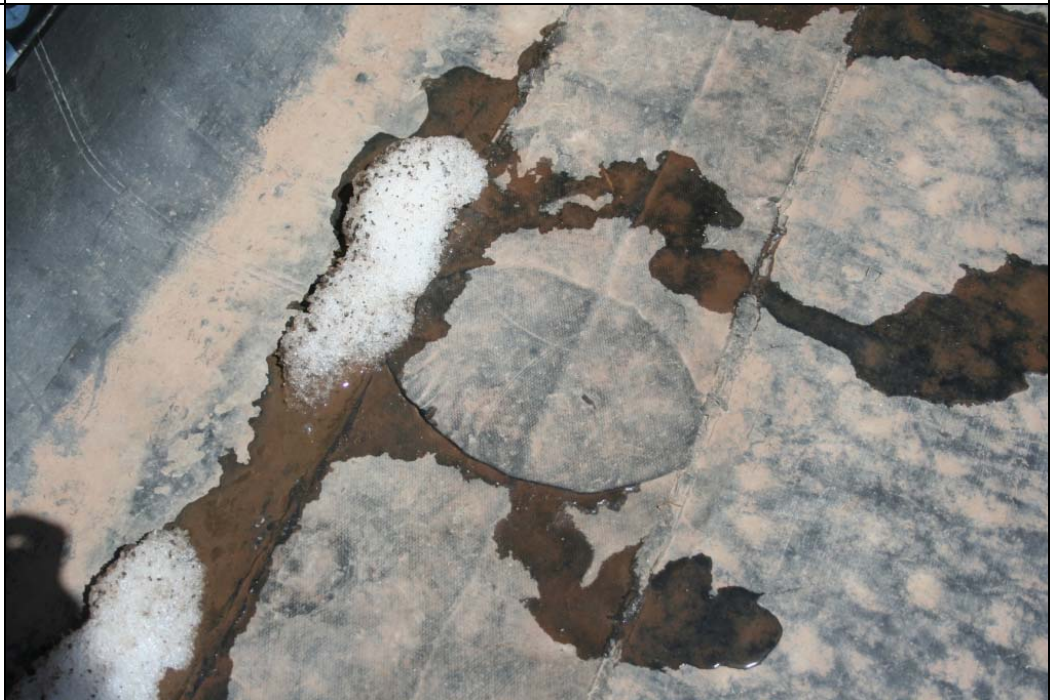
**Unit 29
Photo 3**

Notes: Patch located under west window.

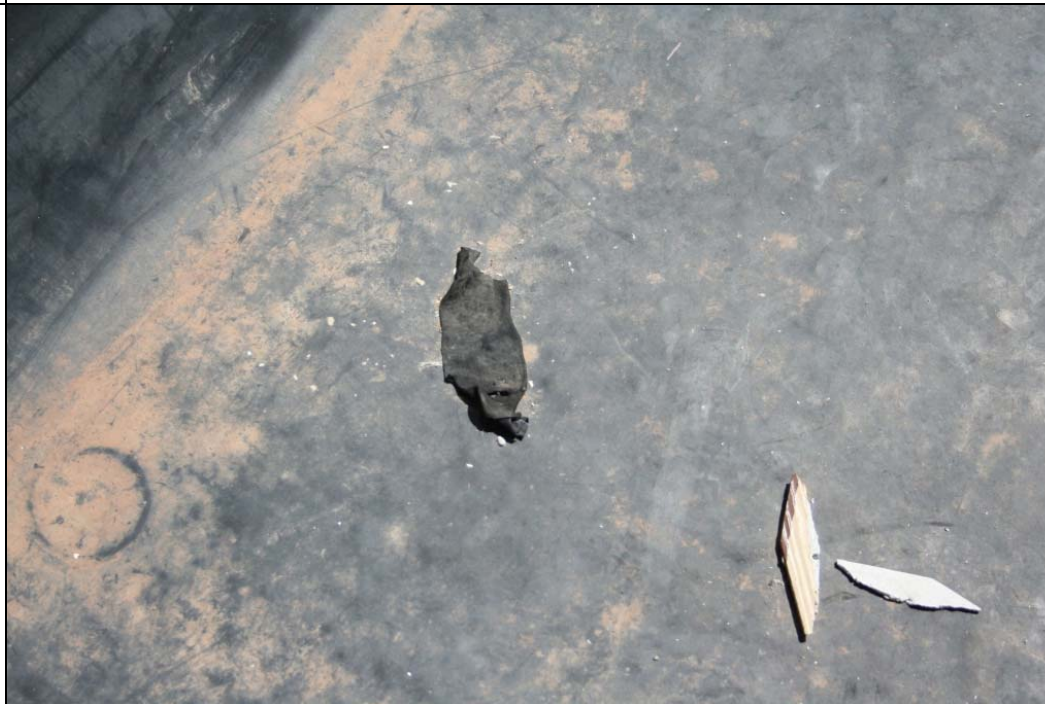
**Unit 30
Photo 4**

Notes: Detail of sealant in Photo 3. This is most likely not a patch. Note minor construction debris. Removed.

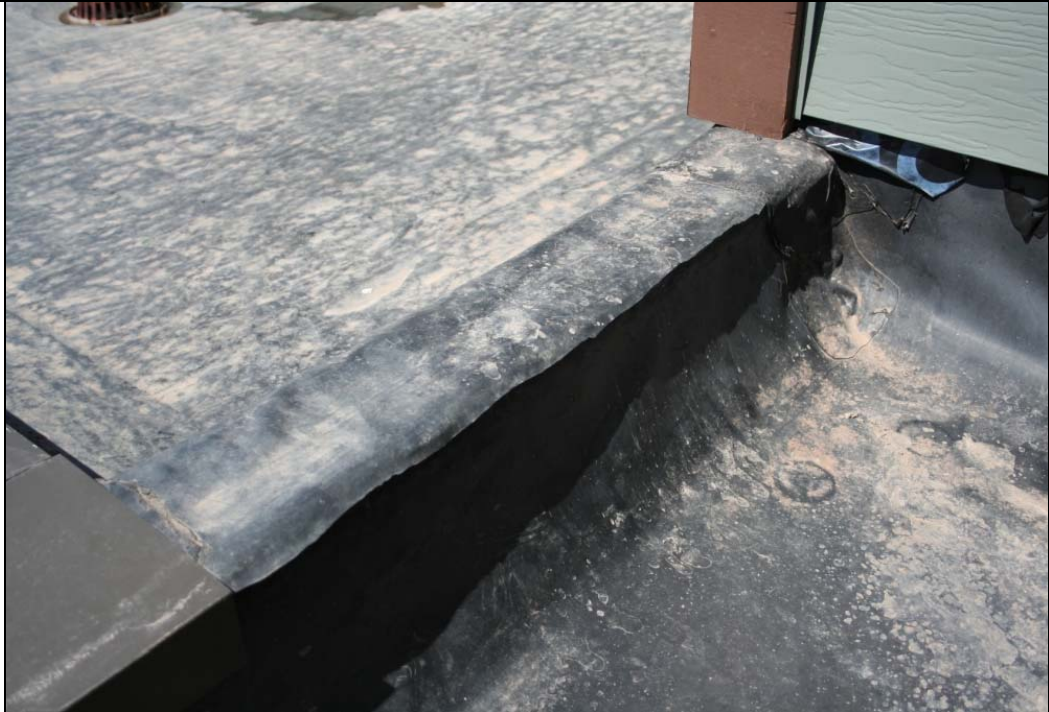
**Unit 30
Photo 5**

Notes: North parapet cap. Membrane from Unit 29 laps over the top of the parapet cap. The edge of the membrane is not fully adhered.

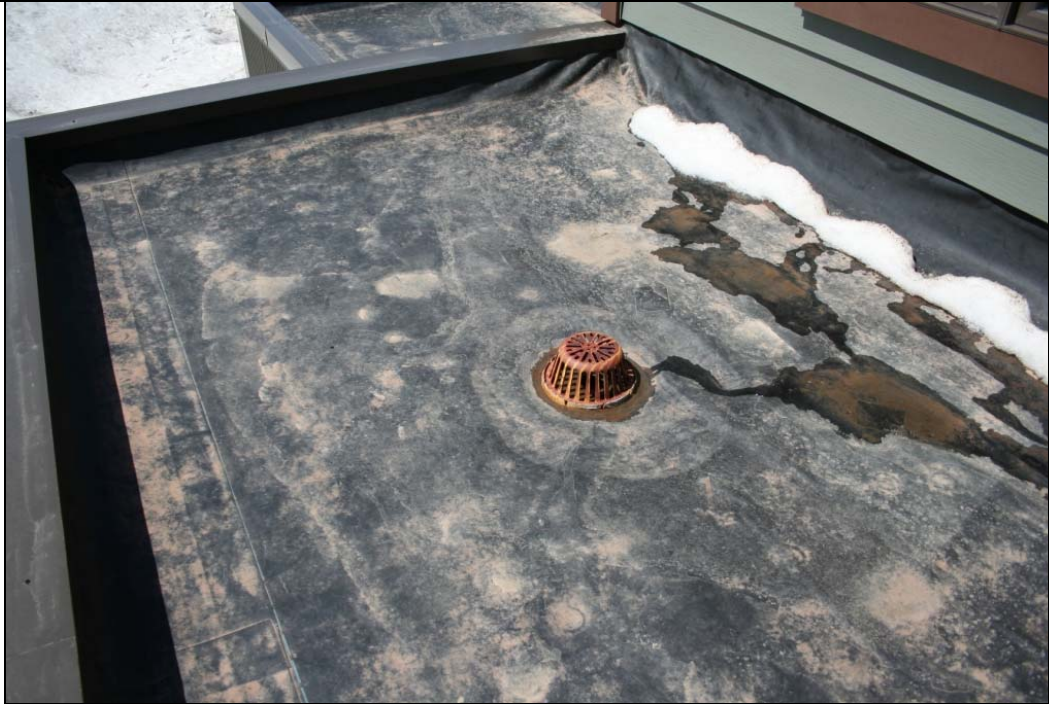
**Unit 31
Photo 1**

Notes: Roof Photo #1.

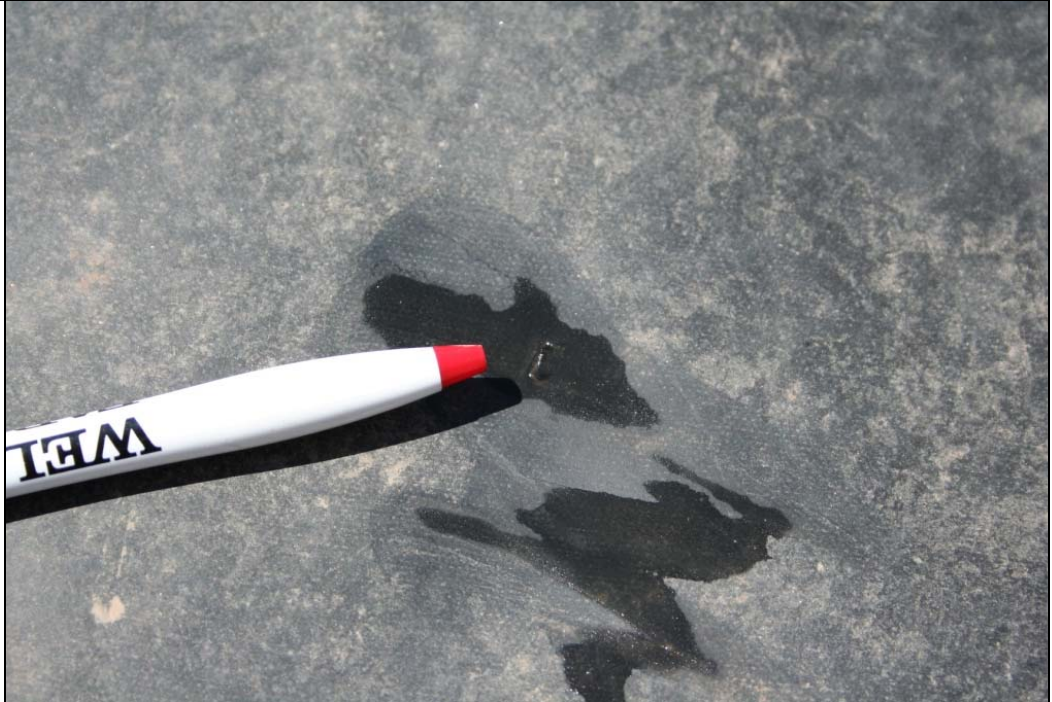
**Unit 31
Photo 4**

Notes: 1 Hole approximately 2' northwest of roof drain. Water discharged from saturated substrate.

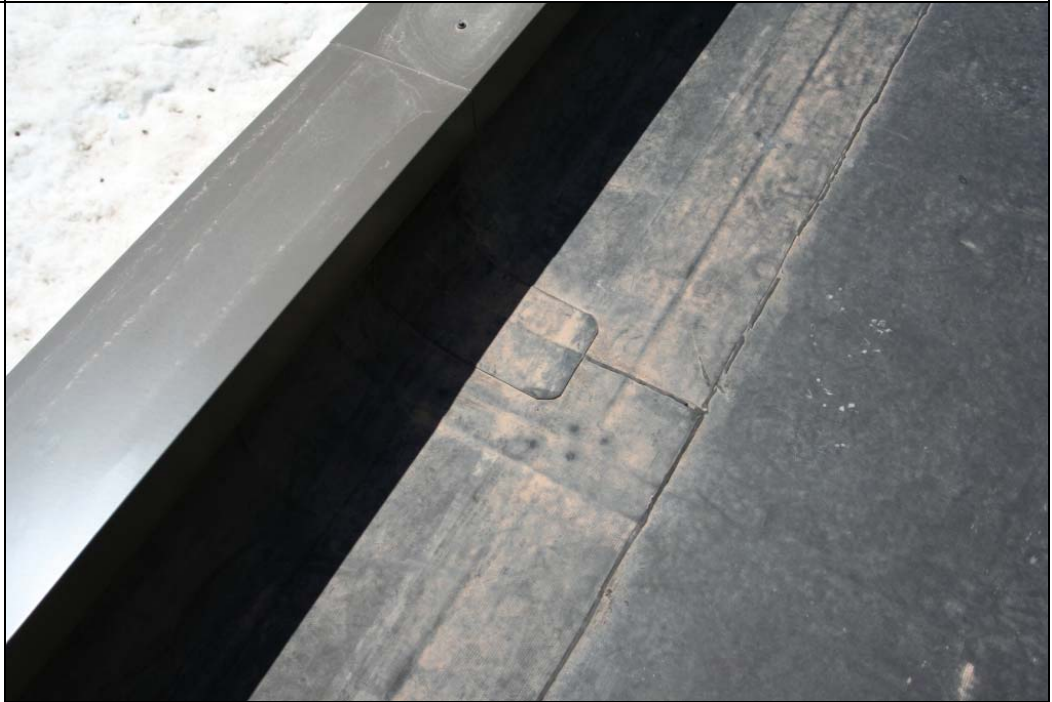
Unit 33
Photo 4

Notes: Glued seam at west centerline.

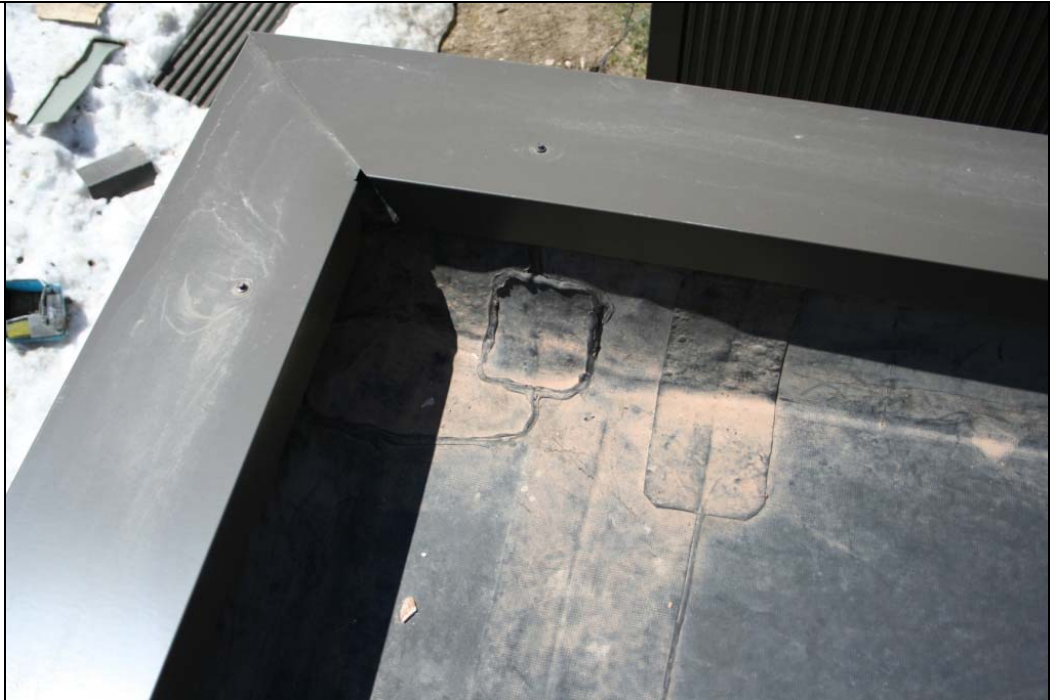
Unit 33
Photo 5

Notes: Glued patch at northwest corner.

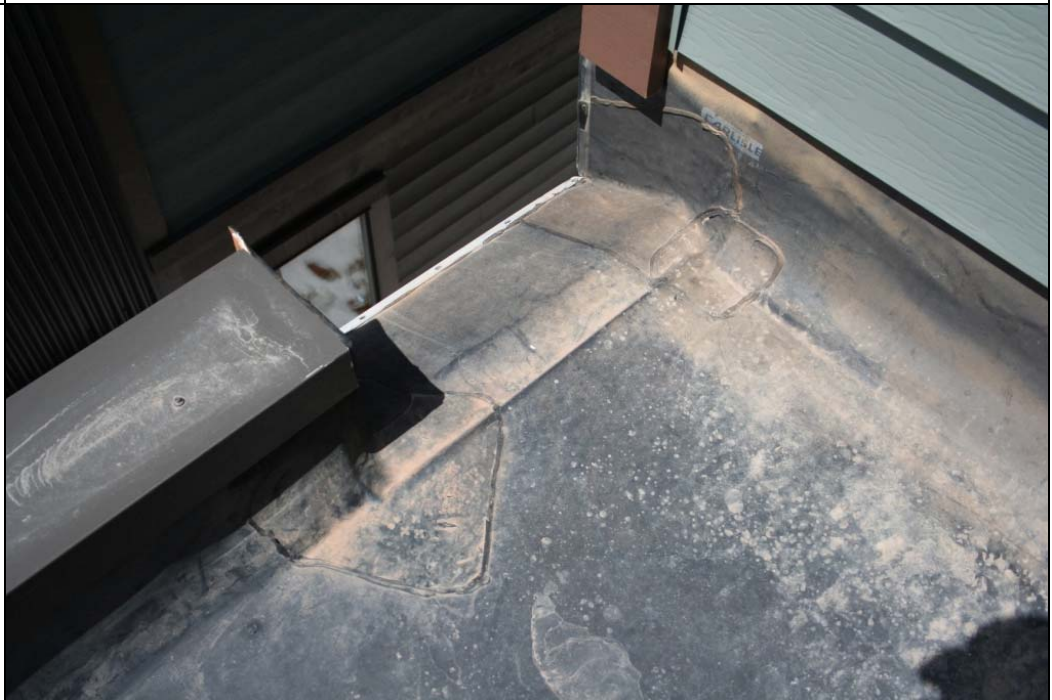
Unit 33
Photo 6

Notes: Glued patches at northeast overflow scupper.

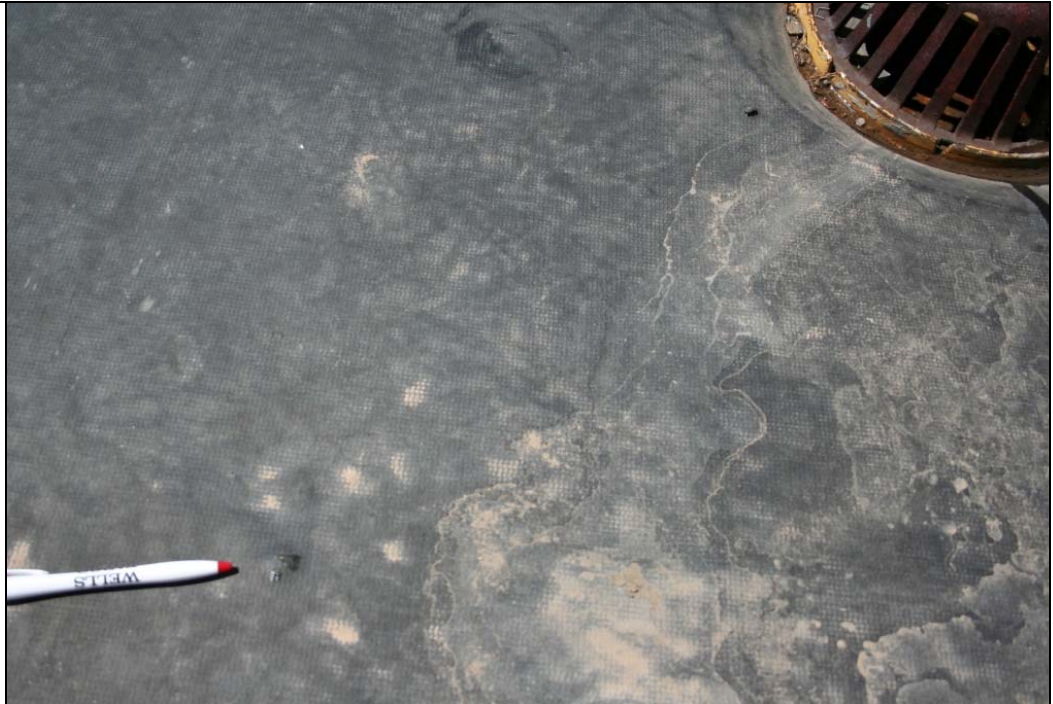
**Unit 33
Photo 7**

Notes: Nail head protruding southwest of drain.

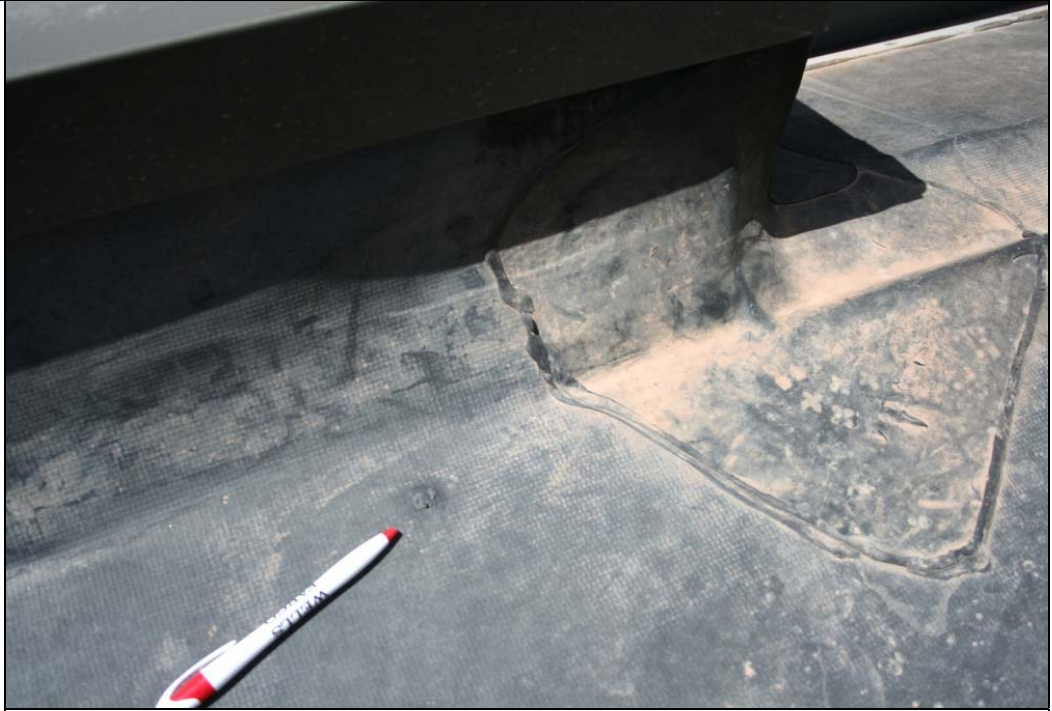
**Unit 33
Photo 11**

Notes: Proximity photo of Photo 10.

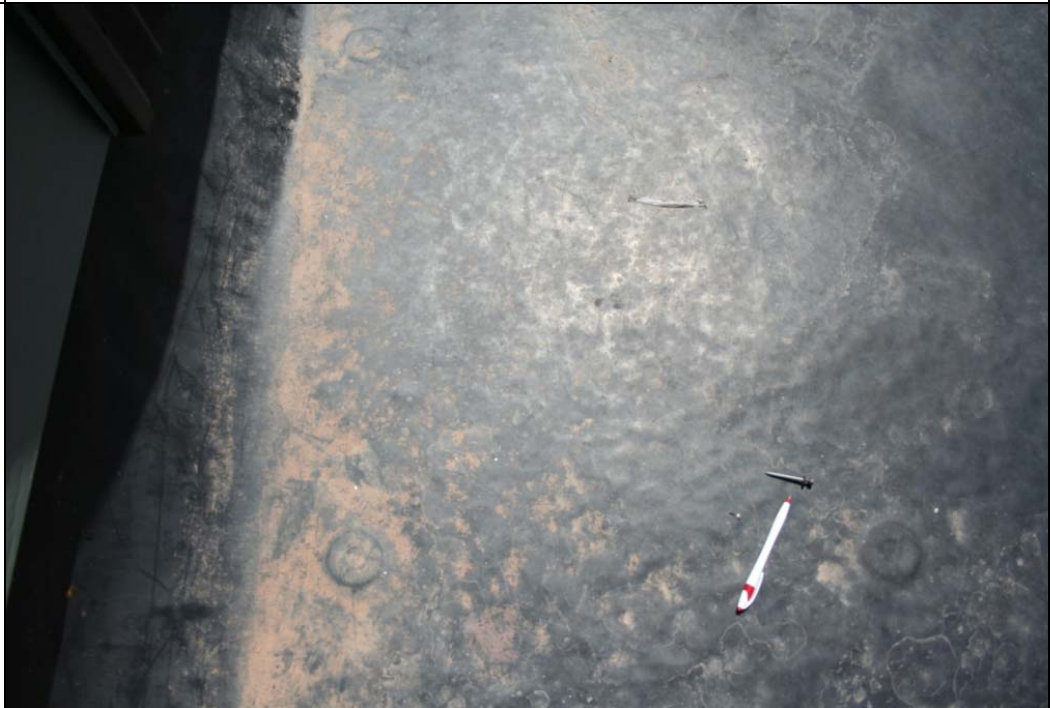
**Unit 34
Photo 3**

Notes: Screw from construction project. Removed.

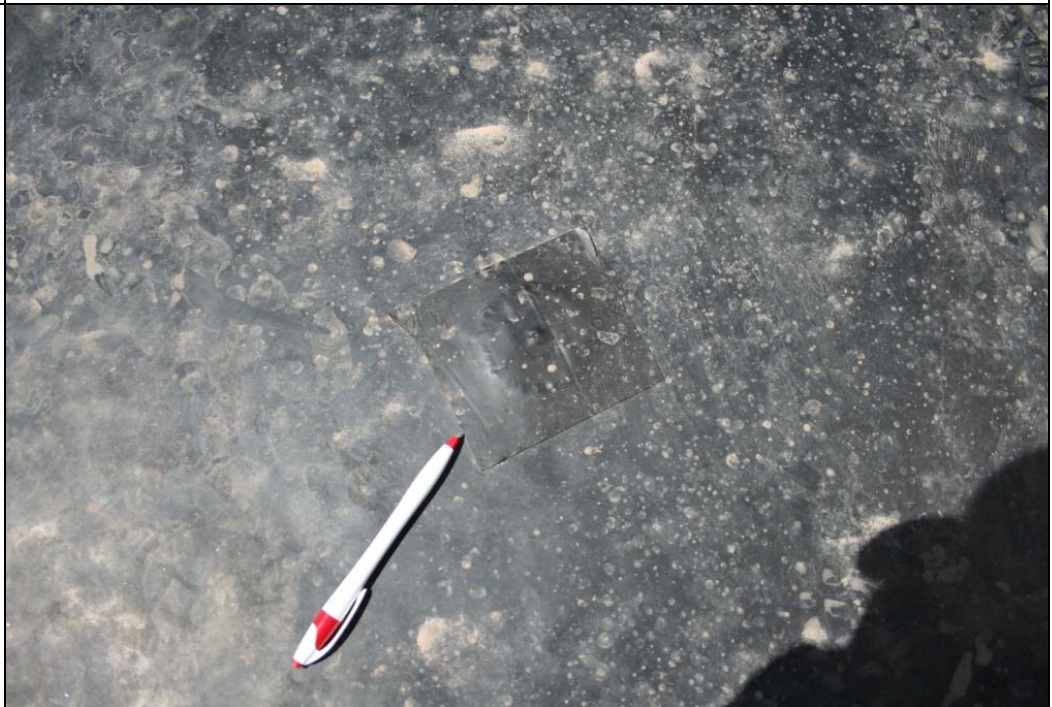
**Unit 34
Photo 5**

Notes: Detail of Photo 4.

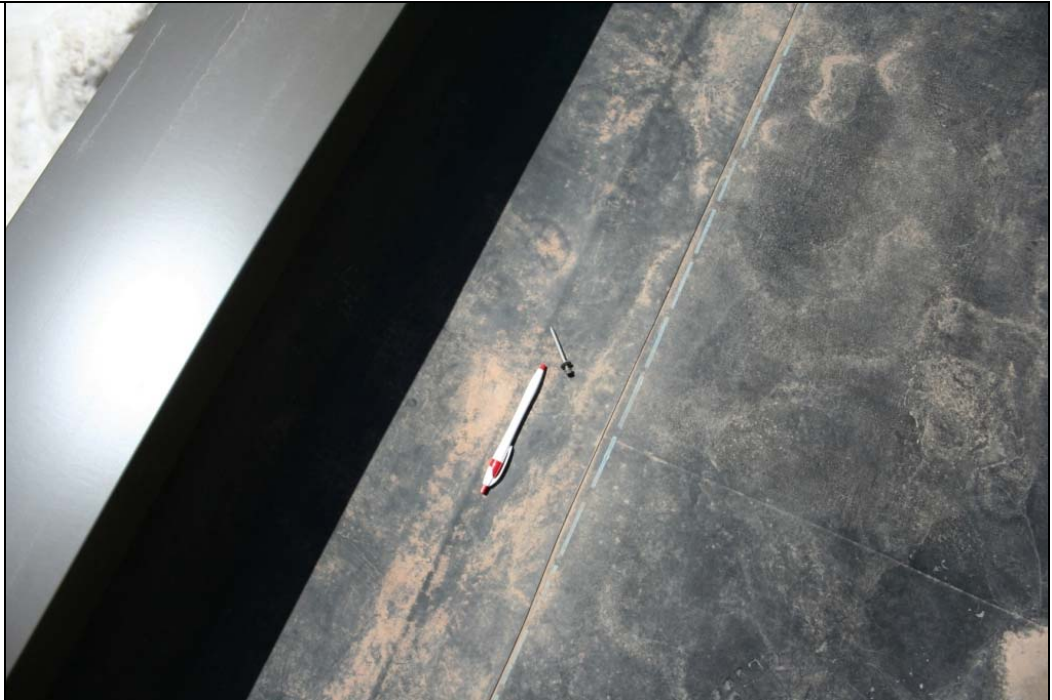
**Unit 36
Photo 3**

Notes: Screw from previous construction project. Removed.

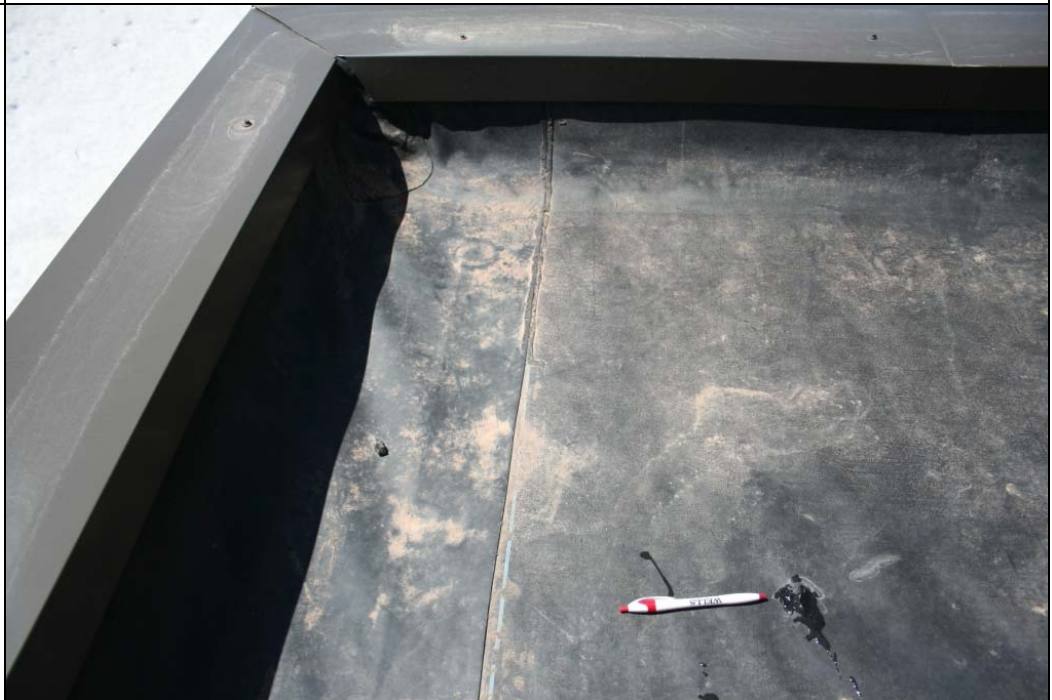
**Unit 36
Photo 4**

Notes: Hole in membrane, northwest corner.

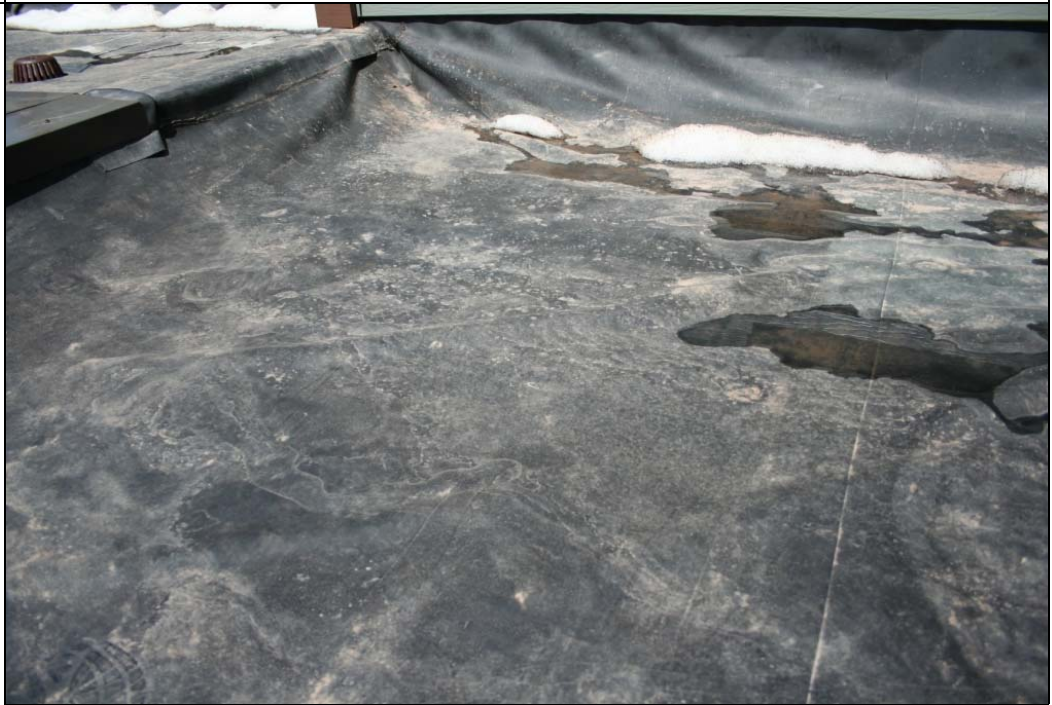
**Unit 36
Photo 6**

Notes: Membrane is not adhered to substrate.

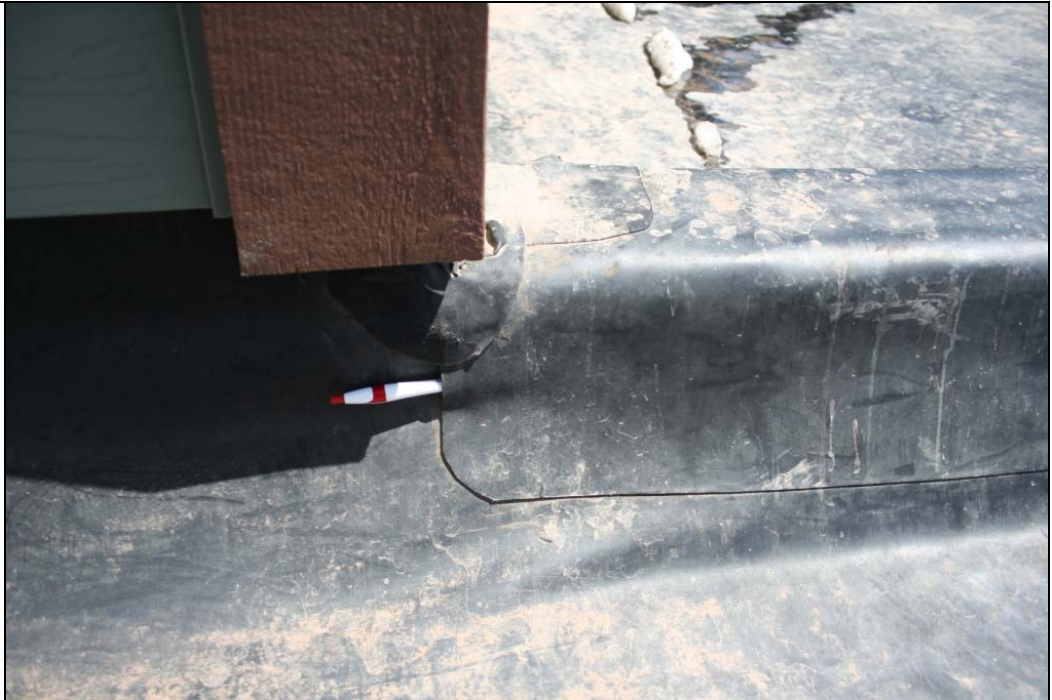
**Unit 37
Photo 3**

Notes: Seam not fully adhered in south parapet cap.
