ARCHITECT'S FIELD REPORT

PROJECT	Eagle's Nest Townhouses 11 Morning Glory Way & 31 Marcellina Lane Mt. Crested Butte, CO 81225	DATE	5/9/11
----------------	--	-------------	--------

WORK OBSERVED
Phase II – Roof Audit, Existing Conditions Units 1 through 8

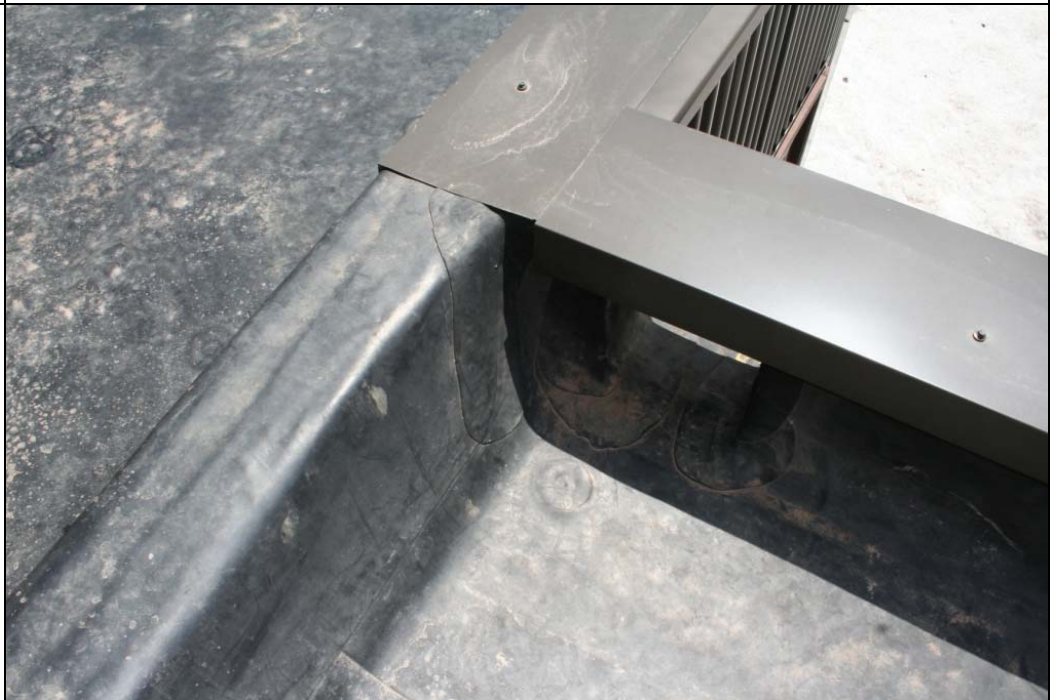
**Unit 37
Photo 4**

Notes: Lapped membrane at corner.

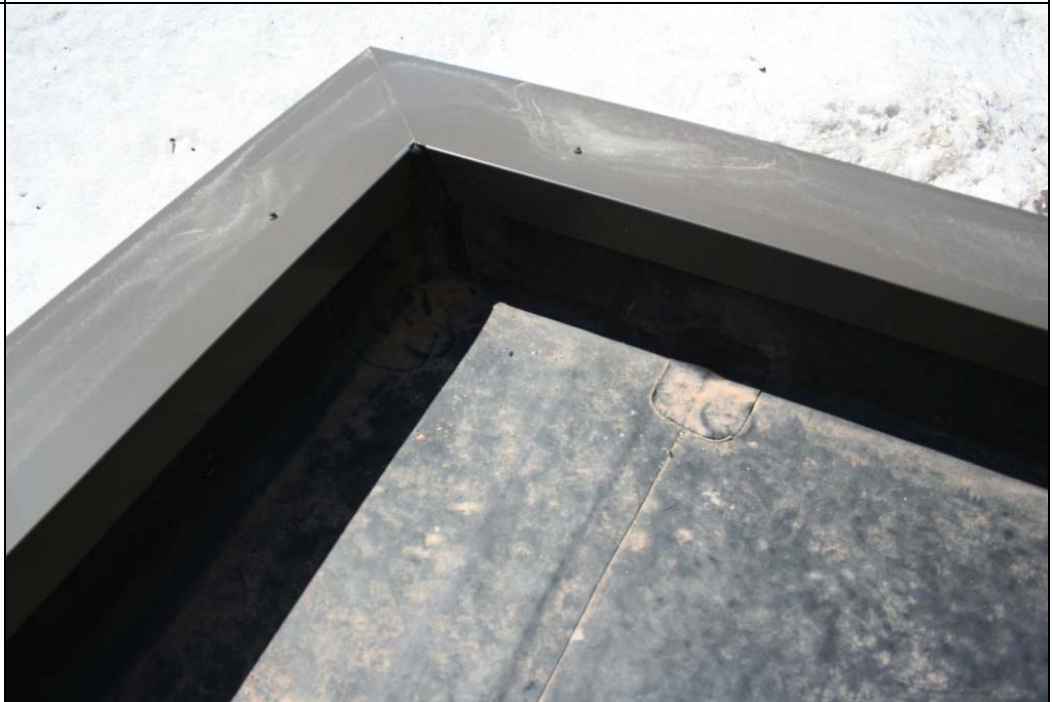
Unit 39
Photo 3

Notes: Seam patch at northwest corner.

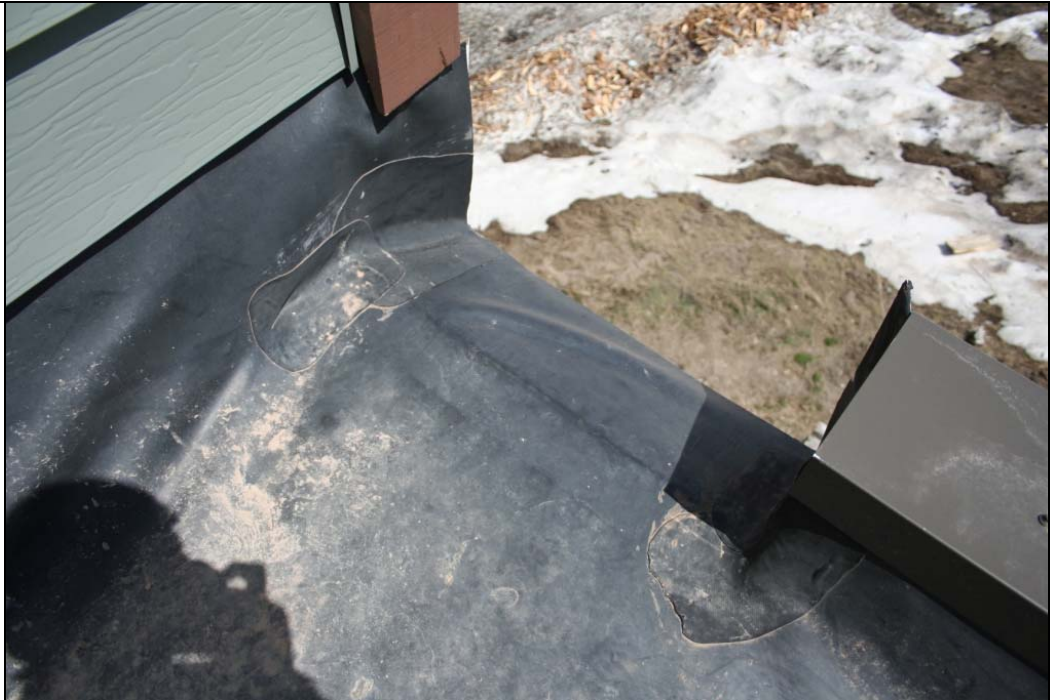
**Unit 40
Photo 3**

Notes: Overflow scupper detail.
